KiwiRail

Muri Station Risk Assessment Report

Appendix C

Condition Photographs of Muri Station

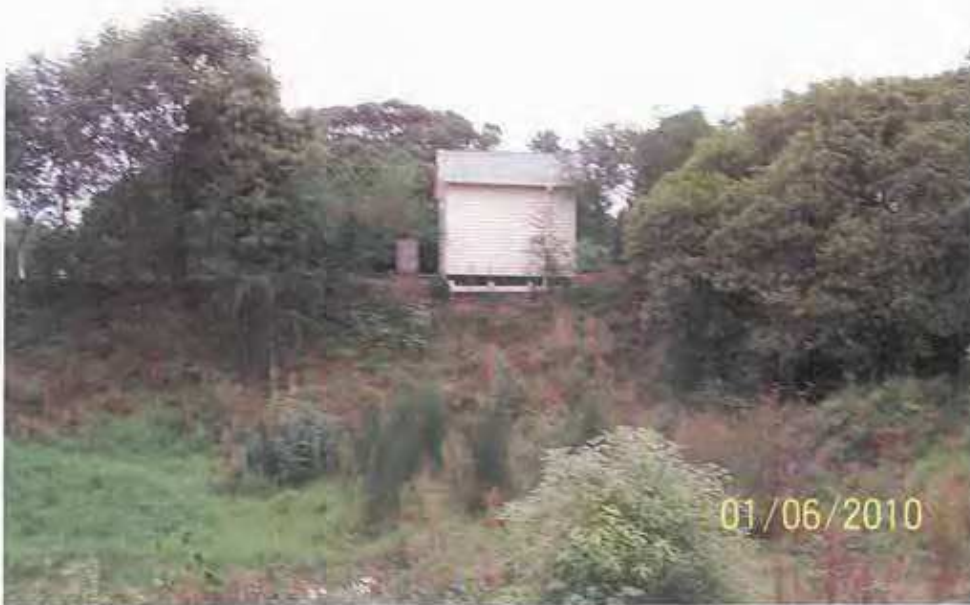
Photo1 – Looking at up platform from up platform access road

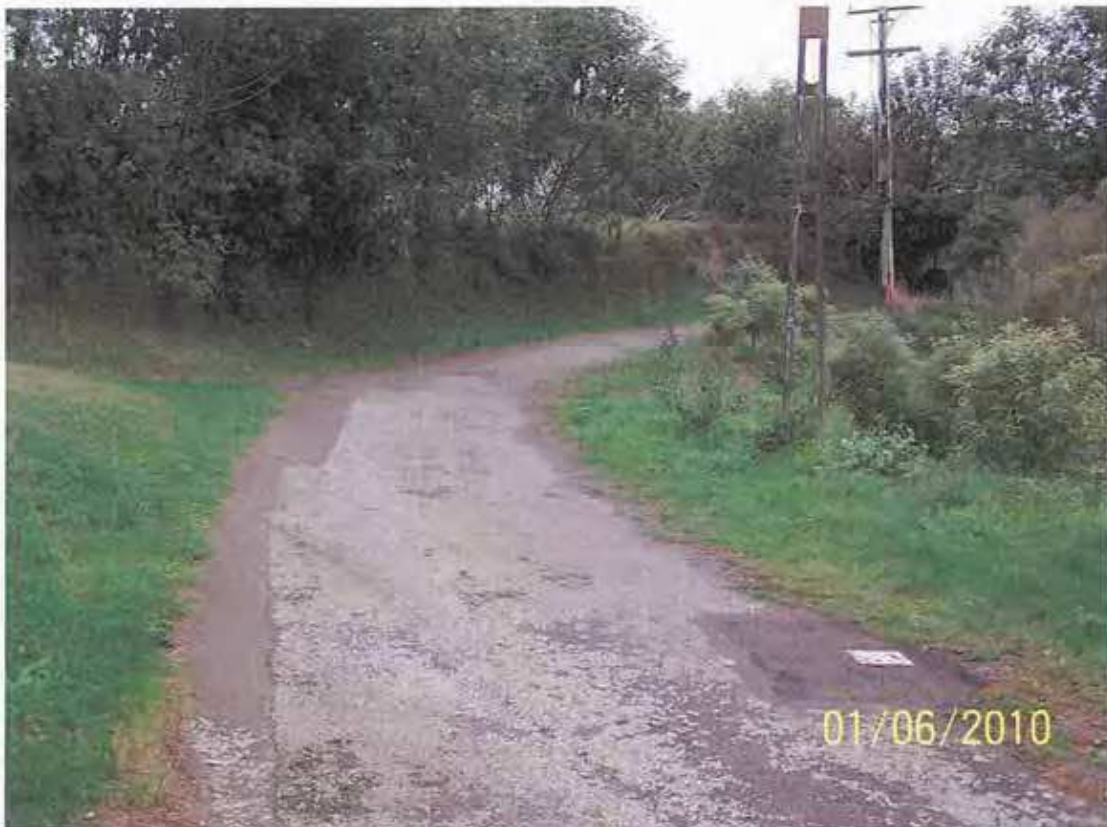
Photo 2 – Formal access to up platform

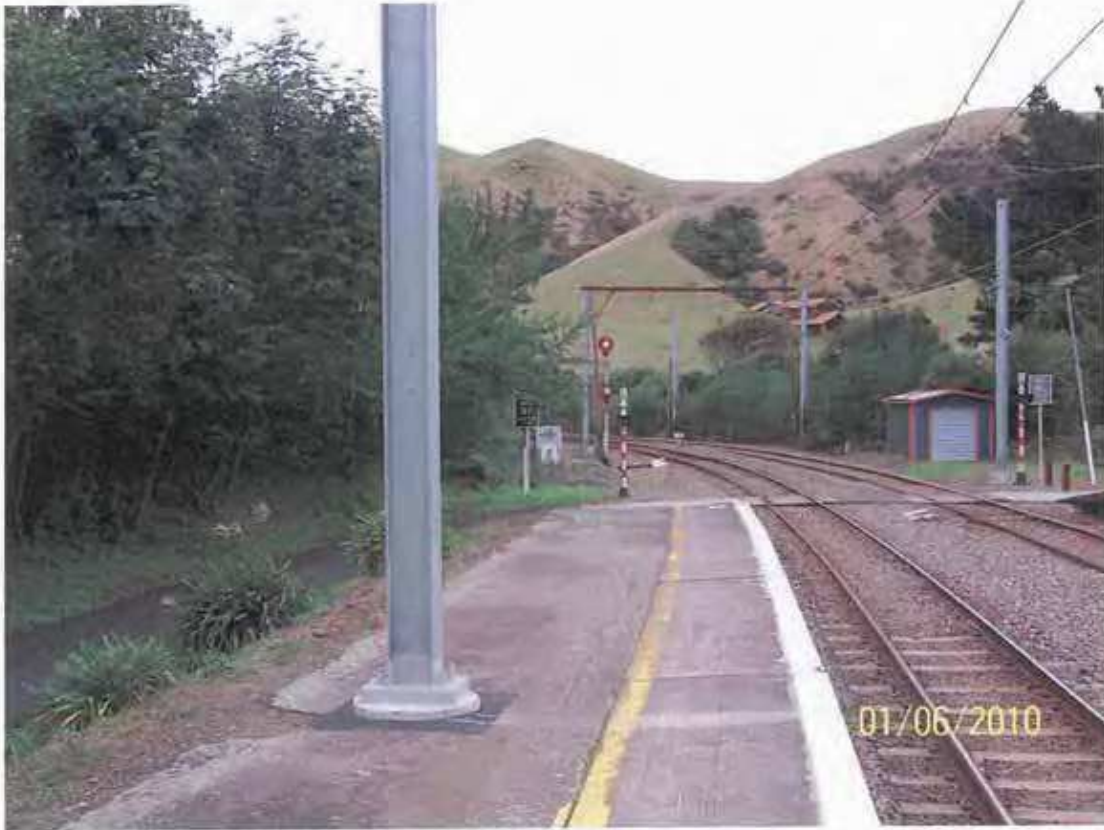
Photo 3 – Up platform looking north

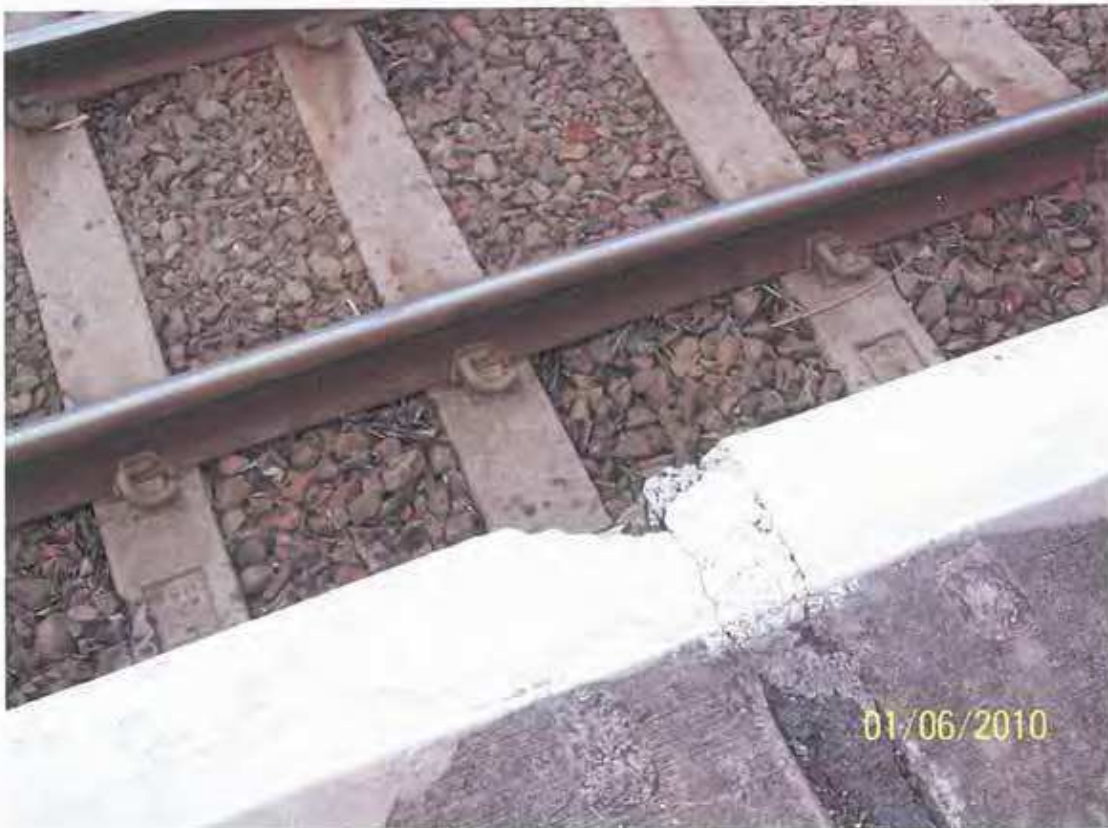
Photo 4 – Up platform edge damage

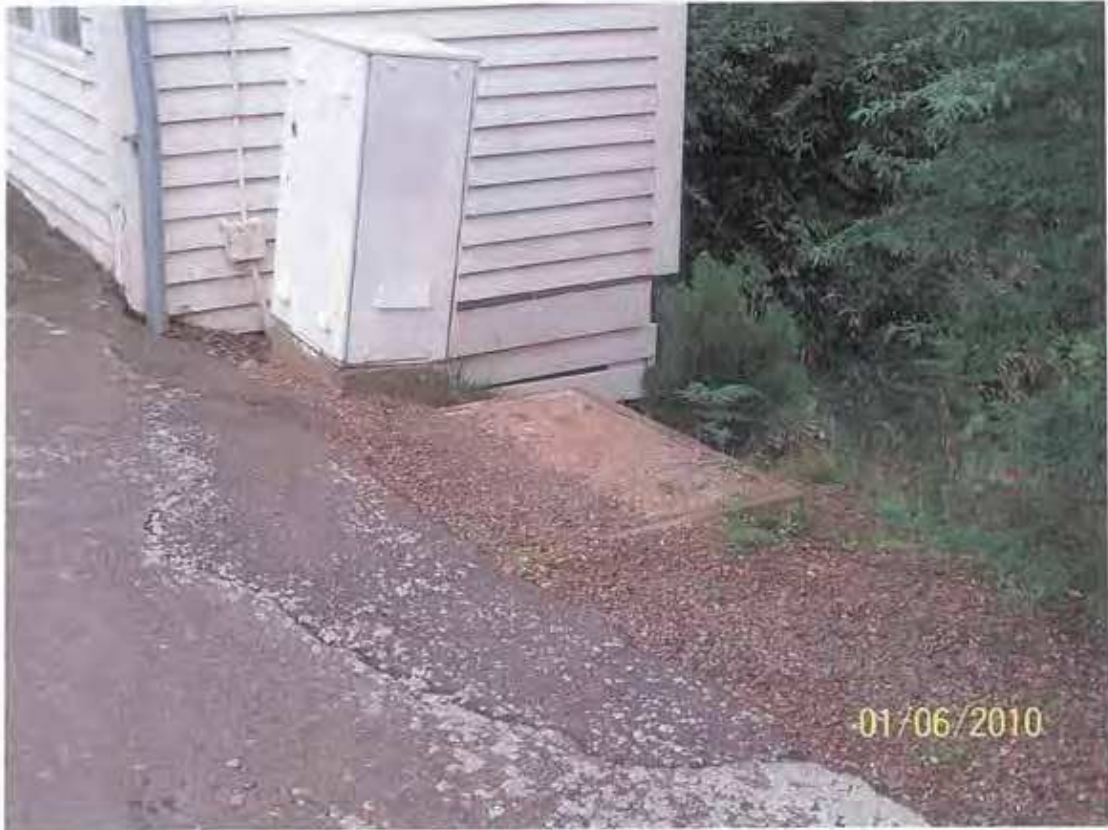
Photo 5 – Up platform surface defect and montrose box

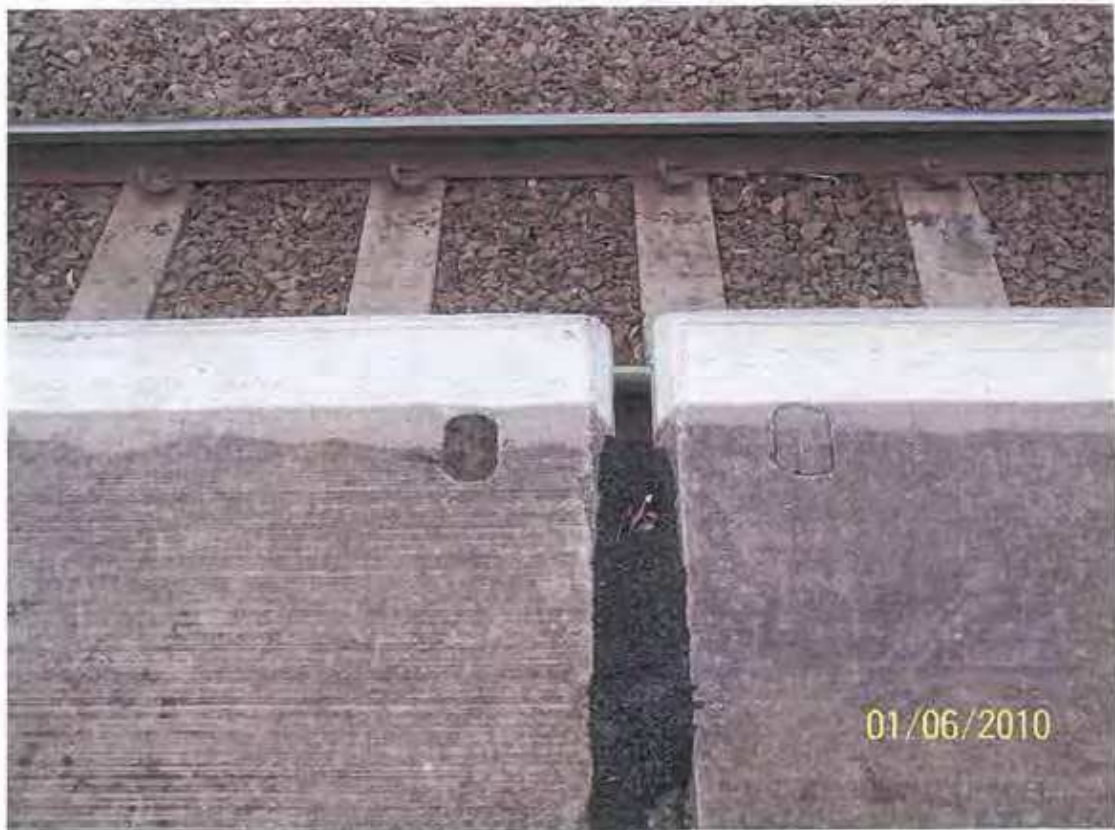
Photo 6 – Up platform platform edge defect

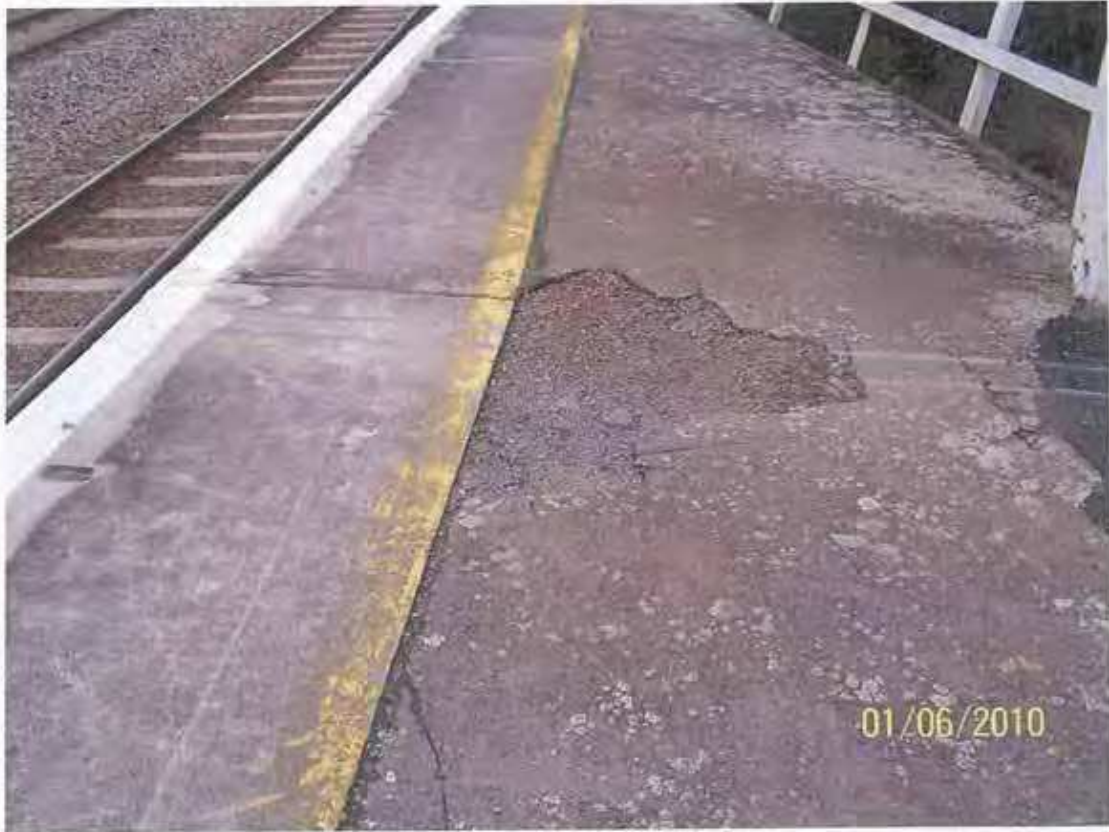
Photo 7 – Up platform surface defect

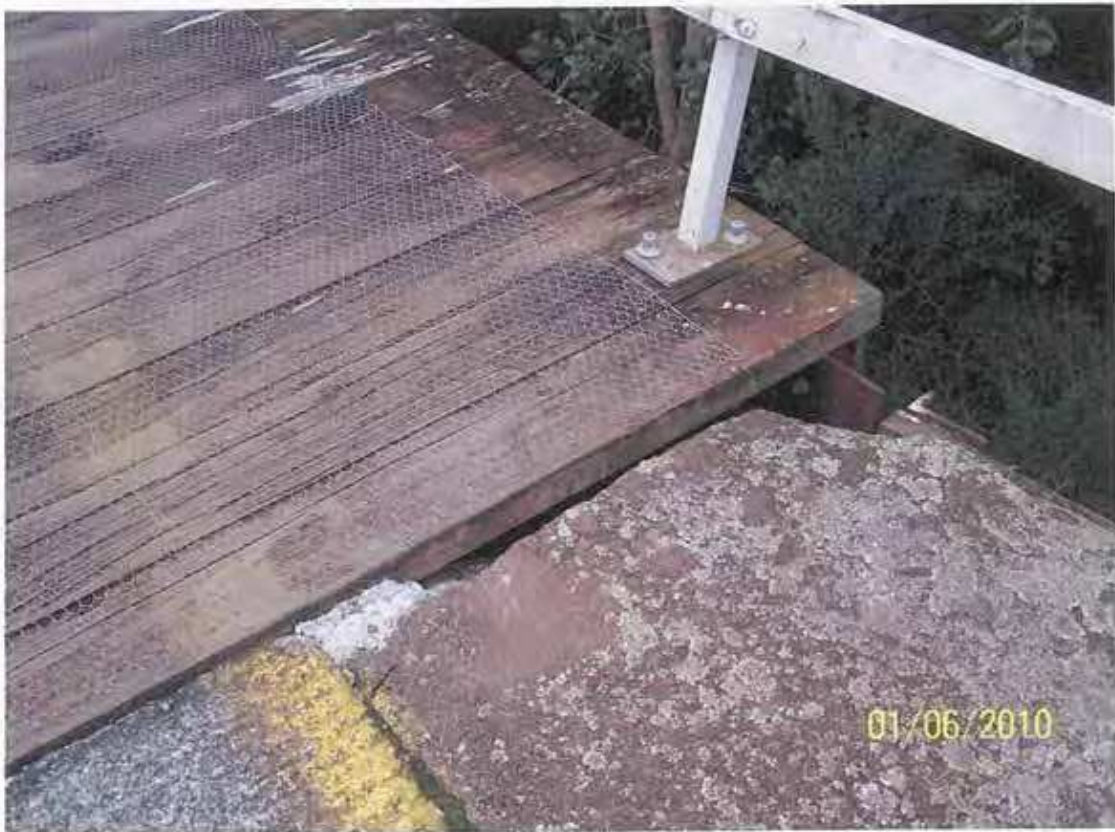
Photo 8 – Up platform timber to concrete platform transition

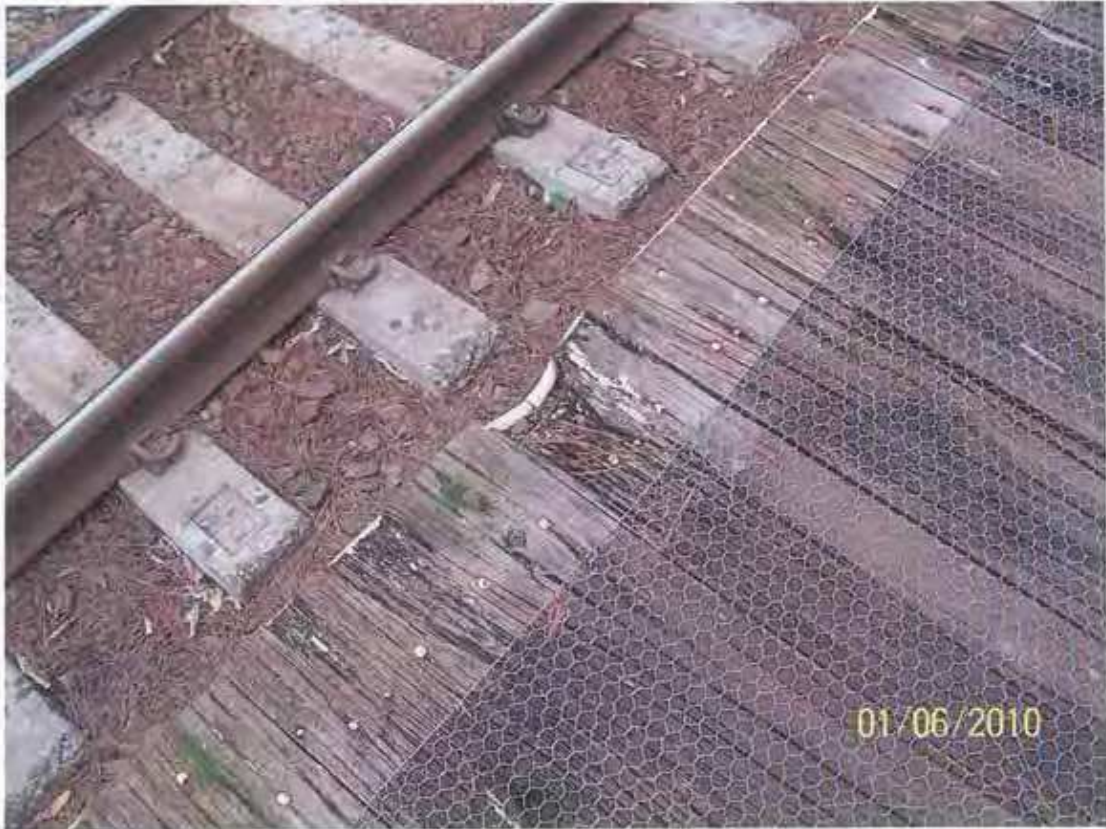
Photo 9 – Up platform timber edge condition

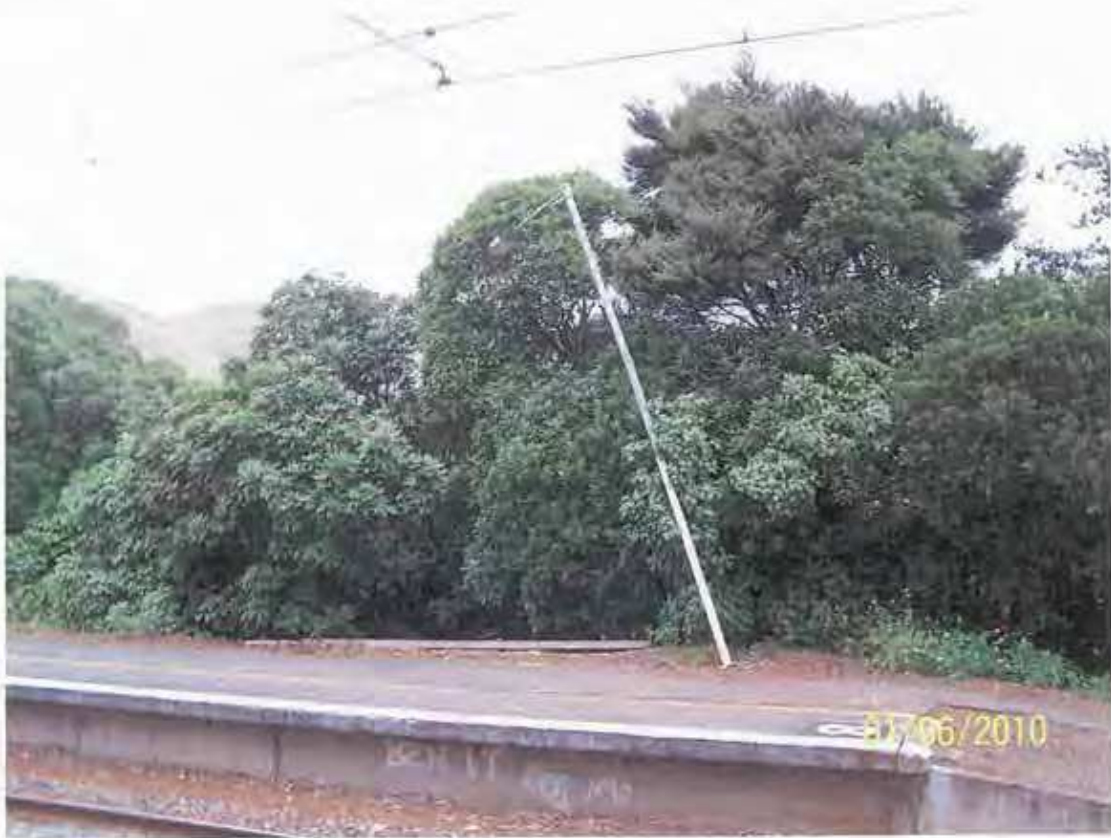
Photo 10 – Down platform lighting mast and damage platform edge

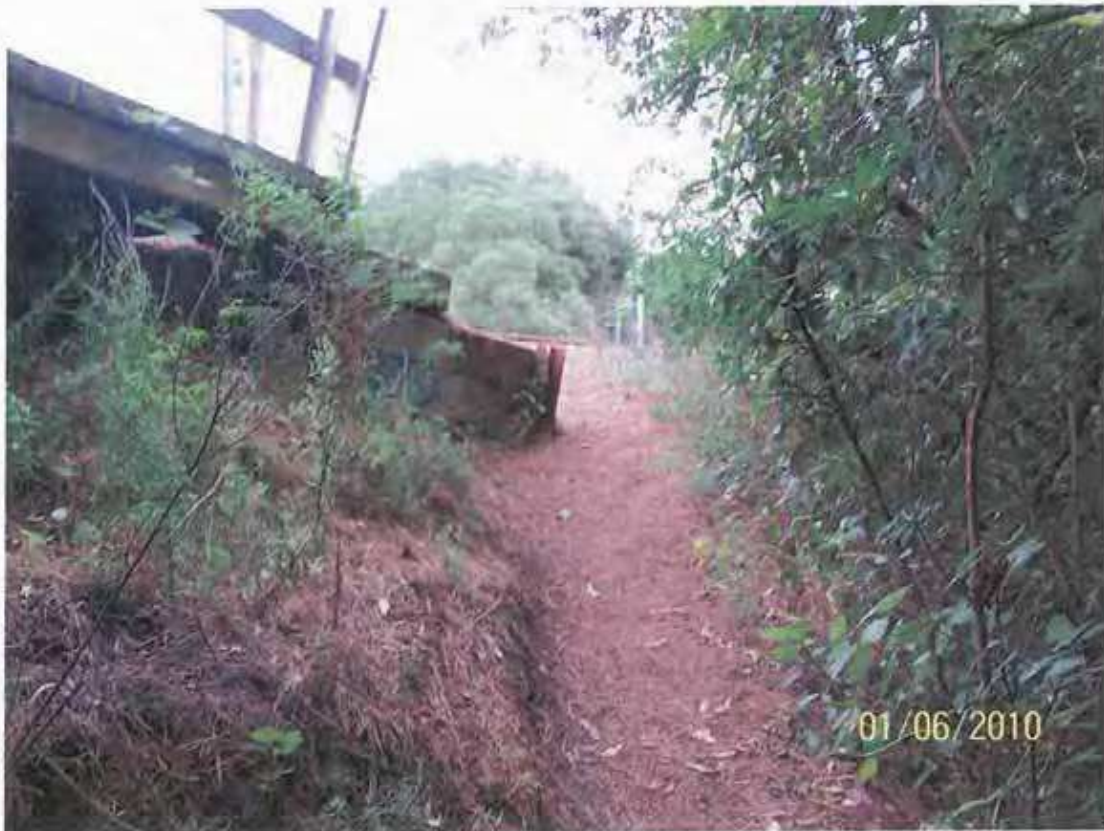
Photo 11 – Up platform southern end – illegal access point

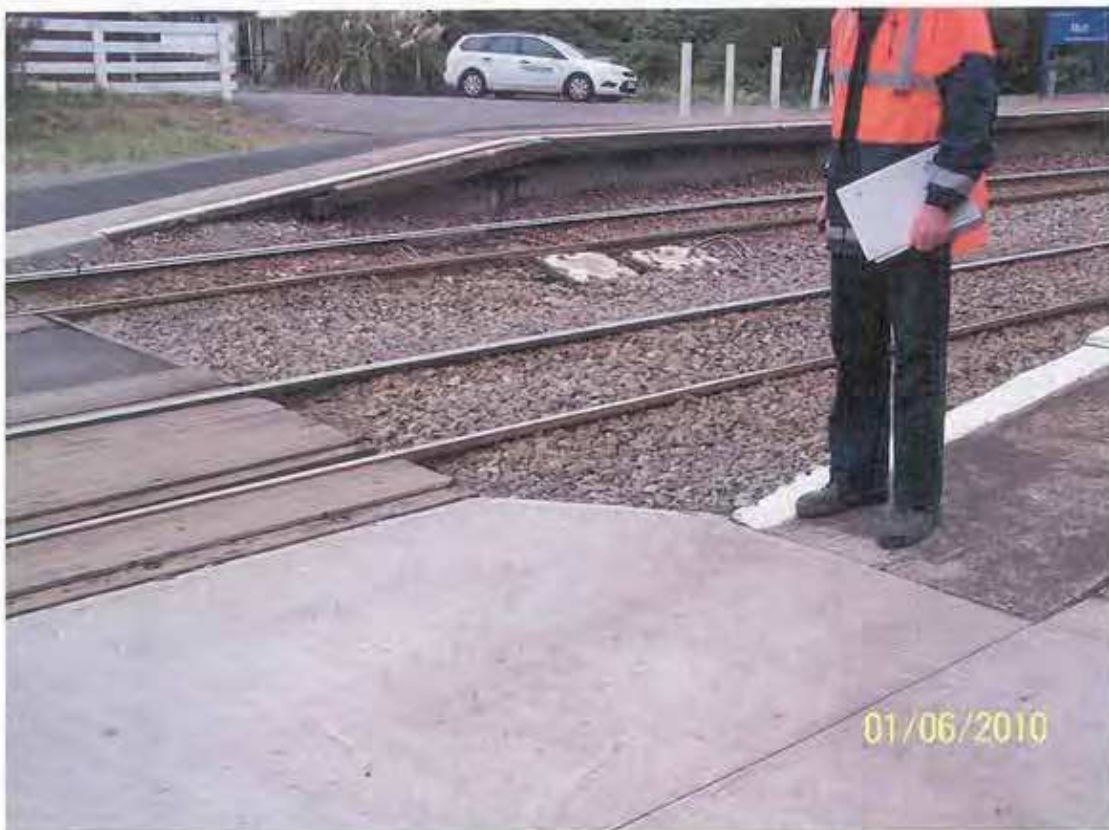
Photo 12– Level crossing devoid of limit lines or TSI's

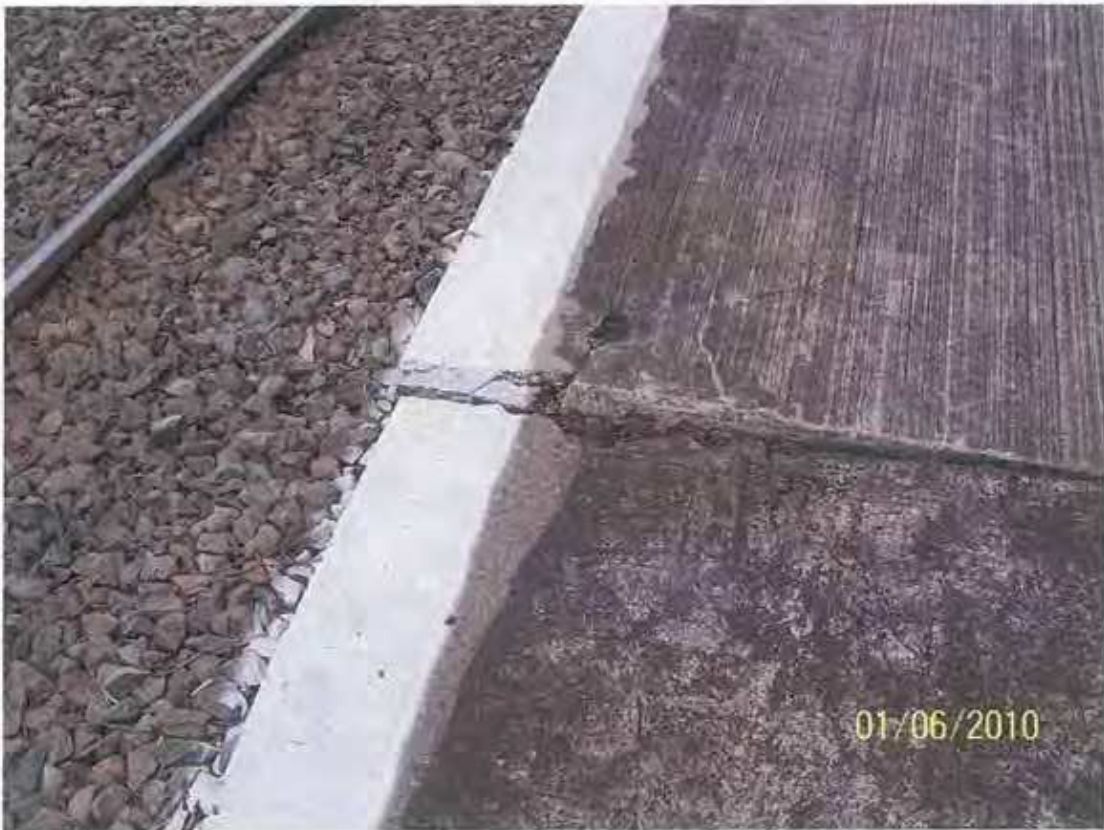
Photo 13 – Up platform northern end – misaligned transition

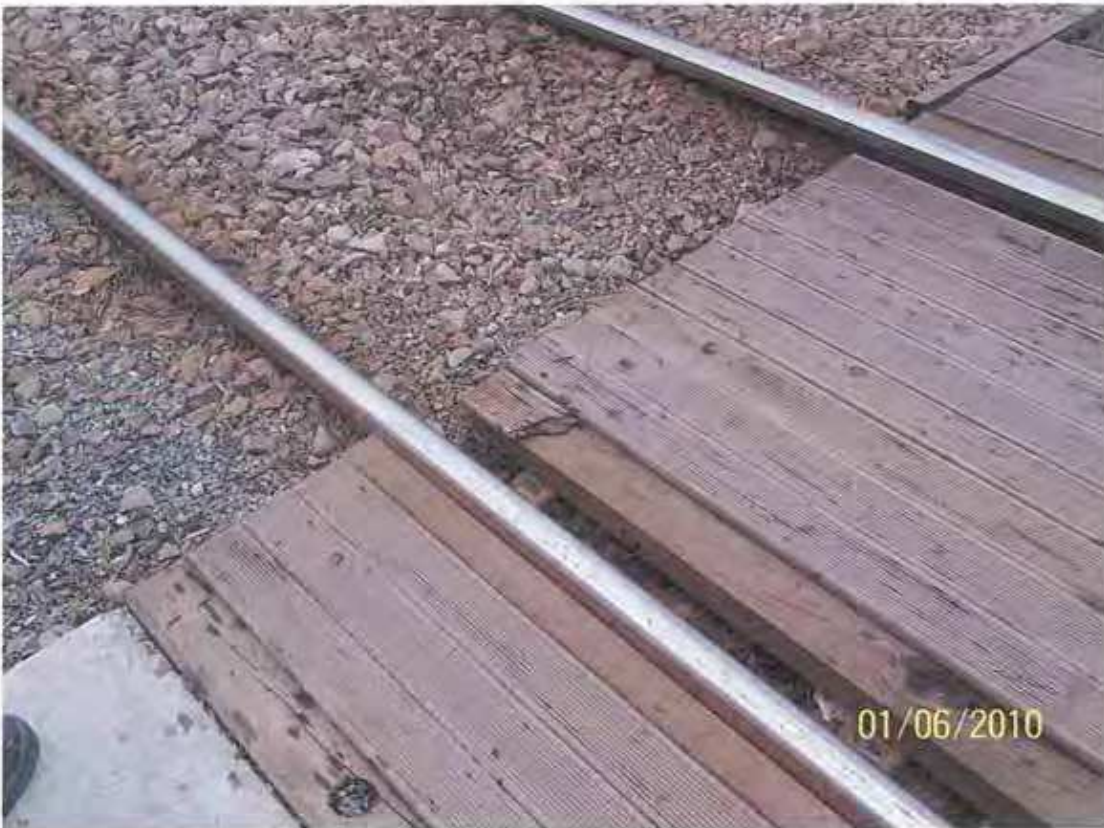
Photo 14 – Level crossing damage and trip hazards

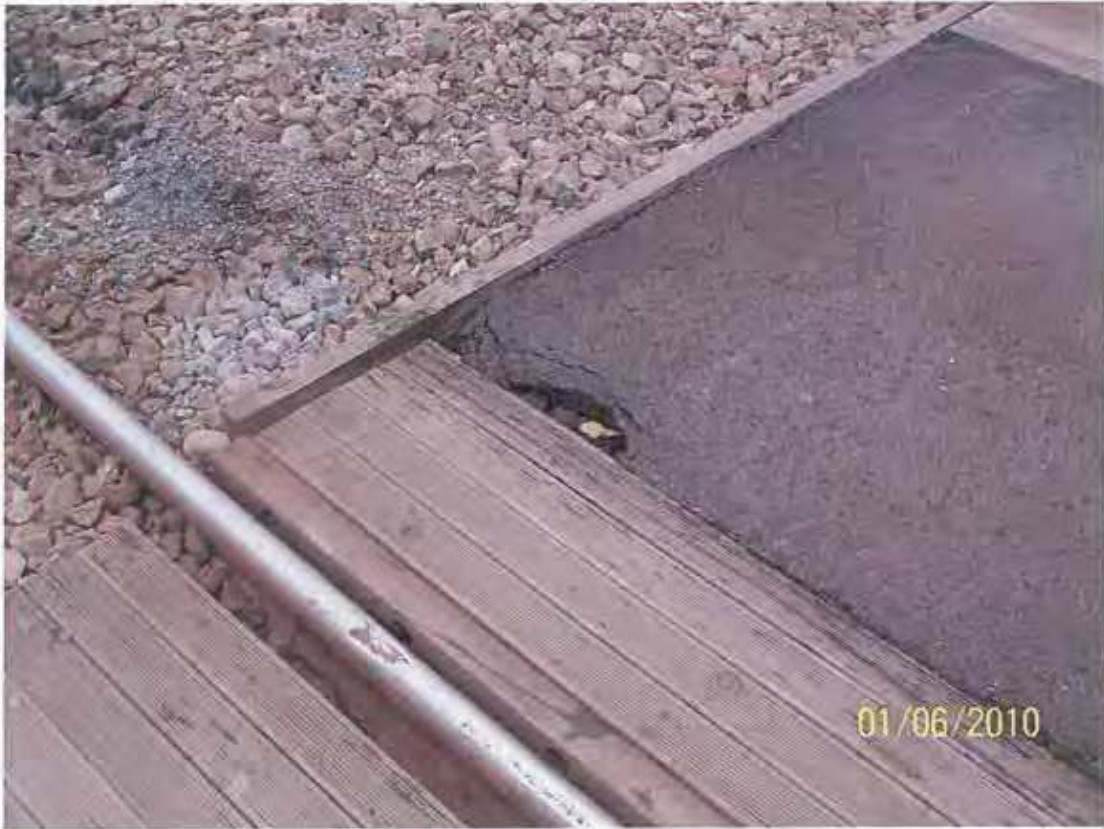
Photo 15 – Level crossing surface defect

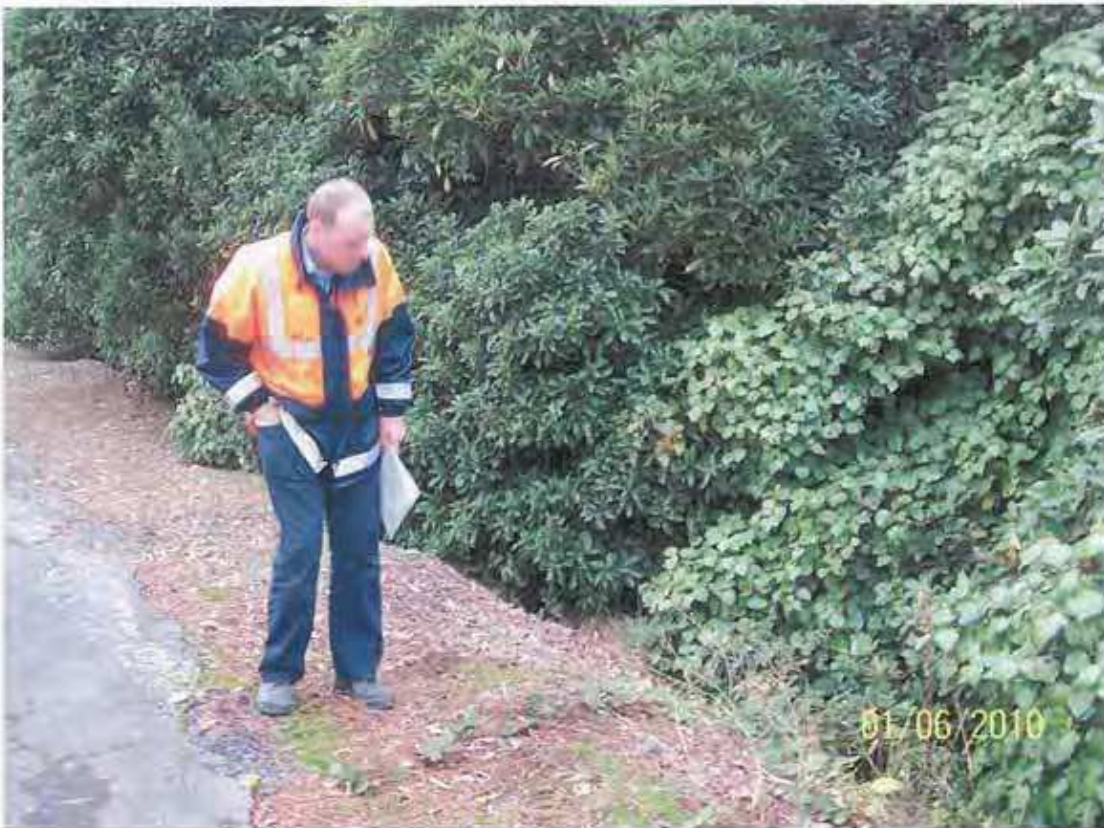
Photo 16 – Down platform – unprotected bak of platform

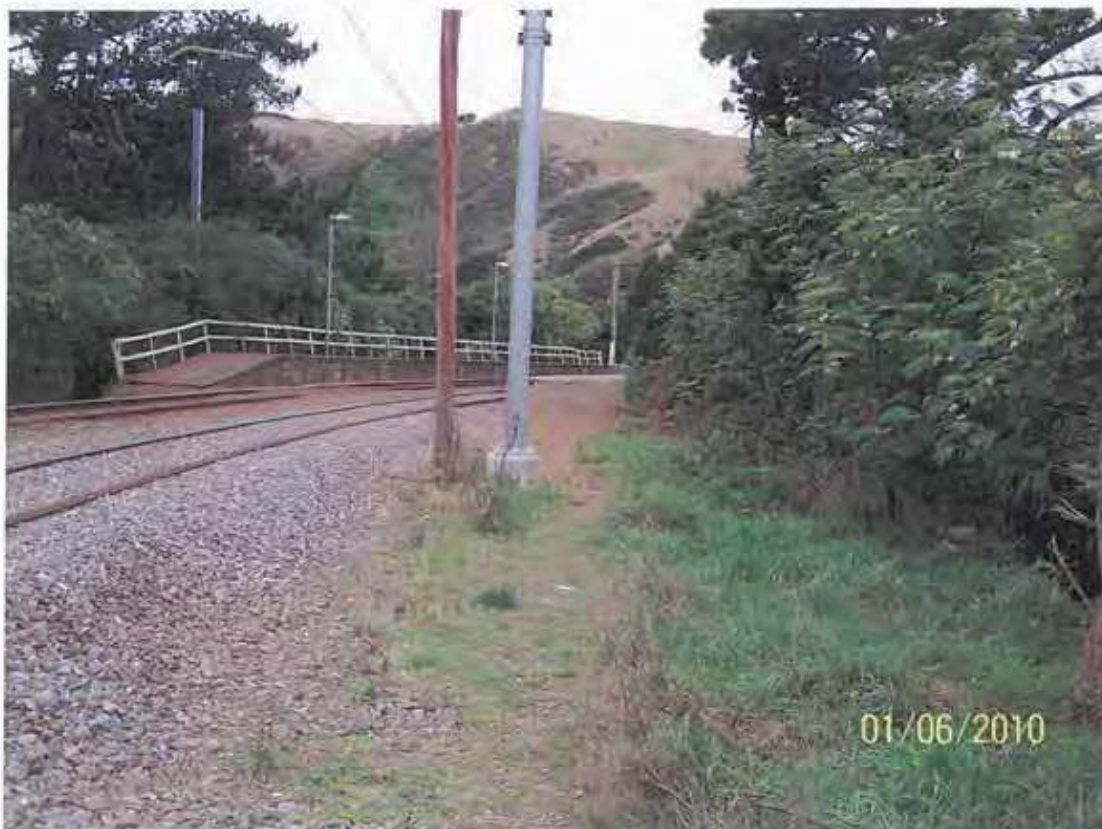
Photo 17 – Down platform southern end – illegal access point

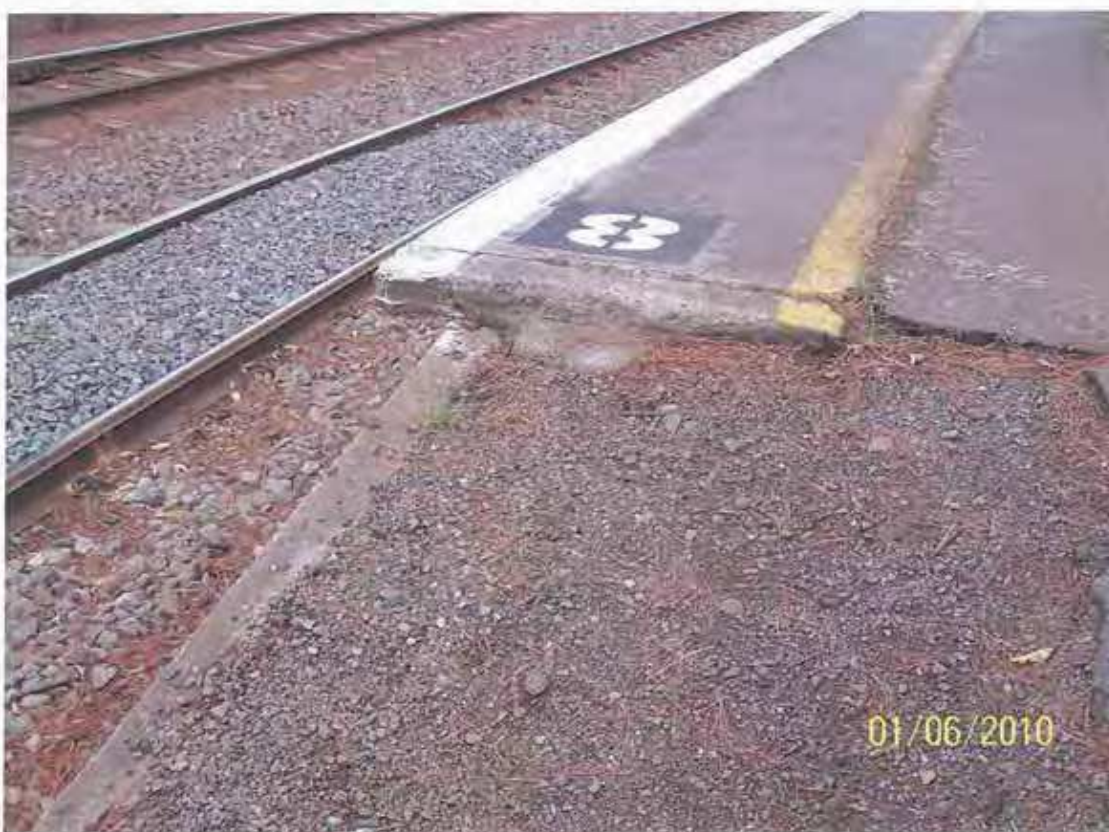
Photo 18 – Down platform southern end – Platform defect

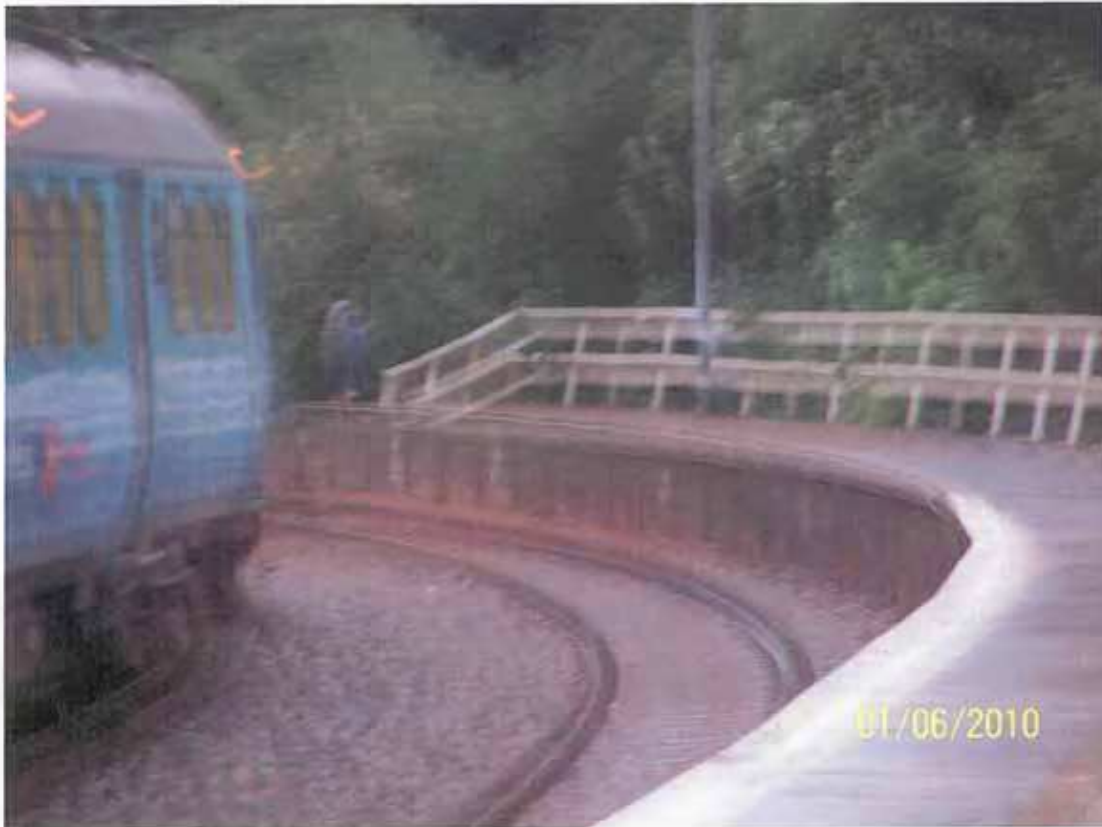
Photo 19 – Up platform southern end – illegal access point in use
