Eastern Bays Shared Path: Freshwater Fish Passage Requirements

EOS Ecology Report No. HUT01-18016-01 | March 2019

Prepared for Hutt City Council

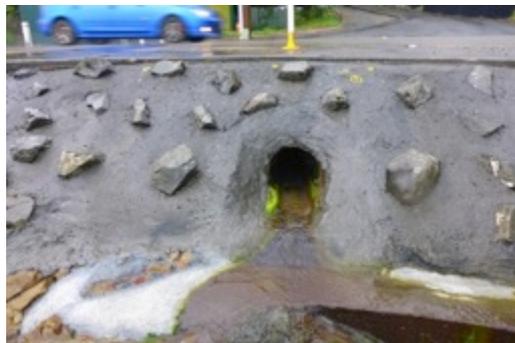
One outlet that possibly has fish upstream was found in Sorrento Bay (Table 1, Figure 2, Figure 3). Howard Road Stream is very small and shallow and does not appear on topographic maps, the REC, or the HCC waterways (hydrology) GIS layer. It drains a steep, narrow catchment before being piped beneath Marine Drive and discharging to the intertidal zone over exposed bedrock. Given its location above bedrock, this outlet does not appear to be regularly blocked by beach gravels. A possible fish sighting was made during the site visit (the only other animal it could have been was a freshwater crayfish/koura). A double curve concrete seawall is proposed at this location.

Howard Road Stream seawall outlet

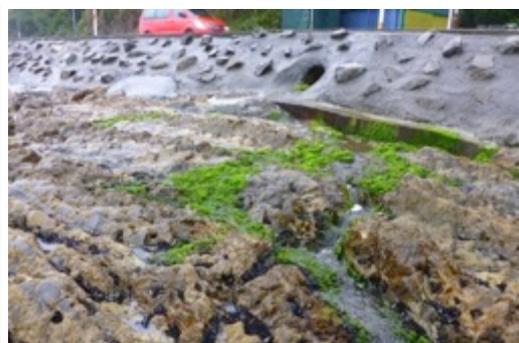
Howard Road Stream flowing over intertidal bedrock

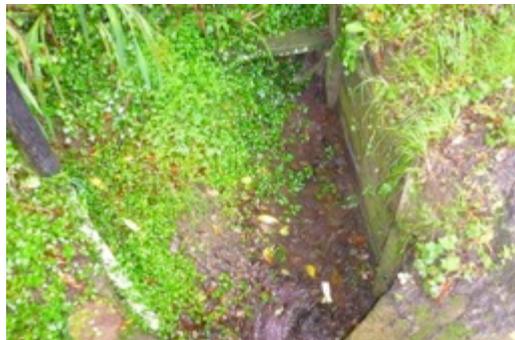
Howard Road Stream channel directly upstream of Marine Drive

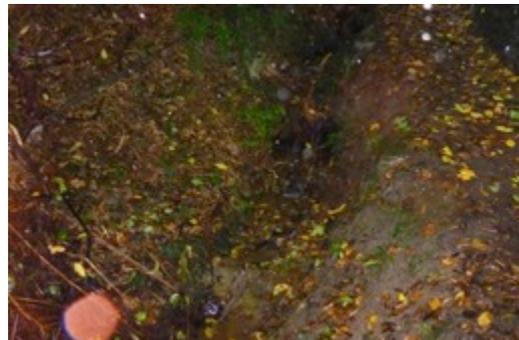
Howard Road Stream channel along public walkway

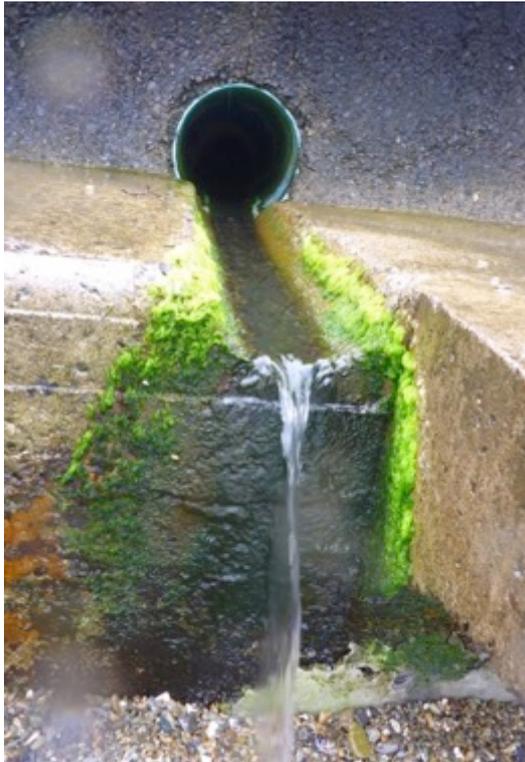
The Wilmore Way Stream outlet discharges to the intertidal zone with an approximately 45 cm vertical drop (at low tide) over the edge of the existing seawall to a pebble beach below (Figure 3, Table 2, Figure 4.). Banded kokopu whitebait could climb this small drop, which will only be evident at low tide. The elevated position of this pipe means it is rarely, if ever, blocked by intertidal gravels. The natural open stream upstream is too small to appear on topographic maps, the REC, or the HCC hydrology GIS layer and drains a short, steep forested catchment. It has limited fish habitat available with some shallow pools observed interspersed by sections of very shallow surface flow (1–2 cm water depth). It is possible fish are present. It is probable this stream has sections of intermittent surface flow during dry periods. A double/triple curve concrete seawall is proposed at this location.

Outlet of Wilmore Way Stream

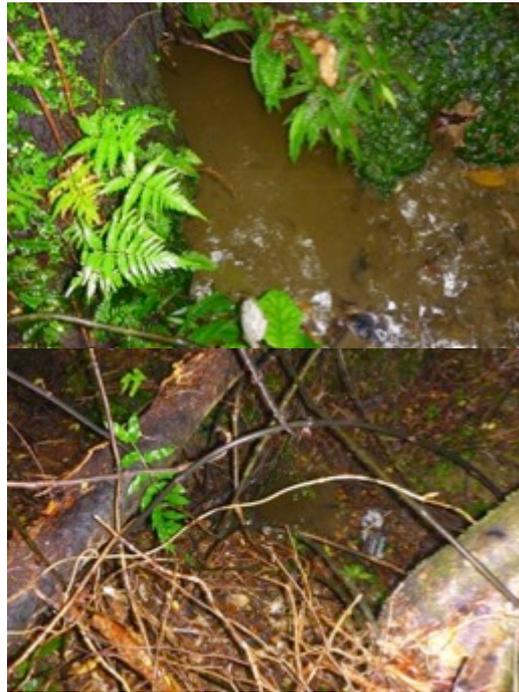
Wilmore Way Stream

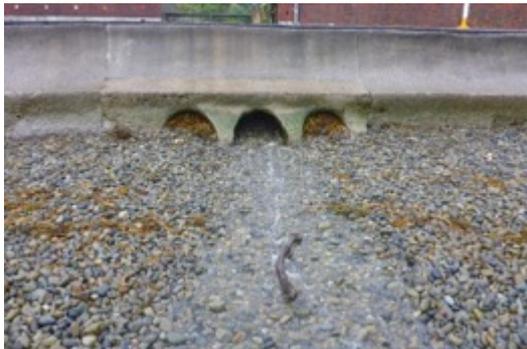
Outlet of Lowry Bay North Stream

The Lowry Bay North Stream outlet consists of triple 600 mm pipes discharging to a cobble beach and appears to be at least partially blocked by beach substrate much of the time (Figure 3, Table 2, Figure 4). At the time of the site visit surface flow could be seen coming through the central pipe only. Lowry Bay North Stream has a relatively large upstream catchment from which banded kokopu have been confirmed (2002 NZFFD record). This stream is large enough to appear on topographic maps and the REC, and the lower section through the urban area is shown on the HCC hydrology GIS layer. A double/triple curve concrete seawall is proposed at this location.

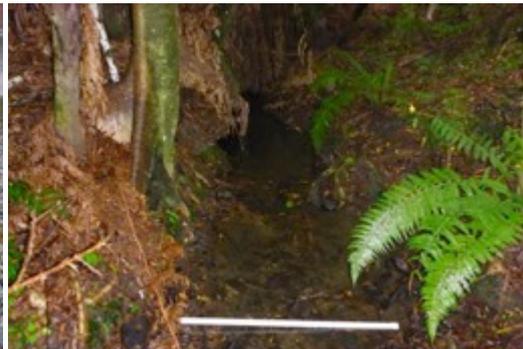
Lowry Bay North Stream at Cheviot Rd end

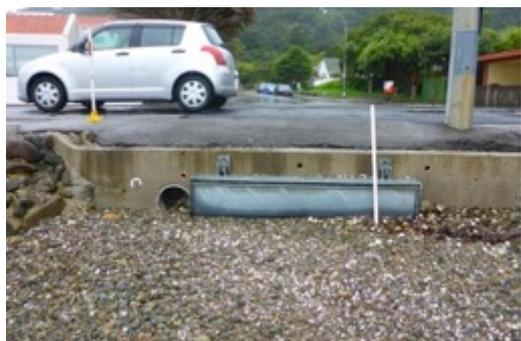
Whiorau Grove Stream discharges to the Lowry Bay beach via two louvered outlets located on either side of the Lowry Bay bus stop (Figure 3, Table 2, Figure 5). Based on HCC hydrology and stormwater pipe GIS layers this stream originates from the forested gully at the end of Whiorau Grove. The stream is too small to appear on topographic maps or the REC, with the HCC hydrology GIS layer only showing some open channel sections through the urban area. While it was not possible to visit this stream upstream of the urban area (no easy public access), based on the size of the channel at Whiorau Grove and Cheviot Street as well as the size of the catchment upstream of the urban area it is highly likely this stream has adequate habitat for at least banded kokopu. At the time of the site visit the current louvered outlets appeared completely blocked by beach sediments with the outlet at chainage 1540 m appearing to be flowing through the gravel while a surface flow was evident at the 1550 m chainage outlet (Figure 5). A double curved seawall is proposed at the chainage 1540 m outlet while a single curve concrete wall is to be built at the chainage 1550 m outlet, although this outlet appears to be seaward of the toe of the proposed seawall and hence will not require an extension.

Whiorau Grove Stream louvered outlet at chainage 1540

Whiorau Grove Stream has twin outlets with existing louvers attached, which were almost entirely buried at the time of the site visit (Figure 5). It is possible these louvers would limit fish passage at times when the outlets are more exposed, although it was impossible to determine this due to them being buried. At this stage it is unknown what will happen to the current louvers should these outlets be extended (i.e., reattached, discarded, or replaced). Whatever the case a freshwater ecologist with knowledge of fish passage will need to be involved in the detailed design of these outlets to ensure fish passage requirements are met.

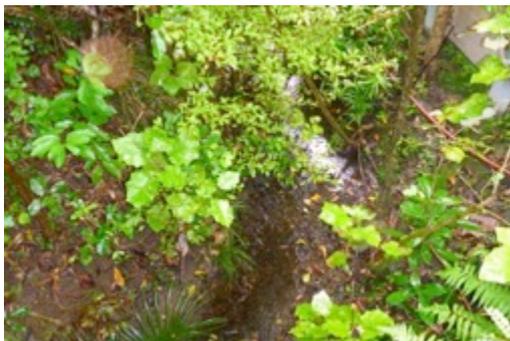
Whiorau Grove Stream at Whiorau Grove

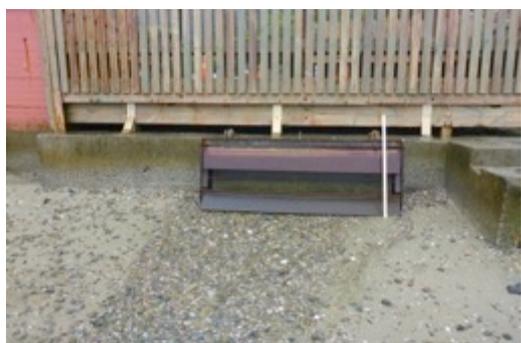
Whiorau Grove Stream louvered outlet at chainage 1550

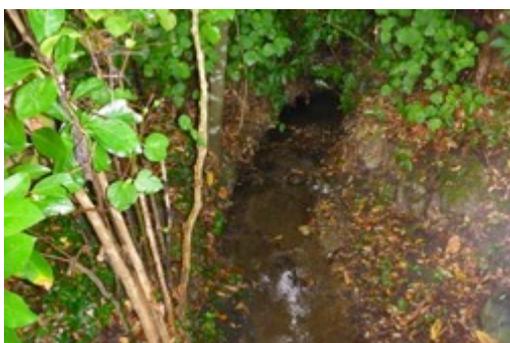
Whiorau Grove Stream at Cheviot Road

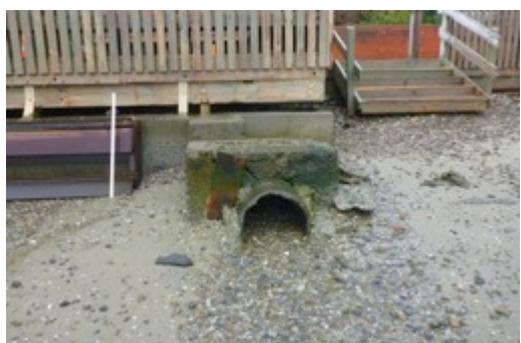
The 30 Cheviot Road Stream outlet discharges to the Lowry Bay beach immediately adjacent to the Whiorau Grove Stream outlet at chainage 1550 m. There is a granted resource consent for the installation of a slip-on duckbill outlet attachment as part of a trial into the ability of these devices to prevent beach material blocking outlet pipes (see GHD, 2018). To gain such a consent it was concluded this outlet was not connected to any upstream open freshwater habitats, however my investigation based on HCC GIS and visiting an open channel at Cheviot Road that appears connected to this outlet would indicate there is indeed open freshwater habitat upstream of this outlet (Figure 3, Table 2, Figure 5). It is unclear on where the short channel indicated on the HCC hydrology GIS layer originates - based on topography it is potentially linked to the Whiorau Grove Stream catchment that discharges to the same location by the Lowry Bay bus stop. I would recommend a duckbill outlet be not installed on this outlet until the source of this flow and extent of open channel upstream is determined. A single curve concrete seawall is proposed at this location, although this outlet appears to be seaward of the toe of the proposed seawall and hence will not require an extension.

30 Cheviot Road Stream outlet

A duckbill outlet valve to limit blockage by beach gravels is proposed (and consented) for 30 Cheviot Road Stream as outlined in GHD (2018) where it is referred to as "Outlet 44". Such an outlet will likely impede fish passage and there would appear to be open freshwater habitats upstream of this outlet that could support fish. While potentially out of scope of this report, it is strongly recommended this decision is reviewed and a thorough catchment investigation (including fish survey) is undertaken before any such outlet device installation is allowed. With respect to seawall construction, this outlet is on the seaward

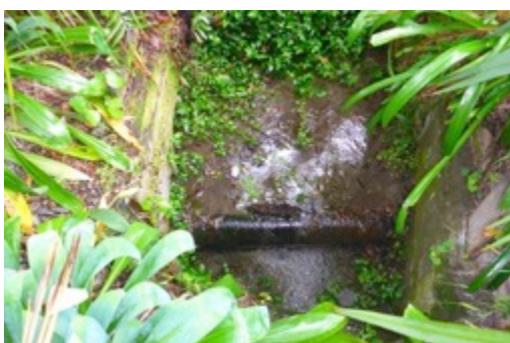
30 Cheviot Road Stream upstream of Cheviot Road culvert

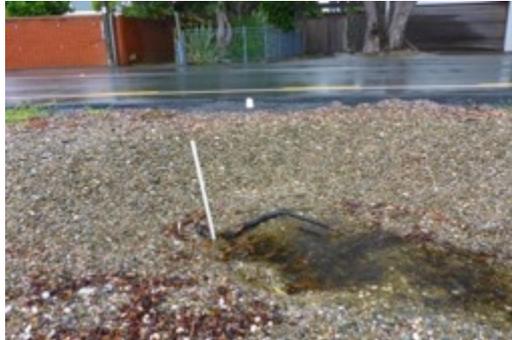
At the time of the site visit the beach outlet of Lowry Bay South Stream (Figure 3, Table 2, Figure 6) was covered in beach gravels through which water was flowing and forming a surface pool. Photos of the same outlet in GHD (2018) show it to be partially open with surface flow. Hence it is likely the opening of this pipe varies over time depending on beach sediment levels. This outlet has been granted resource consent for the installation of a slip-on duckbill outlet attachment to prevent beach material blocking outlet pipes (see GHD, 2018). To gain such a consent it was concluded this outlet was not connected to any upstream open freshwater habitats, however my investigation based on HCC GIS and visiting the open channel in the vicinity directly upstream of Marine Drive clearly show this outlet has open freshwater habitat upstream (Figure 3, Table 2, Figure 6). Taylor & Kelly (2001) report observing a school of approximately 10 banded

kokopu in the pool upstream of the Marine Drive culvert, including large adults, hence at least one species of fish is confirmed in this catchment. Based on the fact that fish are known to be present in this stream I recommend a duckbill device be not installed on this outlet. A single curve concrete seawall is proposed at this location.

Lowry Bay South Stream beach outlet

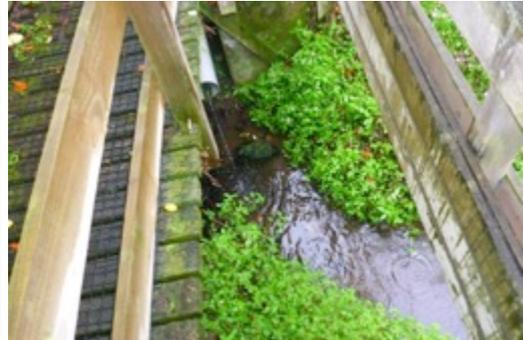
Lowry Bay South Stream upstream of Marine Drive

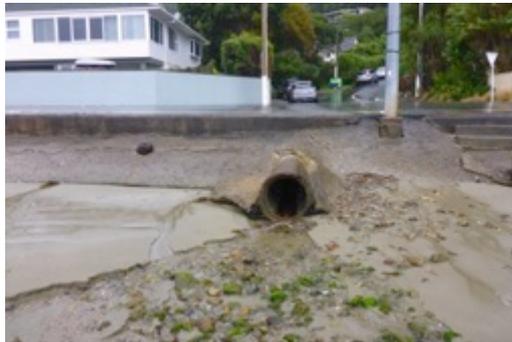
The Gill Road Stream outlet pipe at the beach was fully open at the time of the site visit and had flowing surface water (Figure 3, Table 2, Figure 6). The forested catchment upstream of the urban area was not easily accessible hence it is unknown if it has suitable freshwater fish habitat. Based on the other small catchments observed (e.g., Wilmore Way Stream) it is certainly possible fish habitat is present upstream. A double curve concrete seawall is proposed for this location.

Gill Road Stream beach outlet

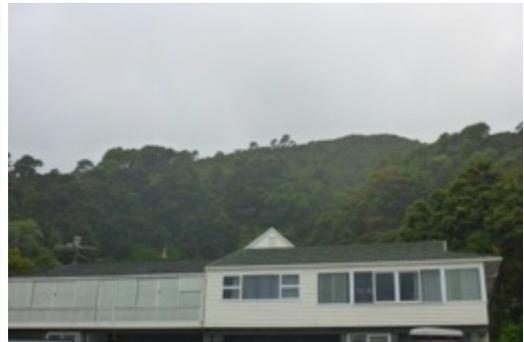
Gill Road Stream forested catchment

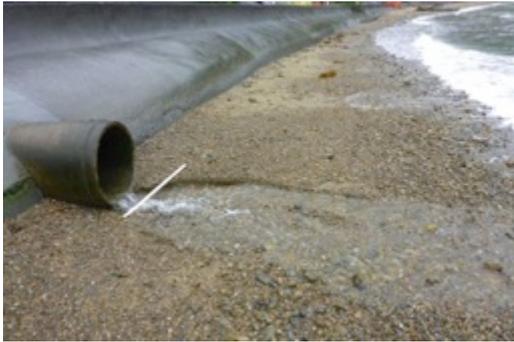
York Bay North Stream had a fully open pipe outlet at the time of the site visit with an open channel directly upstream of Marine Drive and a forested catchment upstream of the urban area (Table 3, Figure 7, Figure 8). At the time of the visit during low tide flow from the pipe had caused minor scour of beach gravels leading to a slightly perched outlet (approximately 10 cm). Banded kokopu are confirmed to be present upstream (2003 NZFFD record). This stream is large enough to appear on topographic maps, the REC, and the lower section through the urban area is shown on the HCC hydrology GIS layer. However topographic maps and the REC appear to have a single stream outlet in York Bay, whereas in reality there are two permanently flowing streams discharging to the bay (see Section 3.3.2 below on York Bay South Stream). A triple curve concrete seawall is proposed at this location.

York Bay North Stream beach outlet

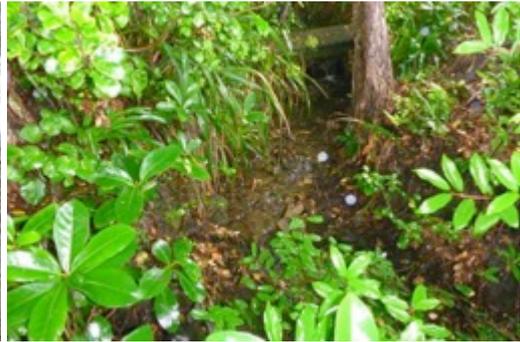
York Bay North Stream upstream of Marine Drive

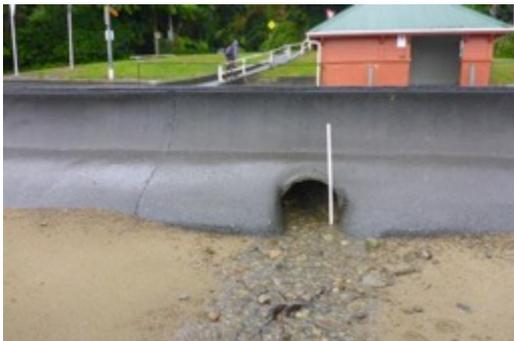
York Bay South Stream had an open pipe outlet with a cobble-pebble substrate filling the bottom of the pipe at the time of the site visit. Upstream of Marine Drive is an open channel where two small schools of juvenile galaxiid fish (most likely young banded kokopu) were observed during the site visit (Table 3, Figure 7, Figure 8). Upstream of the urban area the stream has a forested catchment. This stream is large enough to appear on topographic maps, the REC, and fragments of the lower section through the urban area are shown on the HCC hydrology GIS layer. However topographic maps and the REC appear to have a single stream outlet in York Bay, whereas in reality there are two permanently flowing streams discharging to the bay (see Section 3.3.1 above on York Bay North Stream). The current level of the pipe (and beach), which has resulted in the culvert base being filled in natural gravels, provides ideal conditions for fish passage. A double curve concrete seawall is proposed at this location.

York Bay South Stream beach outlet

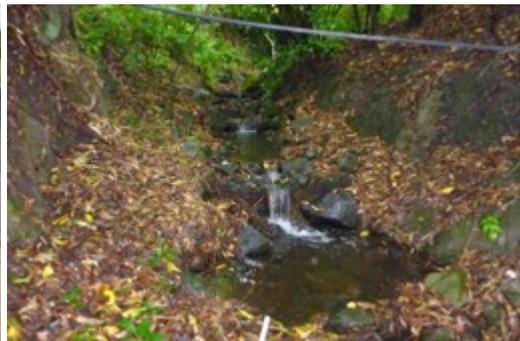
York Bay South Stream upstream of Marine Drive

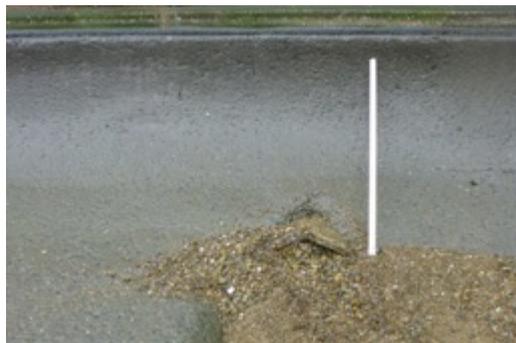
The beach outlet pipe of 421 Marine Drive Stream was almost completely filled with gravel with no surface flow evident at the time of the site visit (Figure 8, Table 4, Figure 9). Upstream of the Marine Drive culvert the stream flows through another culvert under a parking area, which has a perched outlet. The upstream catchment consists of a relatively short, steep forested gully and the observed open channel had a very small volume of water present. This stream is too small to appear on topographic maps or the REC, however two short sections are shown on the HCC hydrology GIS layer. It is unlikely this stream has freshwater fish present, although further investigation of upstream freshwater habitats and a fish survey would be required to confirm this. A double curve concrete seawall is proposed at this location.

421 Marine Drive Stream beach outlet

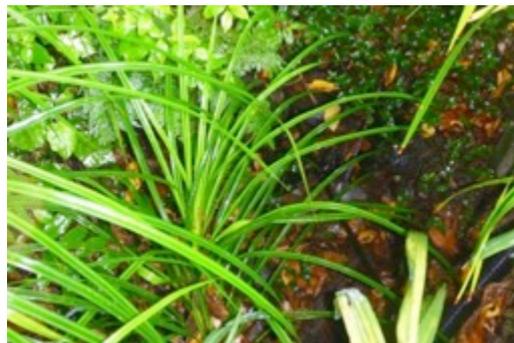
421 Marine Drive Stream open channel

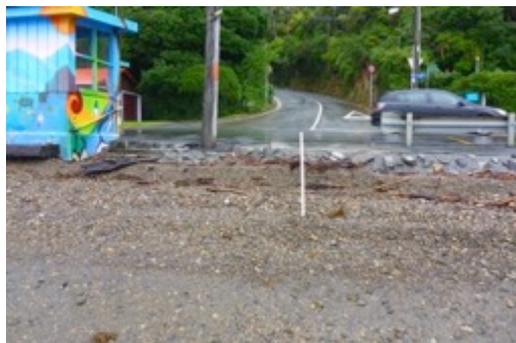
The outlet of Mahina Bay Stream was completely obscured by sediment at the time of the site visit with the flow of the small stream observed upstream of Marine Drive apparently flowing through the beach gravels (Figure 8, Table 4, Figure 9). This stream is too small to appear on topographic maps and is not shown on the HCC hydrology GIS layer but is depicted in the REC. A fish (likely a banded kokopu) was observed in a pool upstream of Marine Drive during the site visit indicating that the outlet must be open enough to provide fish passage at times. A double curve concrete seawall is proposed at this location.

Mahina Bay Stream beach outlet (buried)

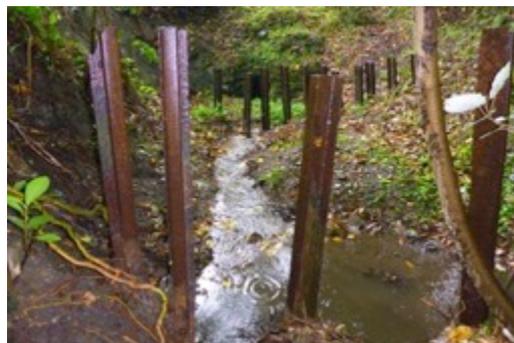
Mahina Bay Stream upstream of Marine Drive

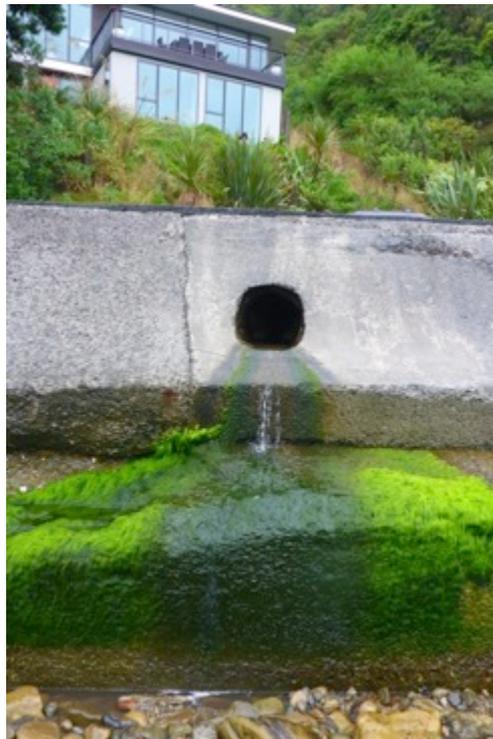
Sunshine Bay Stream had a fully open outlet set in the existing seawall well above the current beach level (Table 5, Figure 10, Figure 11). The natural open stream upstream does not appear on topographic maps, the REC, or the HCC hydrology GIS layer. The upstream catchment could not be assessed during the site visit; hence the state of the freshwater habitat there not known. However, given the short, steep catchment it is unlikely to have suitable fish habitat upstream although further investigation of upstream freshwater habitats and a fish survey would be required to confirm this. A double curve concrete seawall is proposed at this location.

Sunshine Bay Stream beach outlet

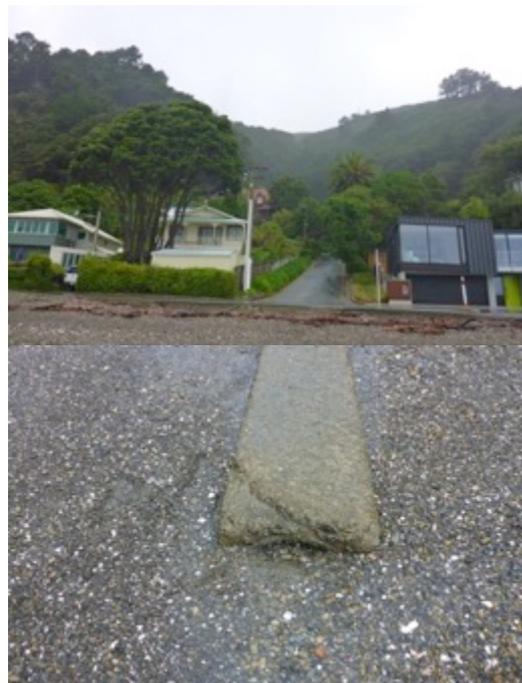
Waerenga Road Stream discharges to the southern end of Days Bay (near Windy Point) with the pipe almost completely blocked by beach sediments at the time of the site visit (Table 5, Figure 10, Figure 11). The natural open stream upstream does not appear on topographic maps, the REC, or the HCC hydrology GIS layer. The upstream catchment could not be assessed during the site visit; hence the form of the open channel is not known. However, given the short, steep catchment that is unlikely to have suitable fish habitat upstream although further investigation of upstream freshwater habitats and a fish survey would be required to confirm this. A double curve concrete seawall is proposed at this location although this outlet appears to be seaward of the toe of the proposed seawall and hence will not require an extension.

Waerenga Road Stream catchment (top) and beach outlet (bottom)
