20 December 2010

5-C1930.00

### **Baring Head – Inspection of World War II Structures**

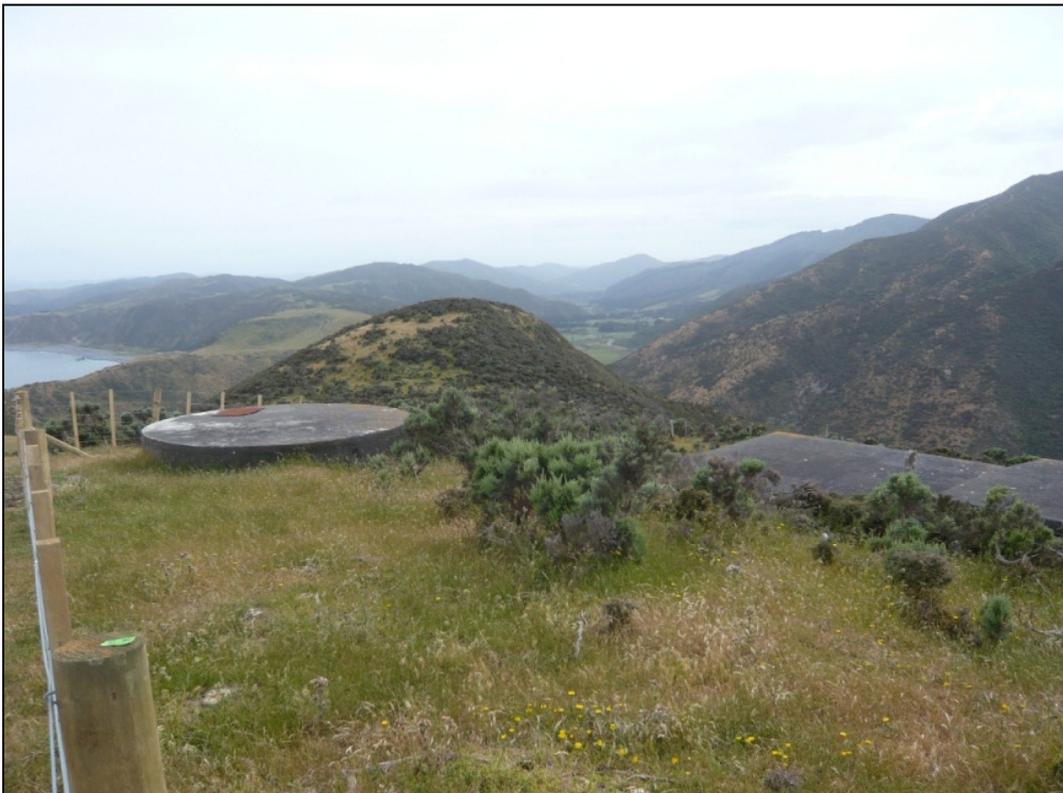
A part buried concrete water storage tank, incorporating a concrete circular lid, is located nearby to these buildings (see **Photo 1** to the rear of this report). This was not inspected during the site visit.

Photo 1 – View along fenceline from above structures (roofs & water storage tank lid visible in foreground)

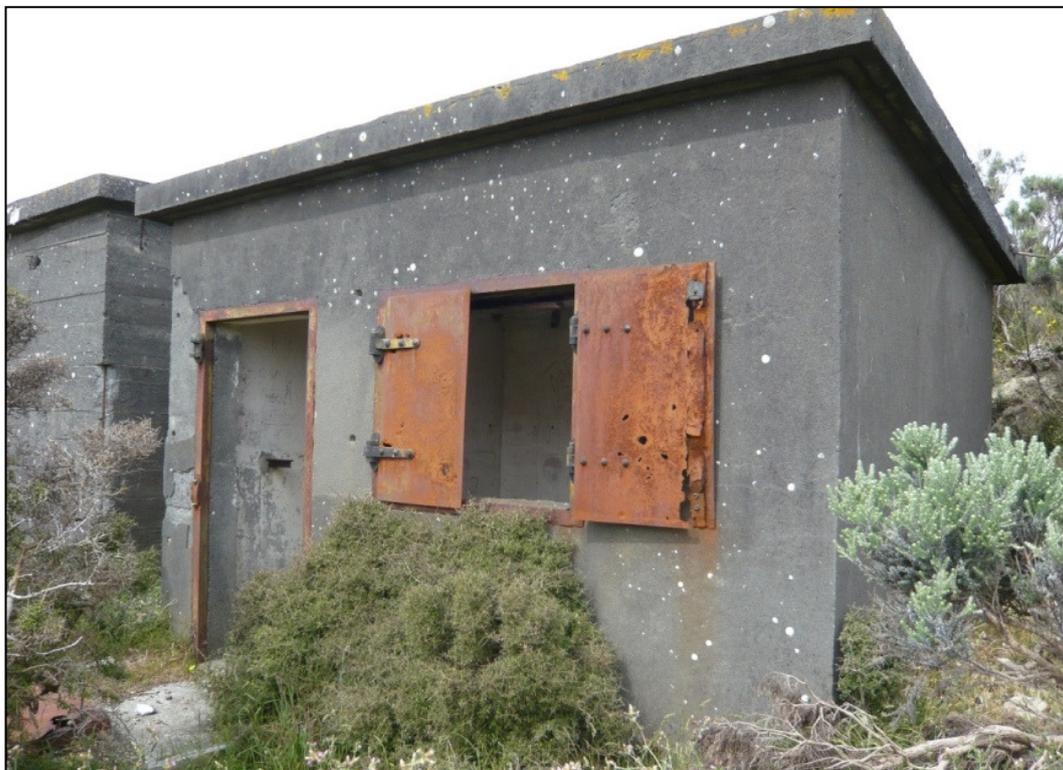
The thickness of the walls, together with the presence of steel shuttering to the single window (see **Photo 2**), indicates that this structure may have been designed to withstand a form of blast loading.

Photo 2 – Structure 1: Front elevation of building showing corroded steel shutters to window

- a) Repair and reinstate steel door and door frame;
- b) Reinststate area of rendering to front face of structure to prevent further loss;
- c) Clean internal areas to prevent future deterioration e.g. abandoned bird nests, grafitti, debris to floor;
- d) Consider appropriate remedial works to steel shutters, to prevent further corrosion.

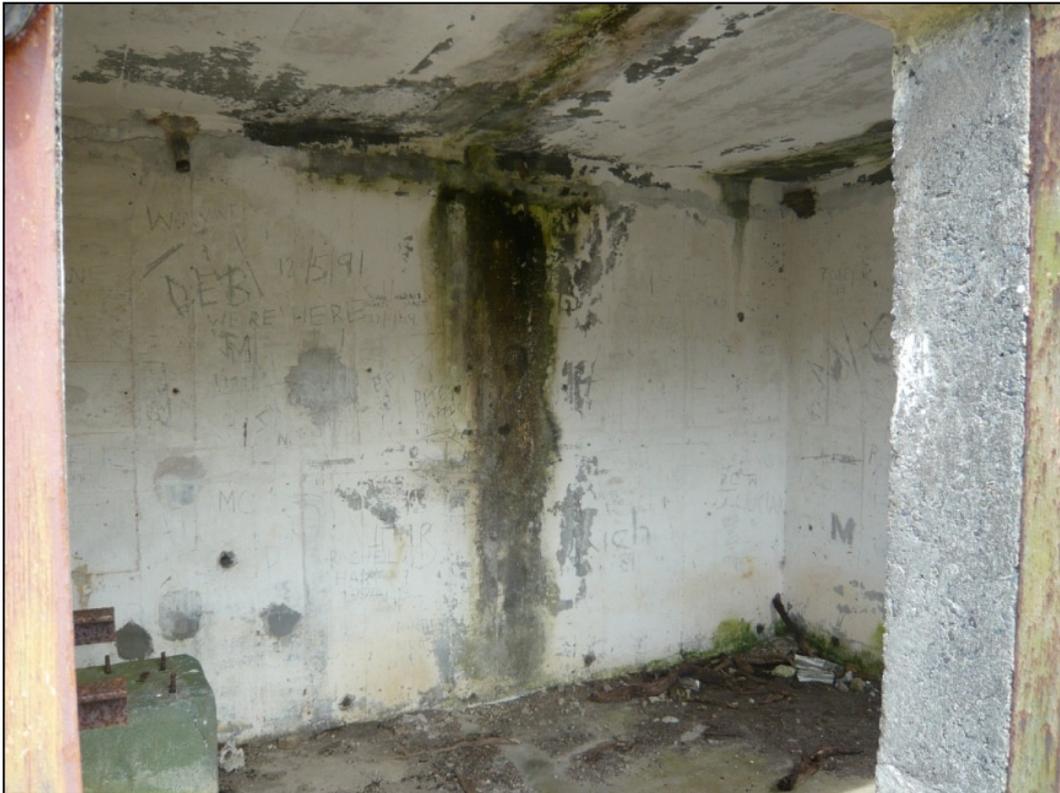
As the roof slopes slightly rearward, rainwater has penetrated the crack and this has resulted in unsightly staining to the rear wall (see **Photo 3**). The roof crack and rear wall are damp to the touch, and this is an indication of ongoing water ingress into the roof slab matrix from above.

Photo 3 – Structure 1: Cracking to in situ reinforced concrete roof and resultant staining to rear wall

- a) Undertake remedial work to roof slab to repair and repair / seal longitudinal crack. This will prevent further water ingress into the external area of the structure;
- b) Repair areas of concrete spalling to internal edges of the doors and windows to prevent further deterioration. Apply an approved rust inhibitor, as appropriate, to exposed reinforcing bars exhibiting signs of corrosion.

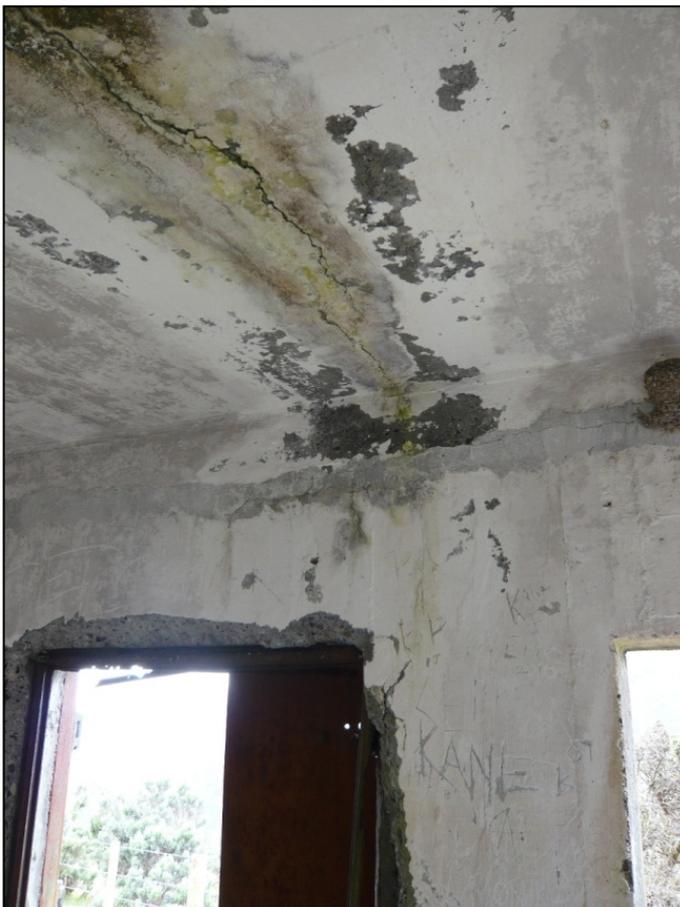
Photo 4

The main defect to the building is a longitudinal crack in the roof soffit which runs the entire length of the roof (from front to back) – see **Photo 4**. There is no evidence of distress / sagging to the slab, which indicates that it continues to be supported correctly by the walls. It is likely that this crack is well-established and therefore does not indicate a recent form of localised failure.

View of cracking to in situ concrete roof.

Spalling to inside edge edge of window.

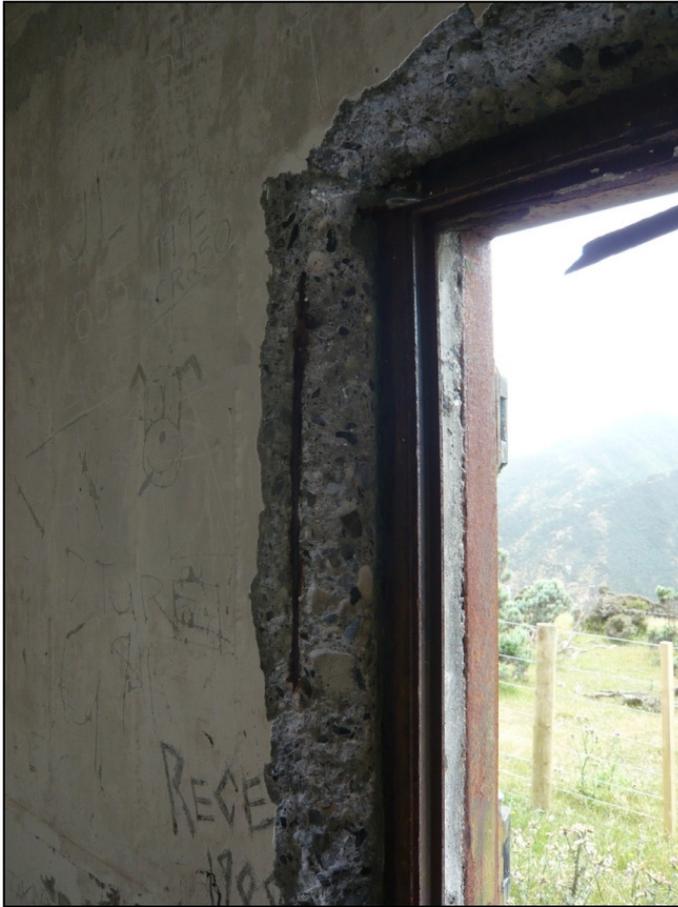
Photo 5

There is spalling evident around the internal edge of the doorway and window, with some exposed reinforcement exhibiting corrosion (round bars 1/4" or 6.4mm diameter) – see **Photo 5**.

View of spalling and exposed reinforcement to internal edge of window.

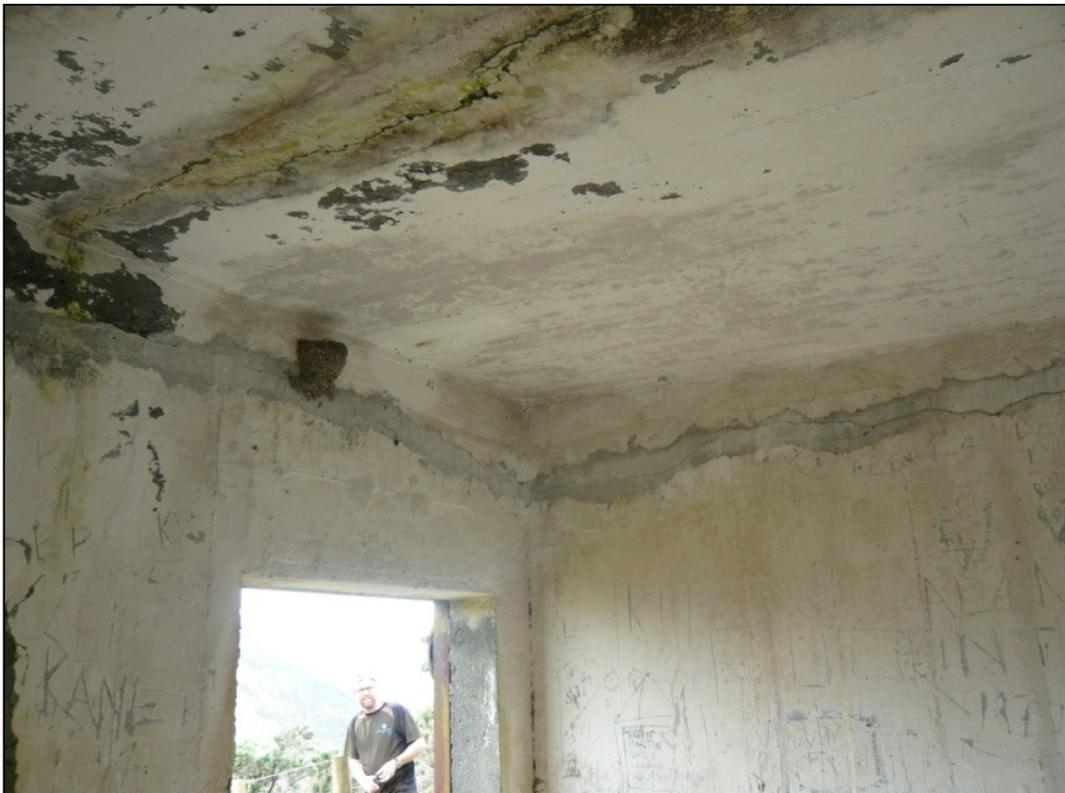
A grout repair was noted running around all of the internal walls just below roof soffit level (see **Photo 6**). This feature is not evident to the external face of the building. It is possible that a rebate was cut into the walls to accommodate a cable / duct of some kind during the operational life of the building, although the rebate is not cut in a straight horizontal line as one would expect. There is cracking along the line of the grout repair, although this is probably due to shrinkage and is not considered as being structural in nature.

Photo 6 – Structure 1: View from inside of building looking towards doorway. Evidence of longitudinal grout patch repair along top of walls

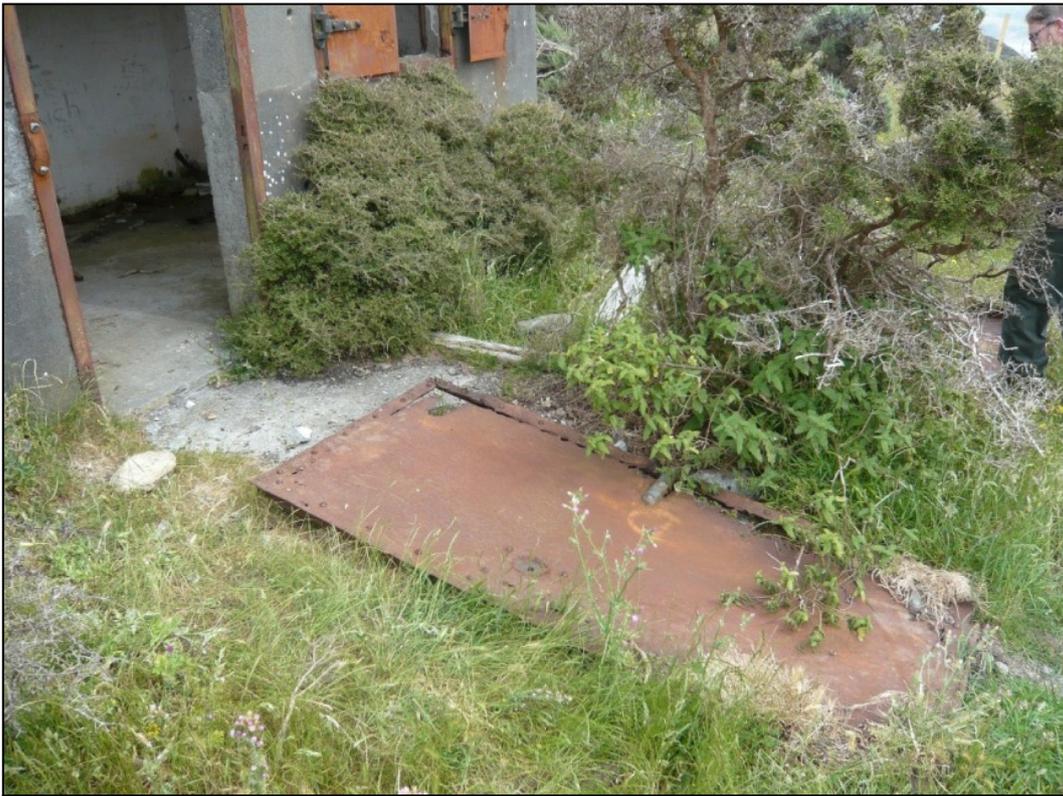
Although the steel door is no longer attached to the door opening, it has not been removed from the site and lies on the ground to the front of the structure – see **Photo 7**. Both the door and window shutters are in an advanced state of corrosion.

Photo 7 – Structure 1: View of steel door removed from structure and lying on ground.

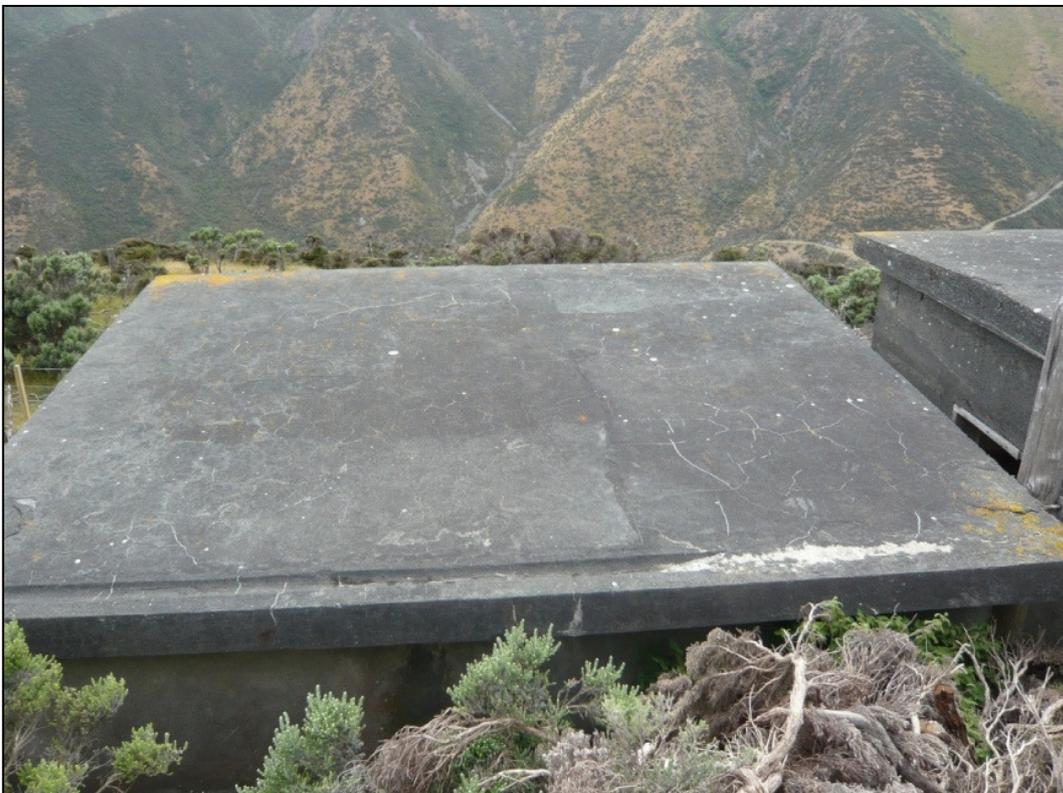
The roof was found to be in good condition (see **Photo 8**). However, a crack, running from front to back was noted – this corresponds with the crack observed to the internal roof soffit.

Photo 8 – Structure 1: View of structure roof taken from above and behind.

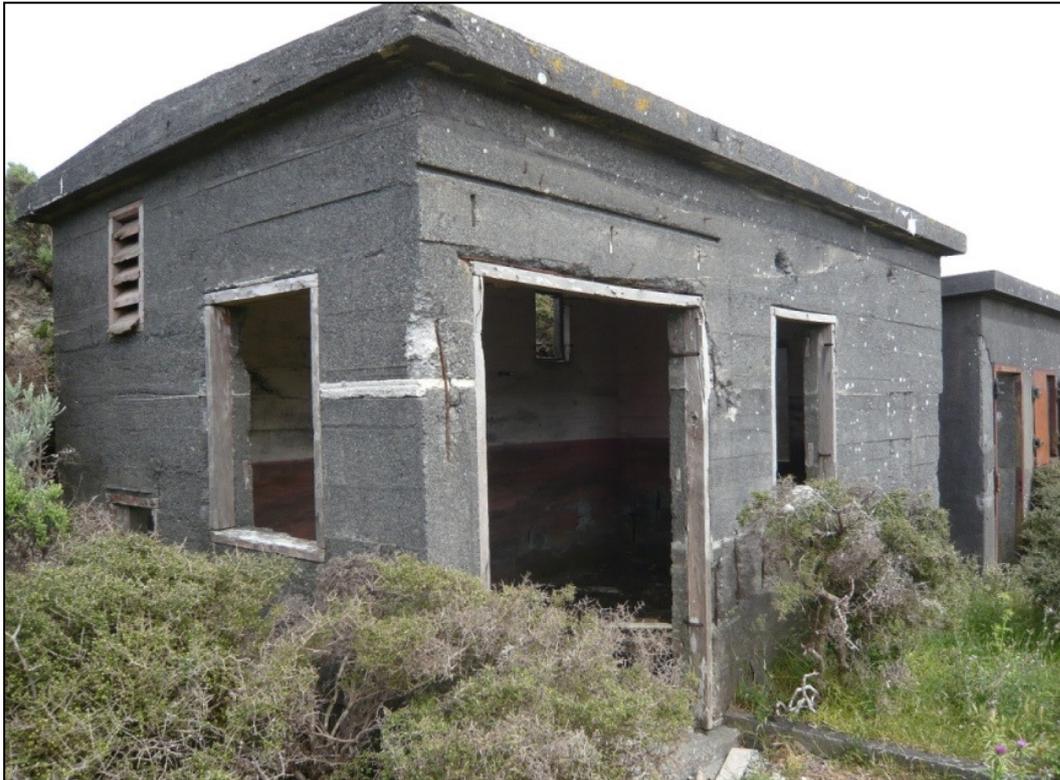
The walls of Structure 2 have been constructed in a 'rough-cast' manner, with wooden horizontally-secured planks used as formwork. There is no evidence of any rendering being applied to the external walls of Structure 2, and this has contributed to the deterioration of the external walls. Spalling and exposed reinforcement is present in several locations, with points of localised failure typically emanating along the line of the rough-cast formwork edges (see **Photos 9 and 11**).

Photo 9 – Structure 2: Front elevation of building showing multiple openings and evidence of spalling / exposed reinforcement.

- a) Repair spalling to external faces, incorporating corrosion inhibitors to exposed steel reinforcement;
- b) Repair isolated areas of spalling to internal walls;
- c) Consider reinstatement of openings / doorways in an appropriate manner, to help protect the building from unnecessary exposure.

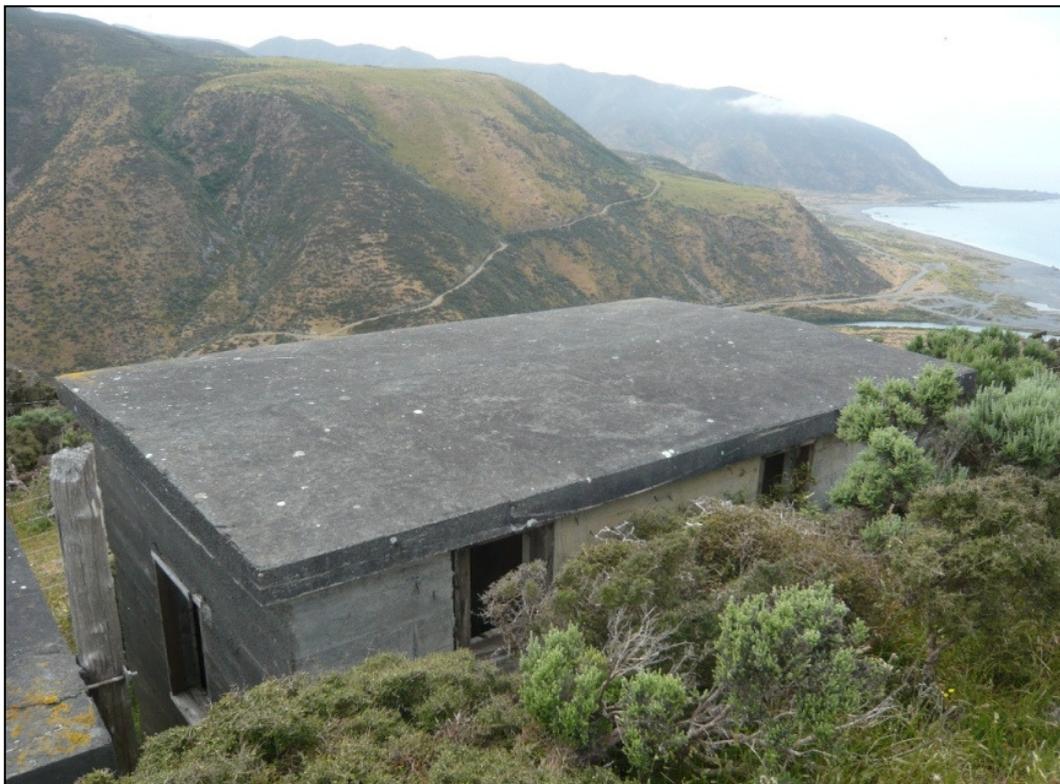
The roof is in good condition, with no evidence of failure or distress to either the external or internal faces (see **Photo 10**).

Photo 10 – Structure 2: View to roof and rear of building, showing openings to rear and side of structure.

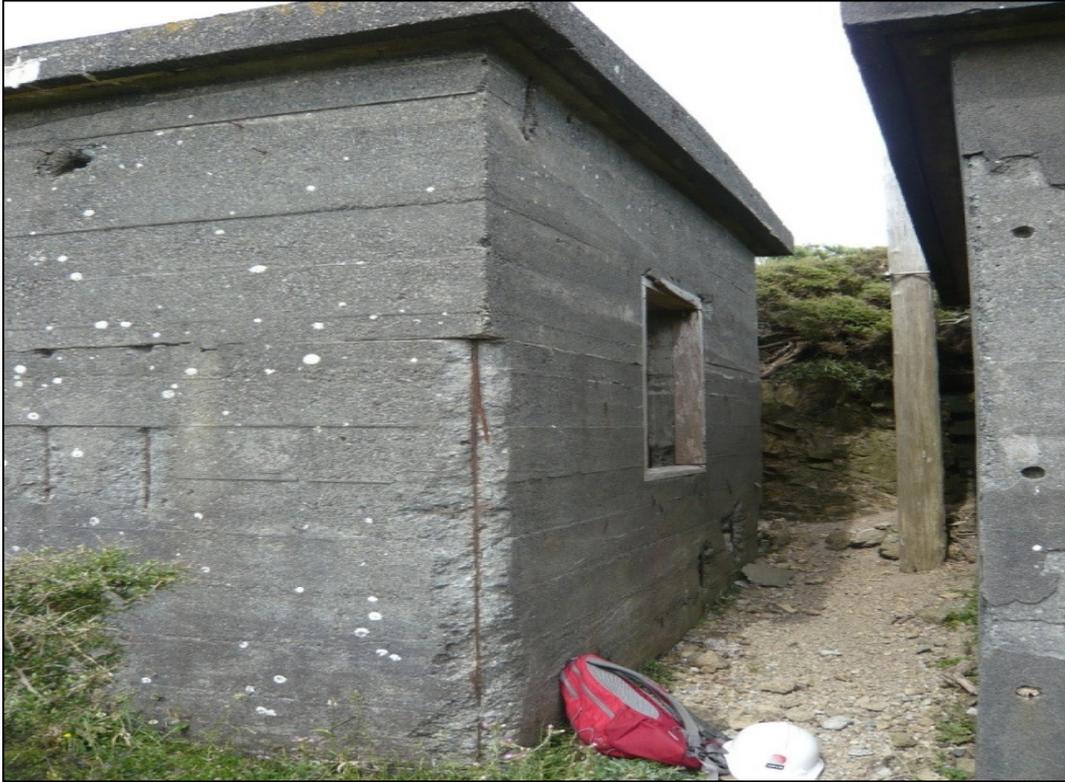
Photo 11 – Structure 2: View to front / side of building showing spalling to front corner and exposed reinforcement

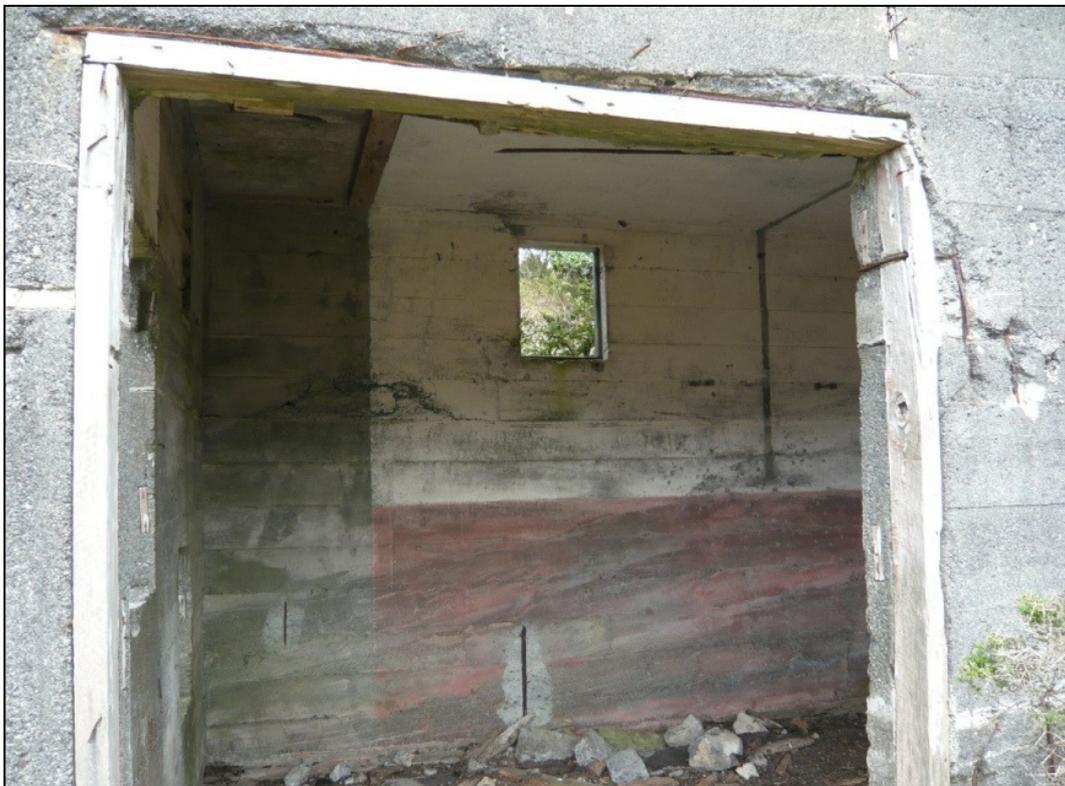
The internal walls exhibit vertical formwork lines, as per the external faces. However, spalling is less evident due to their less exposed nature (see **Photos 12 and 13**).

Photo 12 – Structure 2: View of inside of building taken from doorway

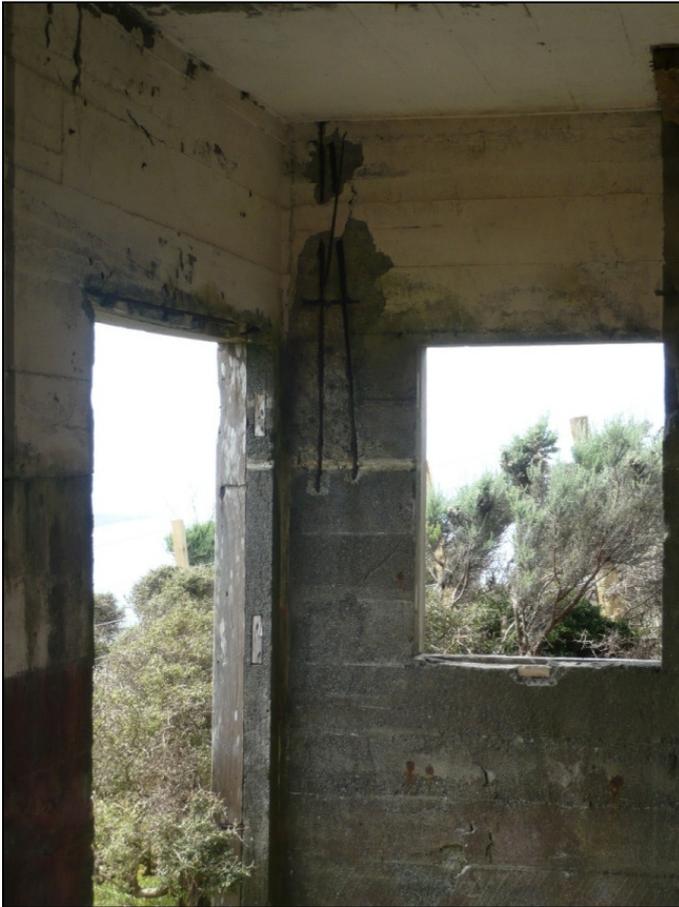
Photo 13

Note spalling and exposed reinforcement to inside corner of wall.

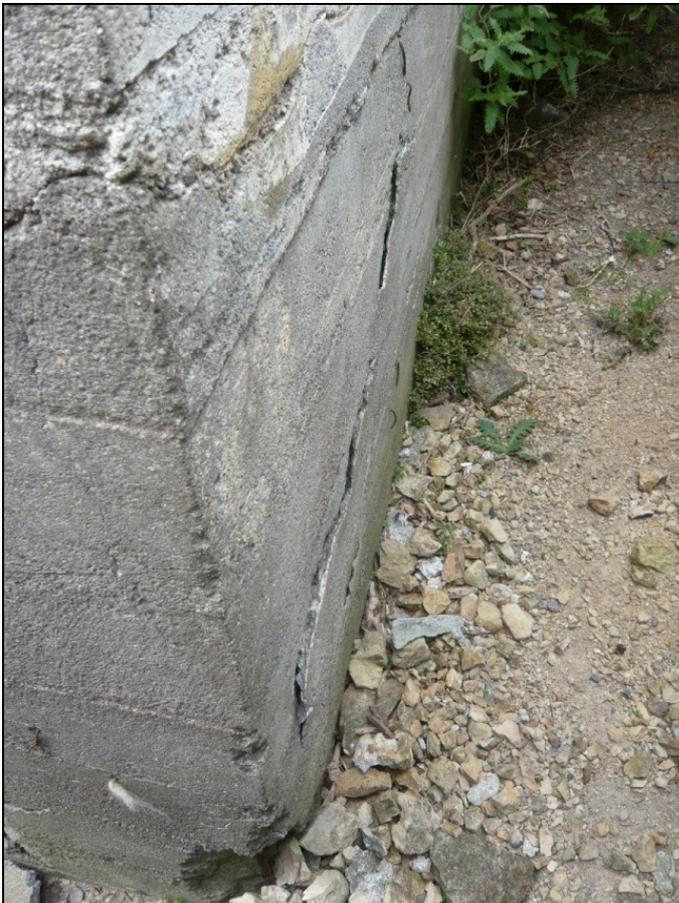
Photo 14

The main defect to this structure was found in the lower right rear corner of the walls. The external face was found to be cracked, and this effect has been replicated to the internal face, with extensive spalling and exposure of reinforcement (see **Photos 14 and 15**). Further investigation would be required to determine the reason for this defect, although the most likely causes would be:

- a) Damage through some form of impact;
- b) Localised movement at the base of the wall;
- c) Prolonged exposure to water and corrosion / expansion of reinforcement.

The defect appears to be restricted to a small area, and is not replicated elsewhere within the building.

View to right rear corner of building exhibiting spalling to concrete.

- a) Undertake investigation to determine cause of spalling to rear right corner of wall and undertake suitable repairs to prevent further deterioration.

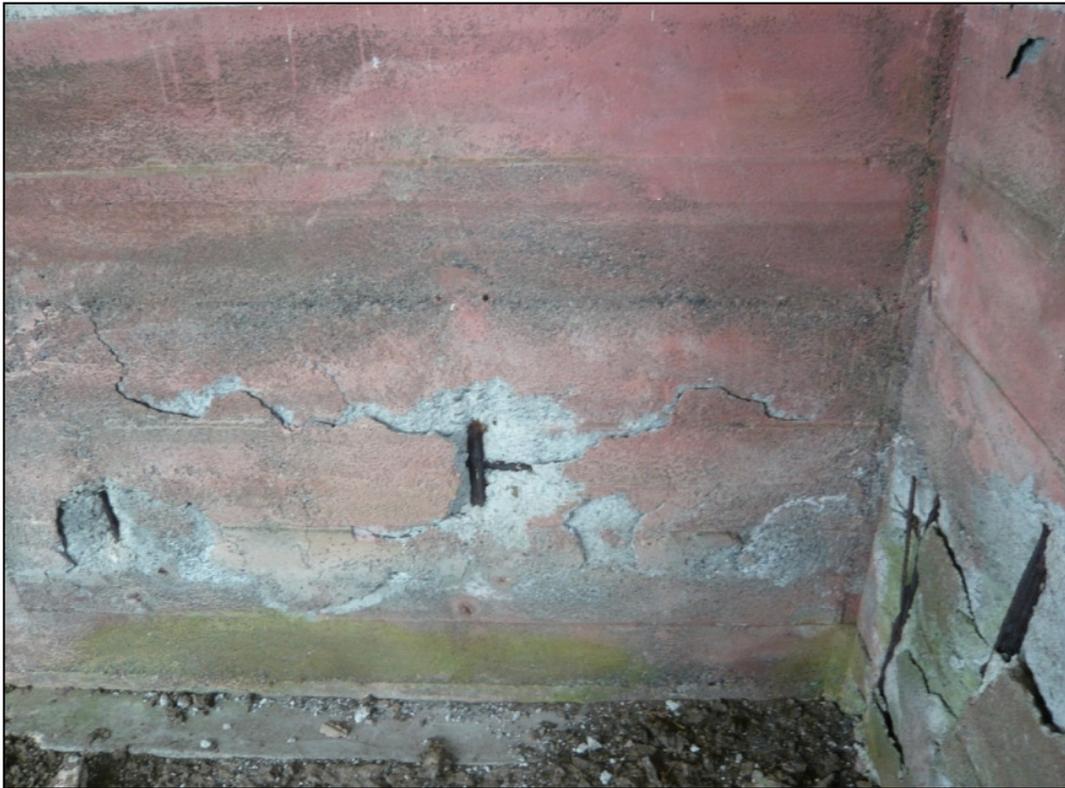
Photo 15 – Structure 2: View of right rear corner of building showing spalling and exposure of reinforcement .

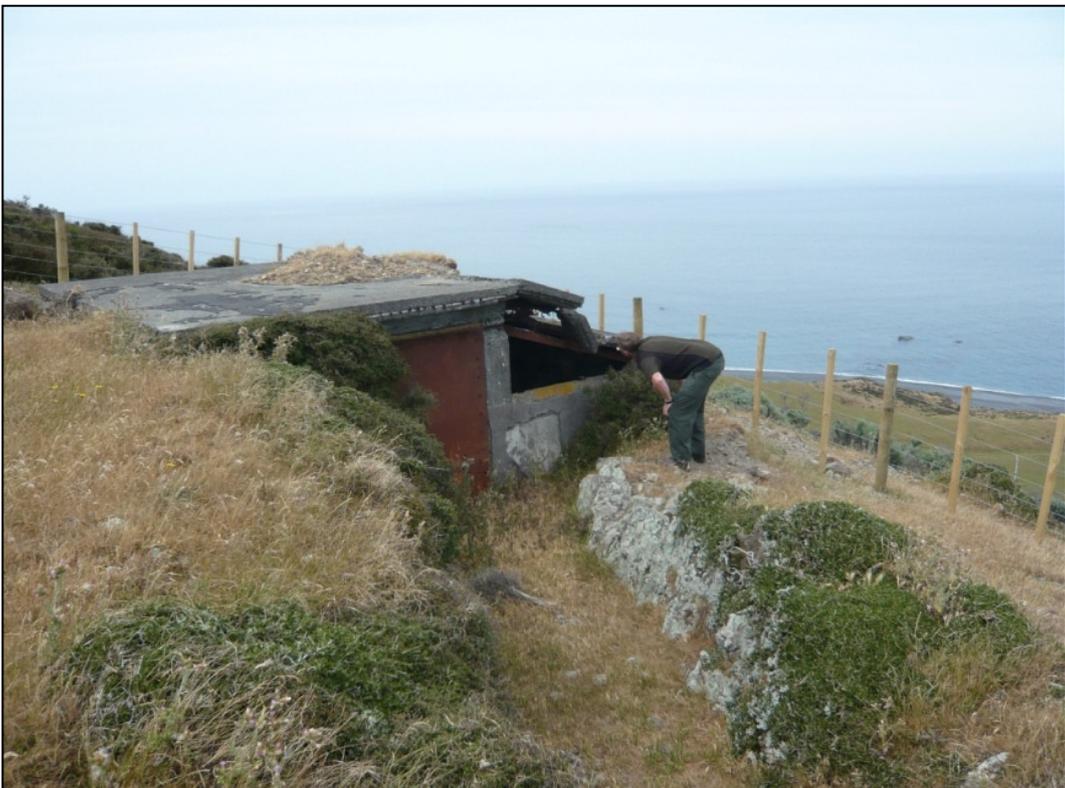
The bunker consists of an cast in situ reinforced concrete partially buried structure. The roof is also cast in reinforced concrete (see **Photos 16 and 17**). In order to provide uninterrupted views, the front half of the bunker roof was originally cast as a cantilever, with steel beams providing roof support.

Photo 16 – Structure 3: View to side of observation bunker showing steel access door and partial collapse to roof.

- a) The collapsed section of roof should be made safe prior as a priority. Complete removal is likely to be required, due to the extreme level of corrosion found within the roof support steelwork;
- b) From a visual observation, it appears that the remaining intact section of roof is supported on one side by a heavily corroded steel beam. It is likely that this beam will have to be replaced, or the remaining section of roof removed, if it is intended to make the bunker accessible to members of the general public.

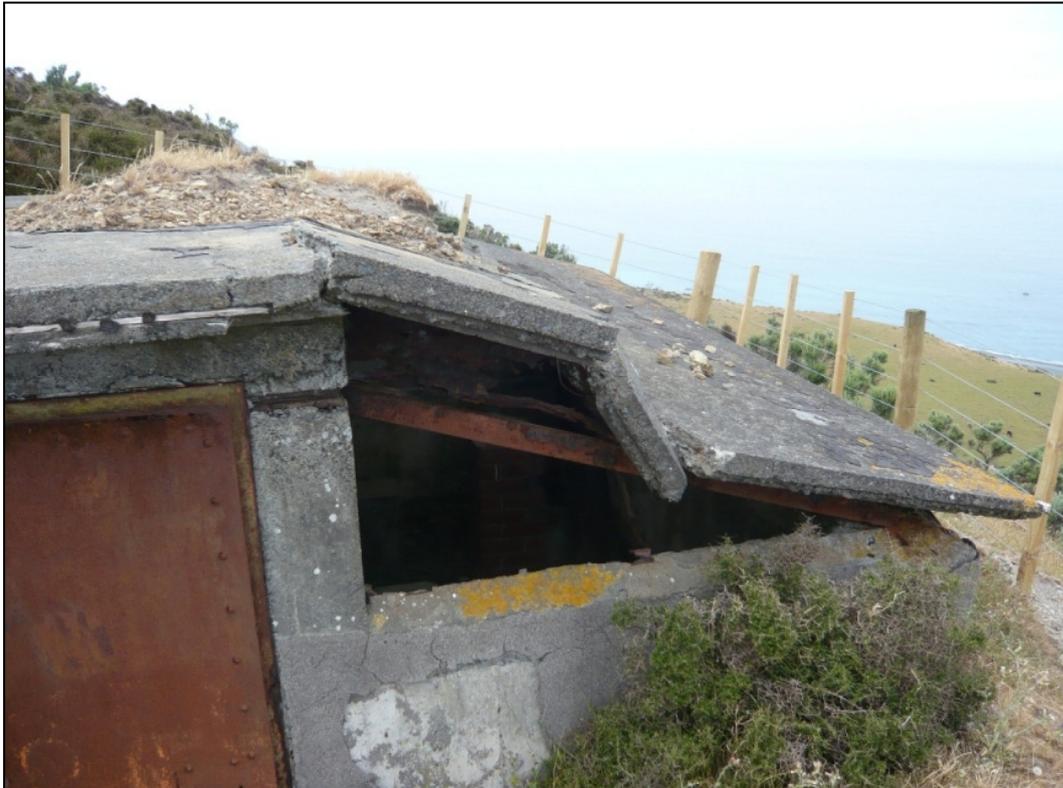
The nature of the location (direct exposure to a coastline environment), coupled with a lack of upkeep, has unfortunately resulted in the collapse of the cantilever portion of the roof into the bunker at some time in the past (see **Photo 18**). For comparative / illustrative purposes of how the bunker would have looked prior to slab failure, **Photo 19** shows a similar structure at Fort Dorset which remains fully intact.

The failure to the roof has been caused primarily by the rapid deterioration of the cantiliver support steelwork. Extensive corrosion and loss of section to the steel has resulted in the concrete roof failing at the interface with the vertical side walls and rotating downward (**Photo 18** illustrates the failure mode – **Photo 22** shows the unprecedented level of corrosion encountered).

Photo 18 – Structure 3: View of collapsed section of cantilever roof

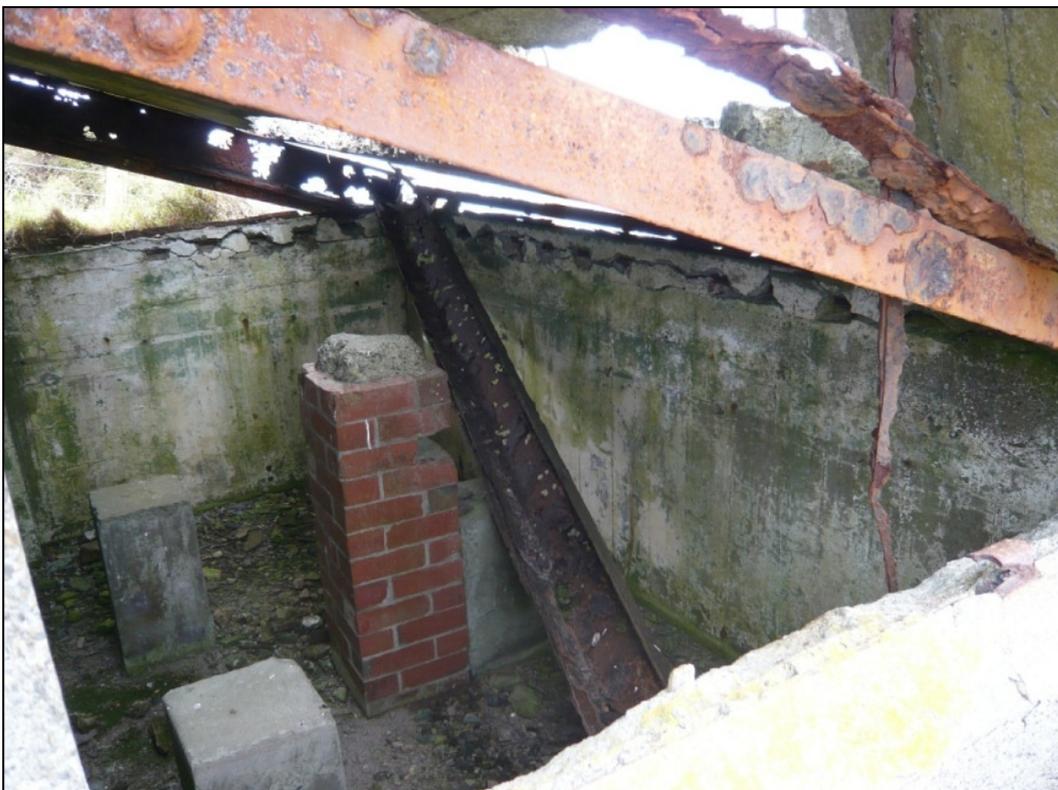
The internal area of the bunker was not accessed, as it was deemed to be too dangerous. However, it was possible to view the bunker from the side of the structure. The vertical walls appear to be in reasonable condition, and the original mounting position for the binoculars is still present (see **Photo 20**).

Photo 20 – Structure 3: View inside bunker showing corrosion / failure  
to cantilever roof support steelwork

- a) When viewed from a position of safety, the internal walls and floor of the bunker appear to be in reasonable condition. It is recommended that a further inspection be undertaken when the structure has been made safe to confirm its integrity.

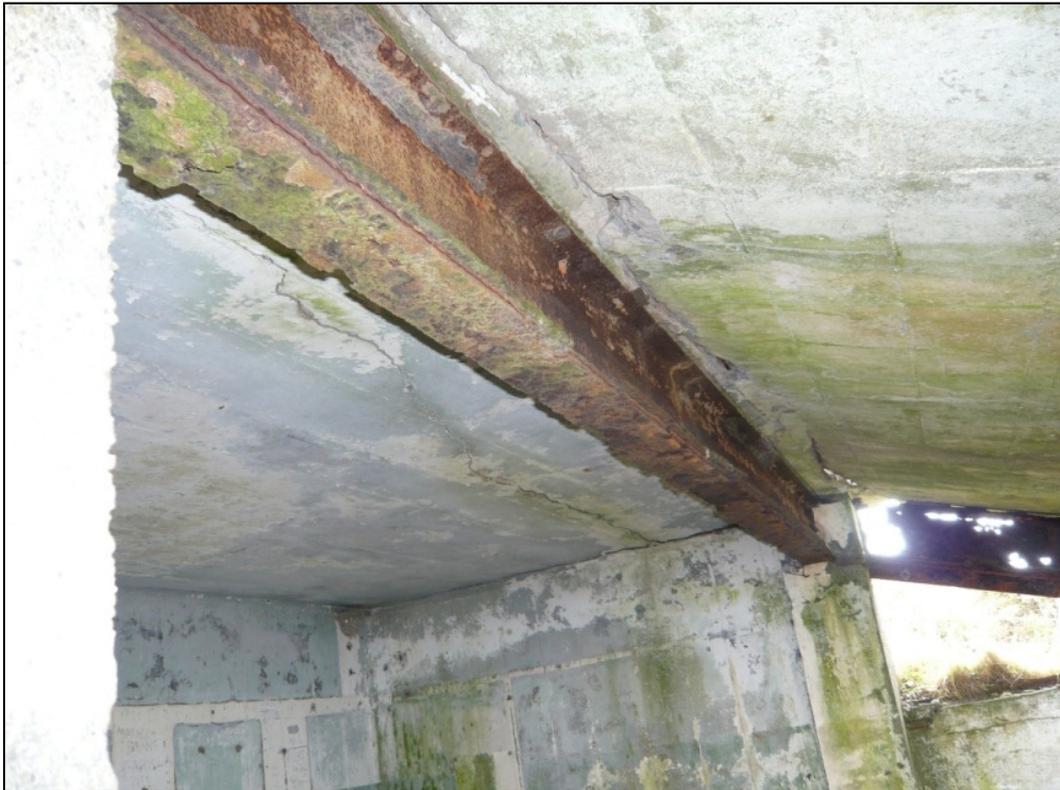
The section of the roof slab still intact is supported by the side and rear vertical walls on three sides. The front edge is supported by a steel cross beam that although in an advanced state of corrosion, has not yet failed (see **Photo 21**). This beam was not subject to such direct exposure when compared to the other steel beams, and is therefore still providing support to the roof at this location. In fact, it could be argued that the failure of the cantilever slab has provided additional protection to this beam. The beam is in poor condition and when it eventually fails it is likely that the remaining section of the roof will be subject to further collapse.

Photo 21 – Structure 3: View of bunker roof rear section supported on badly corroded steel beam.

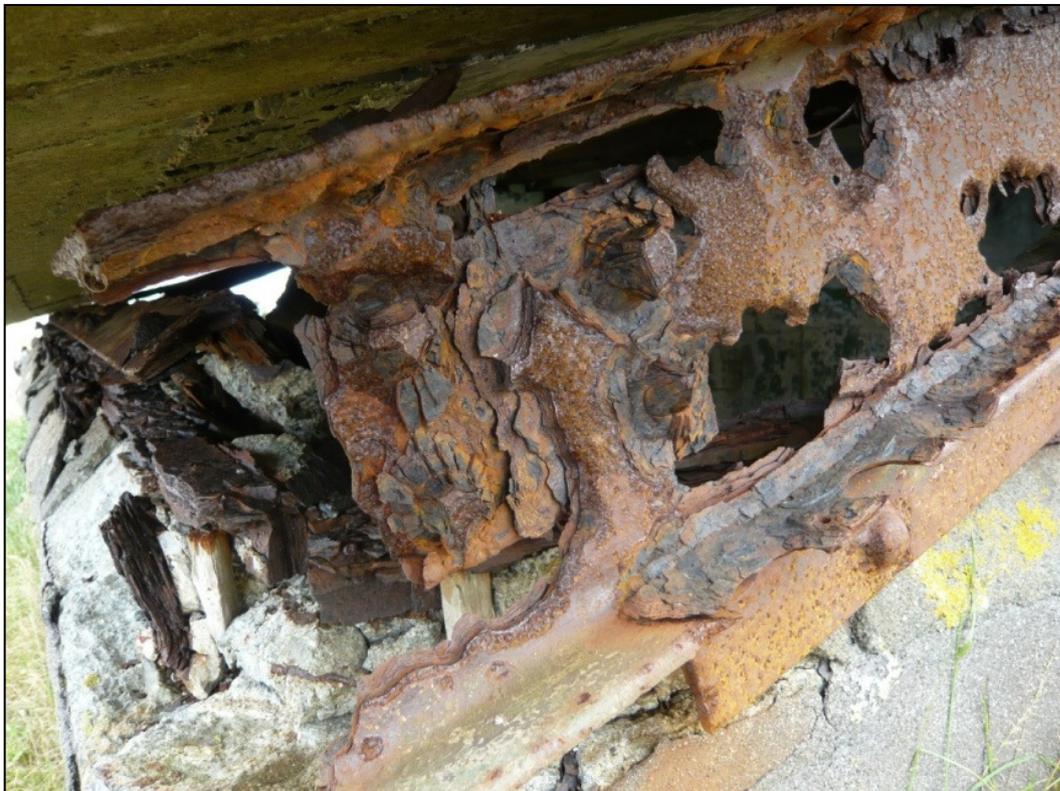
Photo 22 – Structure 3: View showing extensive corrosion to failed section of cantilever roof support steelwork.
