RESOURCE CONSENT
APPLICATION
FOR THE STAGE 4
EXTENSION OF THE
SOUTHERN LANDFILL,
WELLINGTON

Southern Landfill Stage 4

Phase 1 Geotechnical Report

AUGUST 2013

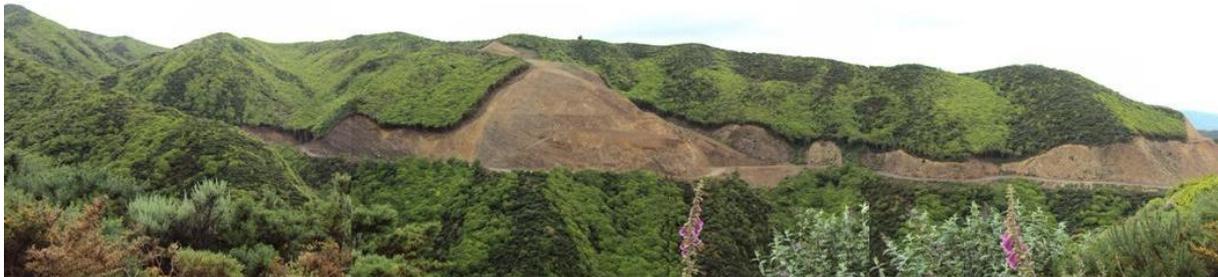
Plate 3-1 View across proposed Southern Landfill Stage 4 area to eastern road

The site comprises a deeply incised valley with steep slopes and natural slope angles typically between 30° to 50°. Slopes steeper than 50° are present, which generally comprise rock, typically encountered in the bottom of the main gully, the access road cut slopes and where Stage 4 area overlaps with Stage 3 area. These steeper slopes comprise either very thin soils over rock or rock, with little to no soil observed on slopes >55°. There is approximately 200 m of relief between natural valley floors and ridges. The majority of the slopes are densely vegetated with scrub and trees, which obscures the landforms (See **Plates 3-1 to 3-3**).

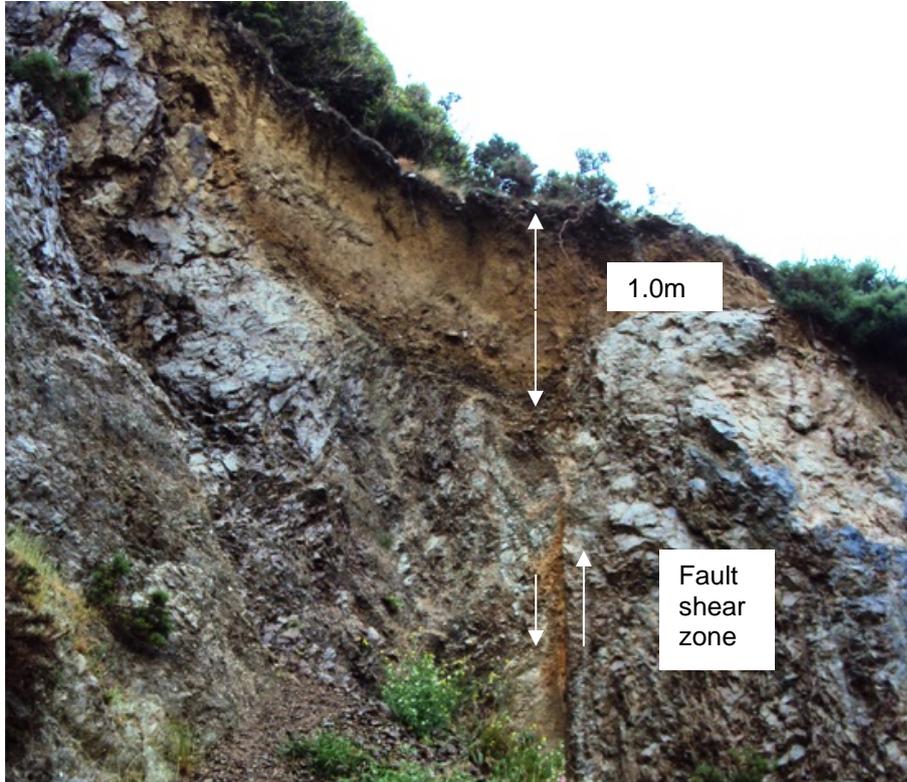
Plate 3-4 Fault shear zone on western access road cut slope

Shears or faults up to about 0.5 m in thickness are common in outcrop (See **Plate 3-4** and **Drawing G-001**). These comprise a zone of intensely fractured rock and contain seams of sheared rock or clay 5 mm to 50 mm in thickness. The shears exhibit variable orientations and have an average spacing of 3 m to 10 m. The orientations of dominant shears or faults exposed in outcrop were measured and have been plotted on **Figure 3-3**. Continuity of the shears or faults was observed to be at least 20 m in places and some features are expected to be continuous for hundreds of metres. Note that only easily accessible locations were assessed, thus there is bias in the data set.

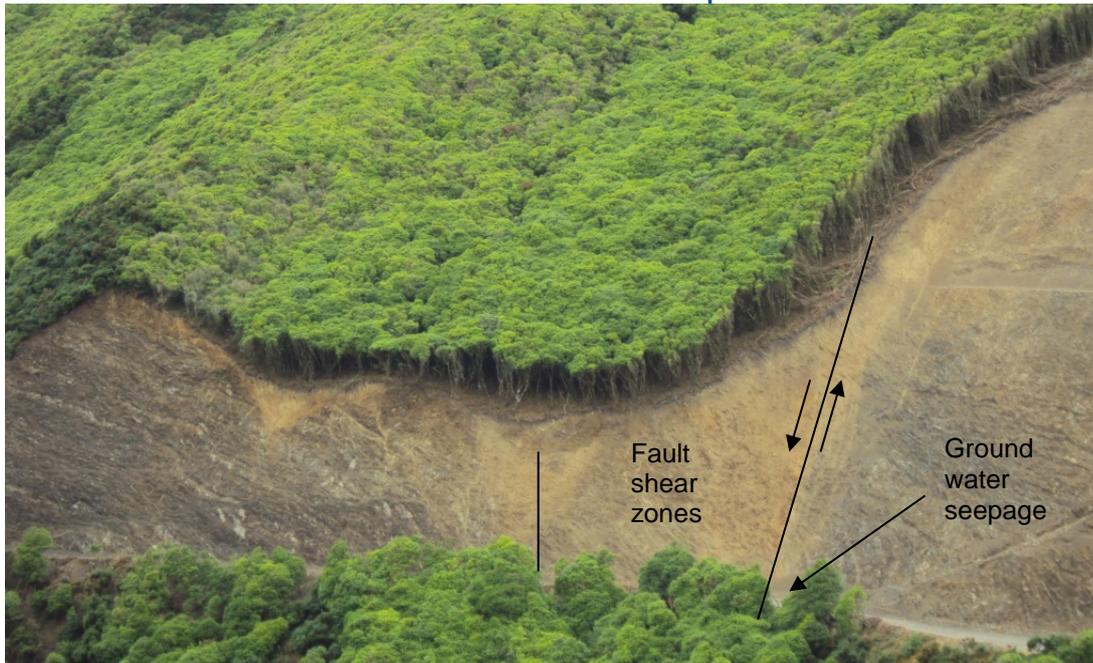
Plate 3-5 Fault shear zones on eastern access road cut slope

The widest shears or faults observed (refer **Plate 3-5**) have less than 1 m to 3 m thickness of sheared material or fault gouge (angular sandstone gravel and cobbles in silty matrix) and groundwater seepage was observed.

In general, it was after intense or prolonged rainfall events that groundwater was observed seeping from minor shear zones and faults. The only groundwater seepage observed from a fault in dry weather was minor (film of water / wetting of 2 m² area at base of fault) from the significant fault shown in **Plate 3-5** on the eastern access road.
