Request for information 2023-037

Request for an explanation in relation to non-compliances at the Porirua Wastewater Treatment Plant

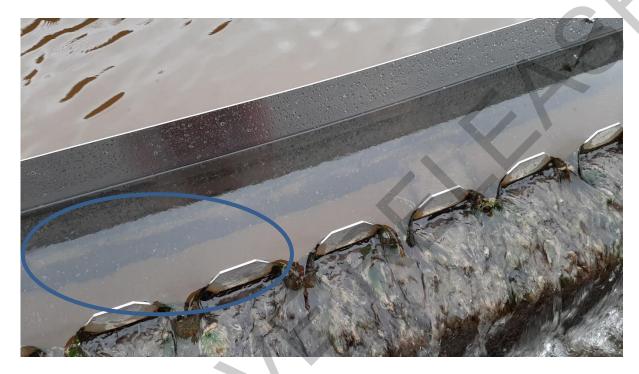
Sampling (see Table 1 above) indicates that BOD and suspended solids were not elevated in the effluent on December 6, as would be expected if a sludge carry-over event had occurred. Further no visible brown plume was reported at the outfall.

On December 6th, as occurs on occasions at this and other activated sludge plants, a small amount of solids was being released as part of the treated effluent. The photo below taken on December 7 shows similar effluent quality as measured on December 6.

We consider that a sludge carry-over should only be defined as the discharge of significant biomass from the clarifiers due to sludge blanket levels reaching the weir levels.
