Mangaroa River Flood Hazard Assessment

EROSION HAZARD REPORT

GW/FP-G-06/64

- Revision A
- 29 May 2006

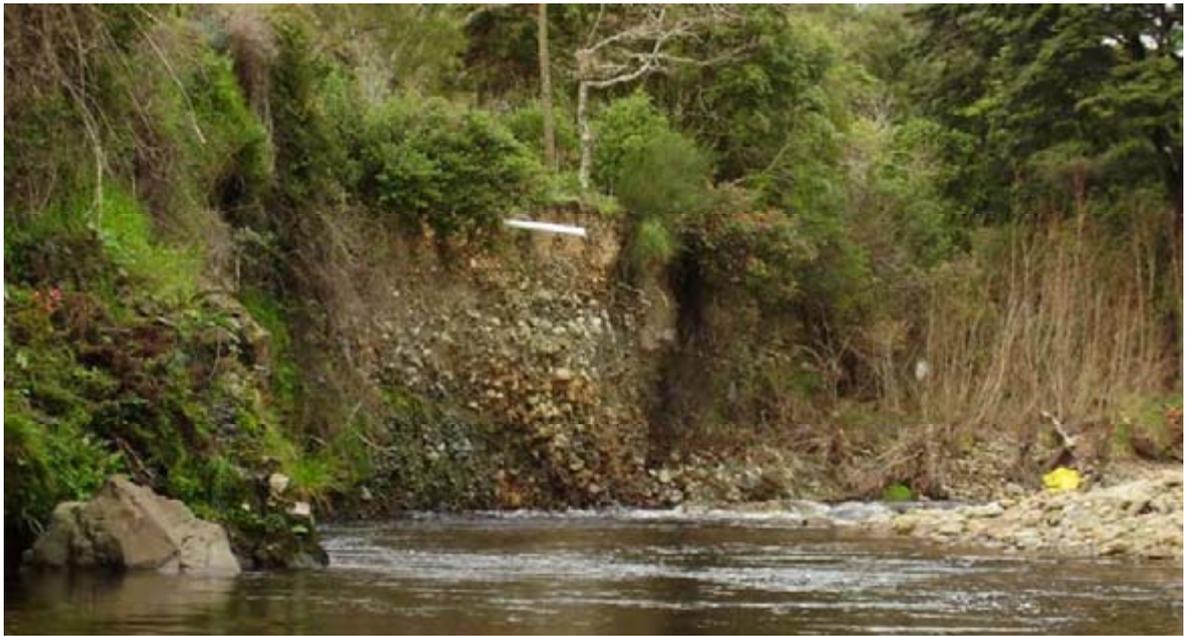
Areas B and C have been classified under the extreme risk category. This section of river, running adjacent to Maymorn Road, is confined by steep banks and has a steeper gradient than much of the upper catchment. The river through this area has relatively higher velocities than those found in the rest of the Mangaroa. These factors contribute to the scour along the banks, see Figure 2.

■ **Figure 2 Erosion Hazard Identified Adjacent to Maymorn Road, Areas B and C**

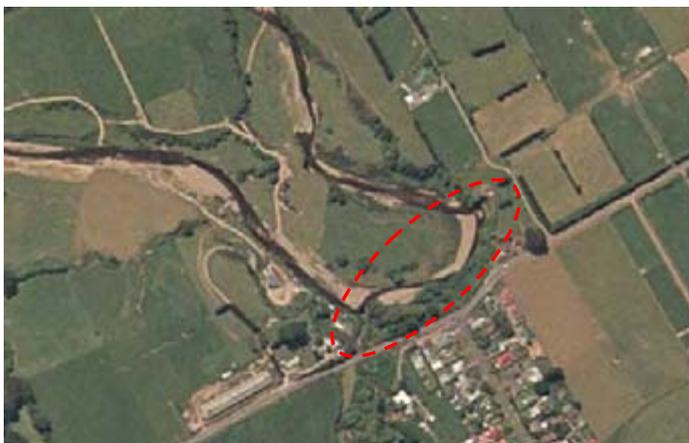
Area E, adjacent to Parkes Road represents another erosion hazard classified in the extreme category, see Figure 3 and Figure 4. The Maymorn housing area is located on a river terrace 15-20m above the river. The steep banks on the river bend have the potential to slip endangering the infrastructure and properties above.

■ **Figure 3 Erosion Hazard Identified Near Parkes Line Road (Area E)**

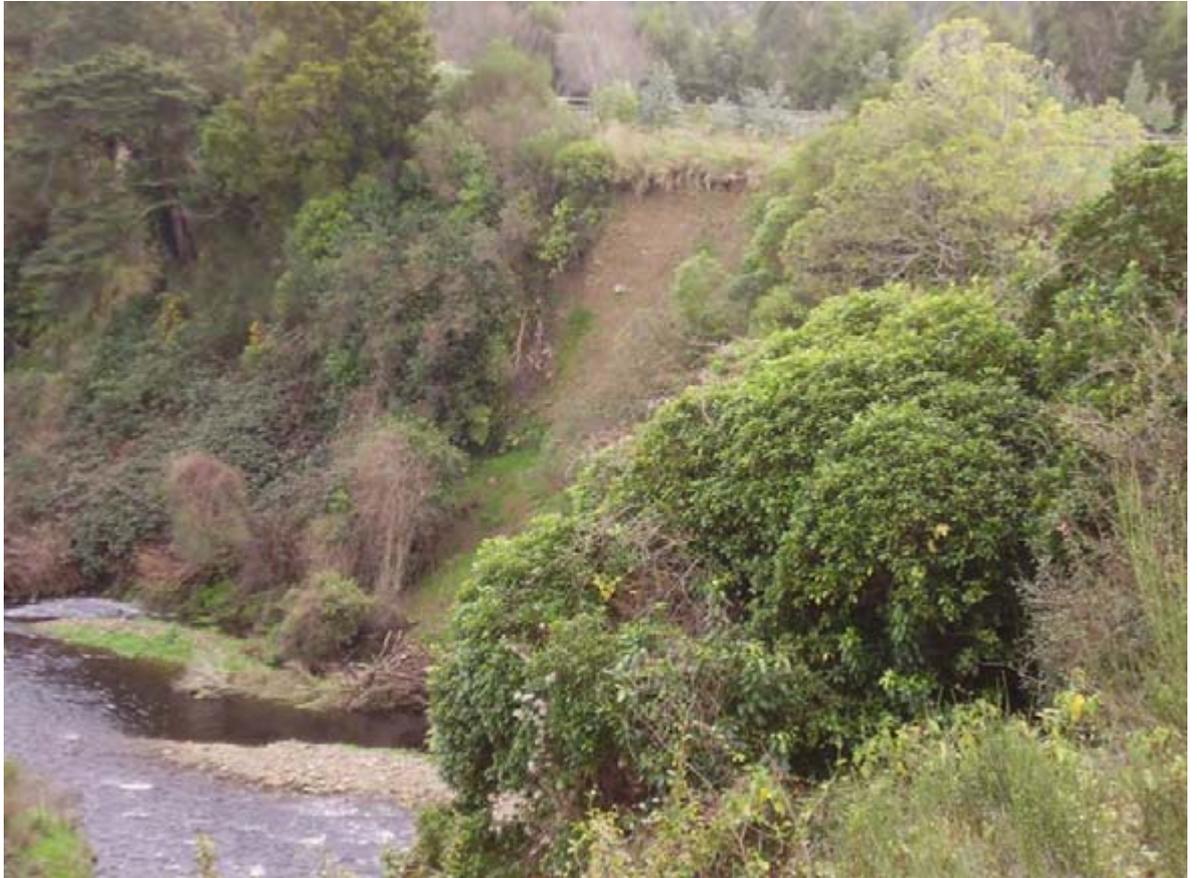
■ **Figure 4 River Banks adjacent the Parkes Road.**

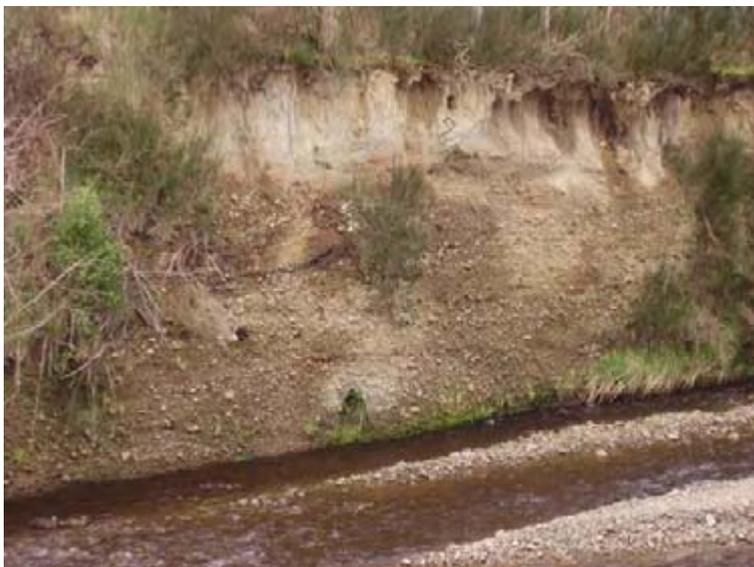
Area I covers 300m of the true right bank upstream of the Mangaroa Hill Road Bridge. This area is also considered to be in the extreme category of erosion risk. Figure 5 depicts the loose alluvial material that the banks consist of.

■ **Figure 5 Mangaroa Hill Bridge Erosion Area**

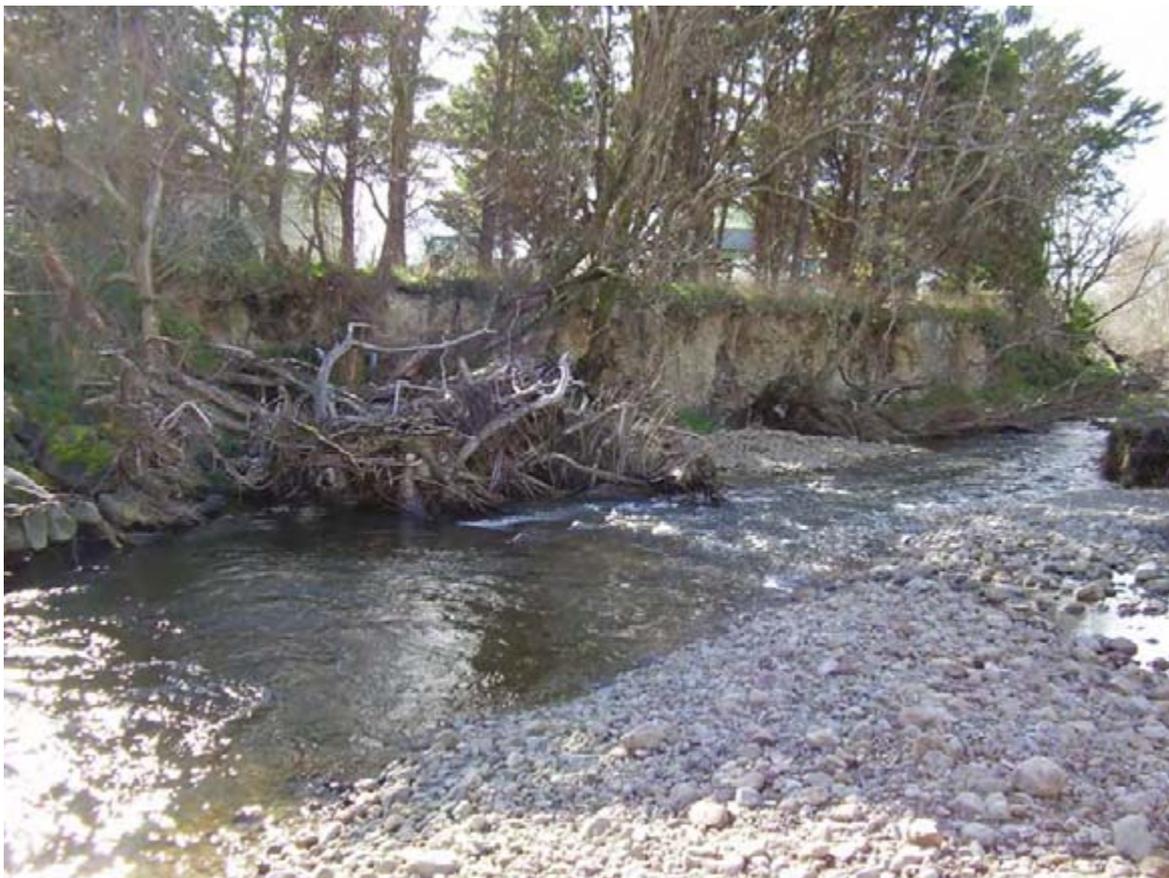
Areas P and Q surround the Mangaroa Valley Road Bridge. The banks in this area demonstrate evidence of recent erosion. Figure 6 shows the close proximity of buildings to the river. Unchecked erosion in this location has the potential to endanger half a dozen buildings at this location.

■ **Figure 6 Erosion of the Banks Near Mangaroa Valley Road.**
