Annual coastal monitoring report for the Wellington region, 2008/09

Juliet R Milne

GW/EMI-G-09/236

October 2009

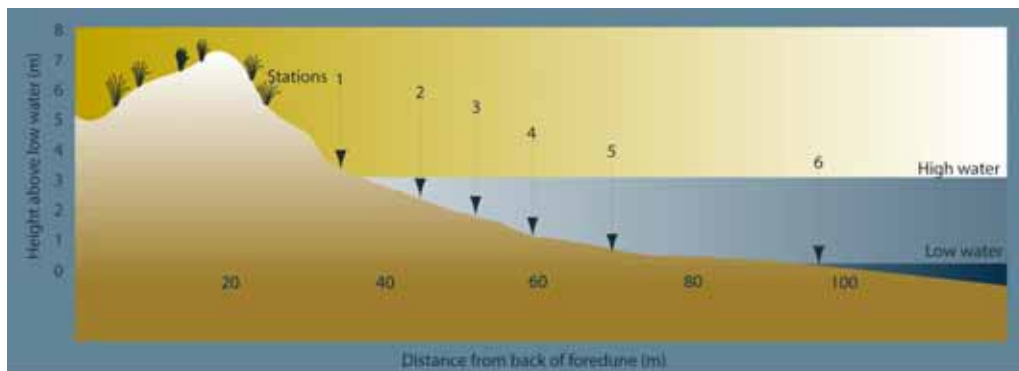
Figure 8.1: Cross-section of sampling transect at Castlepoint Beach

Monitoring was undertaken along two transects, 50 m apart, located towards the northern end of Castlepoint Beach, approximately 750 m south of the Whakataki Estuary (Table A2.5, Appendix 2). Six stations were sampled along each transect (Figure 8.1), with assessments made of sediment grain size (texture), sediment oxygenation and benthic (sediment-dwelling) fauna. Sediment nutrient and contaminant concentrations were not assessed; there are no major nutrient inputs on semi-exposed beaches like Castlepoint, and the risk of toxic contamination is very low.
