Is it safe to swim?

Recreational water quality monitoring
results for the 2014/15 summer

greater WELLINGTON
REGIONAL COUNCIL
Te Pane Matua Taiao

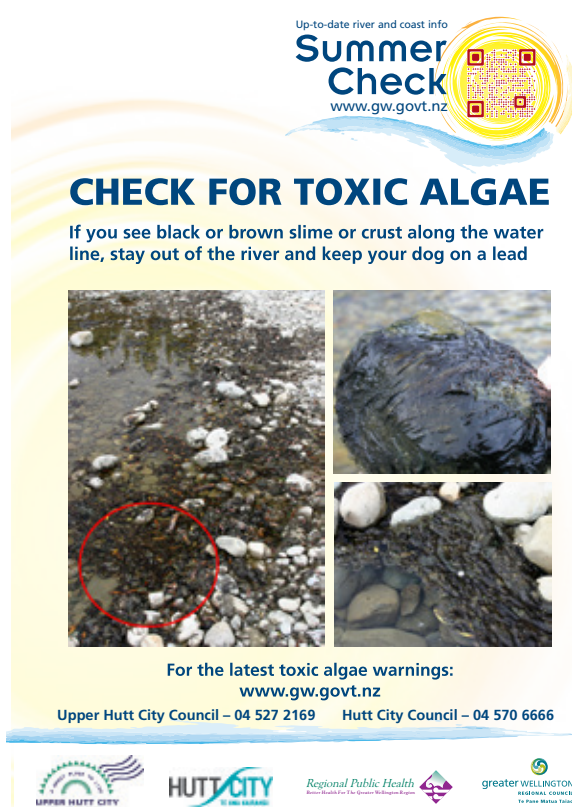
Figure 3.2: Sign used to inform the public of the health risk from cyanobacteria in rivers in the Wellington region

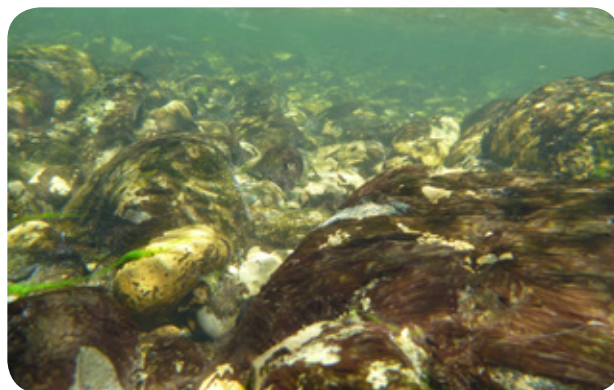
Cyanobacteria mats growing on the river bed at Hutt River at Silverstream on 18 February 2015

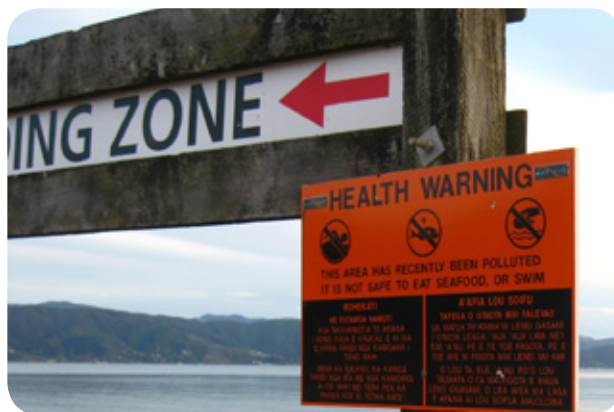
Health warning sign at Petone Beach at Waterski Club on 4 March 2015 following an action guideline exceedance on 2 March. Signs were taken down on 5 March after bacteria counts returned to safe levels
