Mangatarere Stream catchment water quality investigation

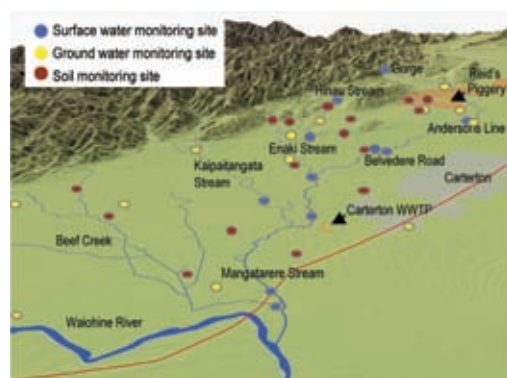
Sampling sites. Stream flow was measured each time water samples were collected.

Greater Wellington spent 13 months on an intensive environmental monitoring programme and also reviewed long-term water quality data and resource consent data from within the Mangatarere catchment. The monitoring programme, carried out in 2008 and 2009, involved monthly water sampling at 11 stream sites and two-monthly sampling of 13 groundwater bores. The water samples were tested for a range of variables such as suspended sediment, nutrients, *E. coli* bacteria and metals. Algae and invertebrate (e.g. insects and snails) samples were also collected to provide an indicator of the stream's ecological health. In addition, soil samples were taken from 16 locations under different land uses and tested for organic material, nutrients, fertility and trace elements. The purpose of the soil and groundwater sampling was to help pinpoint contaminant sources.

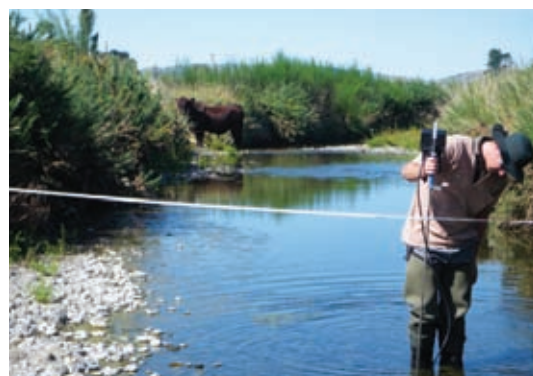
Measuring flow in the Kaipaitangata Stream, a tributary of the Mangatarere stream. Note the cattle beast in the background with access to the stream.

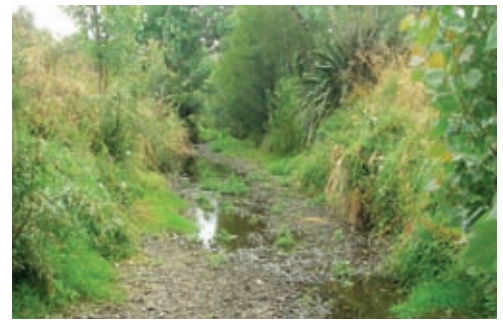
The lower reaches of the Enaki Stream reduced to a few pools in February 2009

Site-specific impacts were identified, particularly in parts of the Enaki Stream and Beef Creek subcatchments. These included compacted soils – which can promote overland flow of effluent into streams and drains – and stock access to waterways, resulting in significant water quality impacts. There was also a lack of flow in some stream reaches during summer. While this can occur naturally, it is made worse by the taking of water from streams and shallow bores for irrigation.

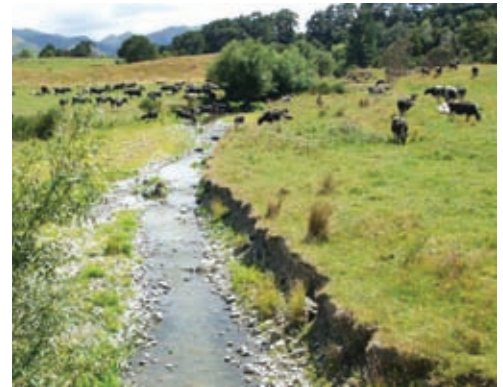
Dairy cows in the Enaki Stream

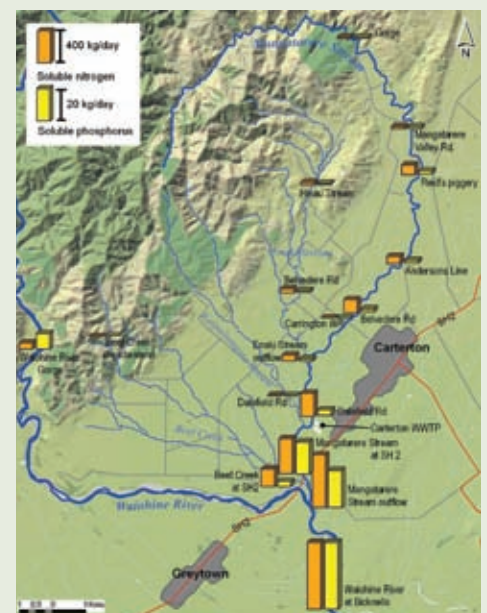
Average loads of soluble (readily available) nitrogen and phosphorus at different locations in the Mangatarere catchment during the investigation period. Loads are calculated by multiplying the nutrient concentrations in the stream by stream flow. The height of each coloured bar is proportional to the nutrient load present.

The total amount or 'load' of nutrients – in particular soluble (available) nitrogen and phosphorus – was found to increase in the Mangatarere Stream downstream from the gorge. While nitrogen loads increased steadily across the plains, phosphorus loads only increased significantly in the lower reaches of the stream below the discharge from the Carterton wastewater treatment plant. Monitoring by Carterton District Council confirms that the wastewater discharge has had a measureable impact on stream health.

Beef Creek was found to contribute relatively large loads of nitrogen and phosphorus to the lower reaches of the Mangatarere Stream. It is estimated that one-third of the nitrogen load in the Mangatarere Stream (as it enters the Waiohine River) comes from Beef Creek. The Beef Creek subcatchment comprises both dairying and drystock farming, highlighting the impact intensive agriculture can have on water quality. These impacts can occur through both surface runoff of dairyshed effluent and fertilisers, and effluent and fertilisers leaching through the soil to enter shallow groundwater systems that are connected to streams.
