On the beaches 2010/11

Annual recreational water quality monitoring report
for the Wellington region

GW/EMI-G-11/88

June 2011

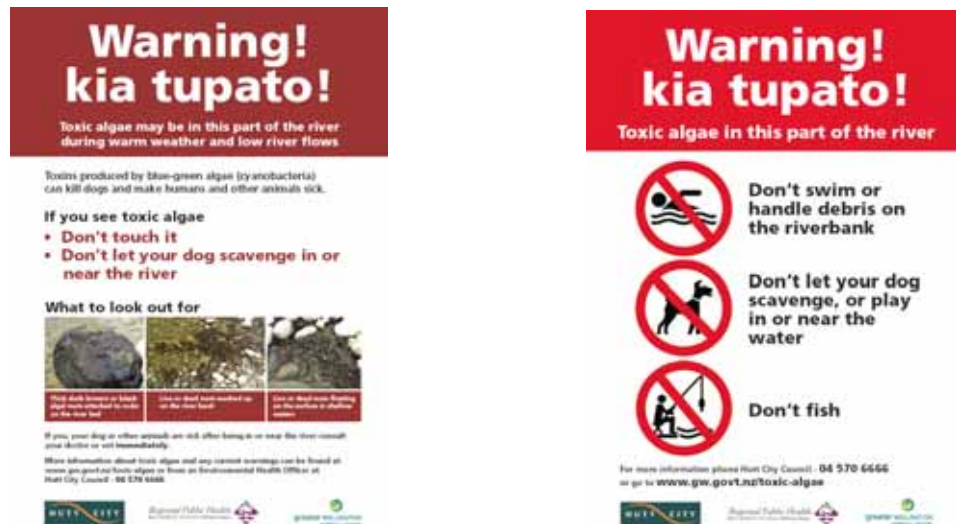
Figure 3.2: Alert (left) and action (right) level warnings signs used to inform the public of the health risk from cyanobacterial mats in rivers in the Wellington region

In 2009, interim New Zealand guidelines for cyanobacteria in recreational lakes and rivers were released (MfE/MoH 2009) for trial by monitoring and health agencies⁶. The interim guidelines for rivers identify a three-tiered alert level framework for benthic cyanobacteria (Table 3.2) which was based on a system that has been applied in the Wellington region for the past two years. Alert and action level signs used to warn the public of the risk from benthic cyanobacteria are shown in Figure 3.2.

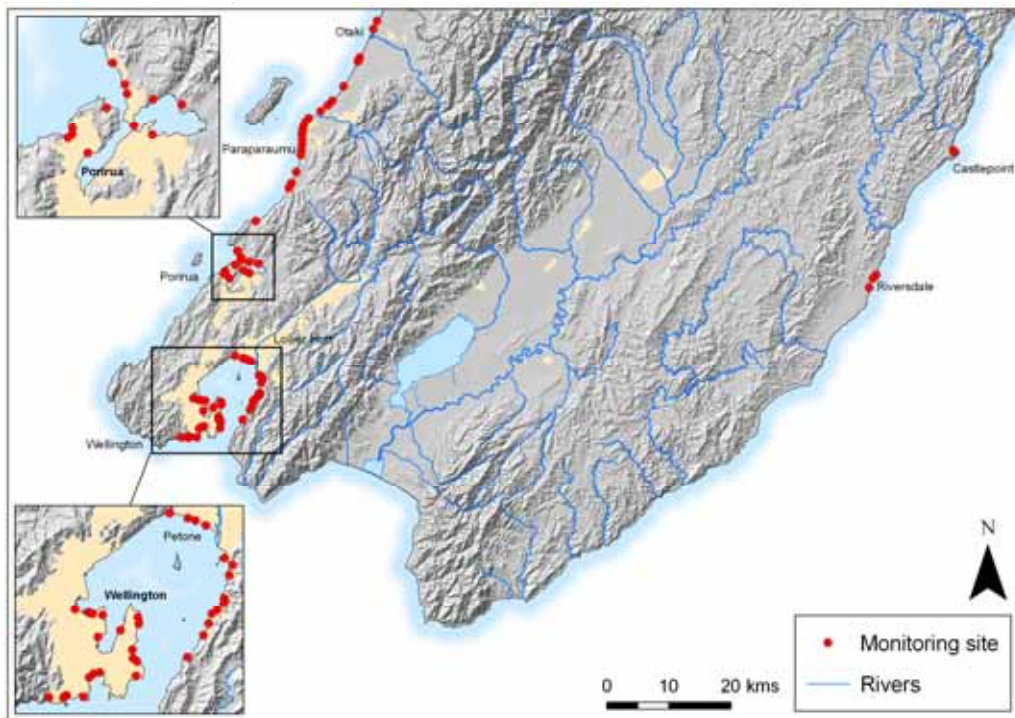
Figure 4.1: Marine recreation sites monitored over 2010/11

Recreational water quality was monitored at 74 marine sites across the Wellington region over 2010/11 (Figure 4.1, Appendix 1), as follows:

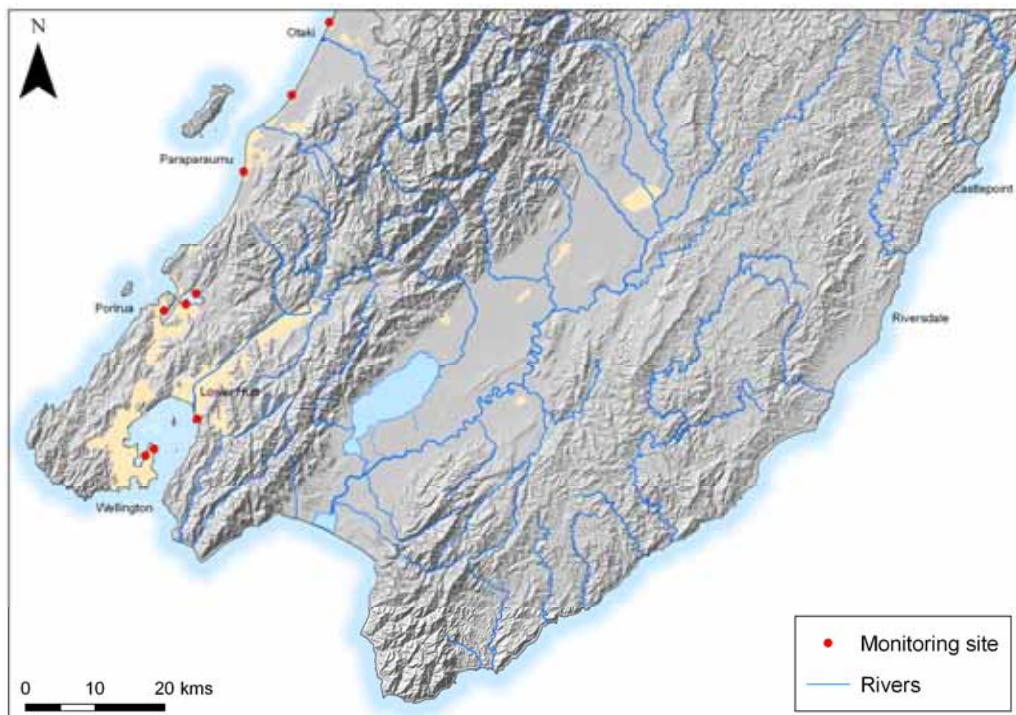
Figure 5.1: Recreational shellfish gathering water quality monitoring sites, 2010/11

Recreational shellfish gathering water quality was monitored at nine marine sites across the Wellington region over 2010/11 (Figure 5.1, Appendix 1), as follows:
