# Seagrass in Porirua Harbour

Preliminary assessment of restoration potential

Prepared for Greater Wellington Regional Council

NIWA Client Report No: HAM2012-037  
Report date: July 2012  
NIWA Project: WRC12206

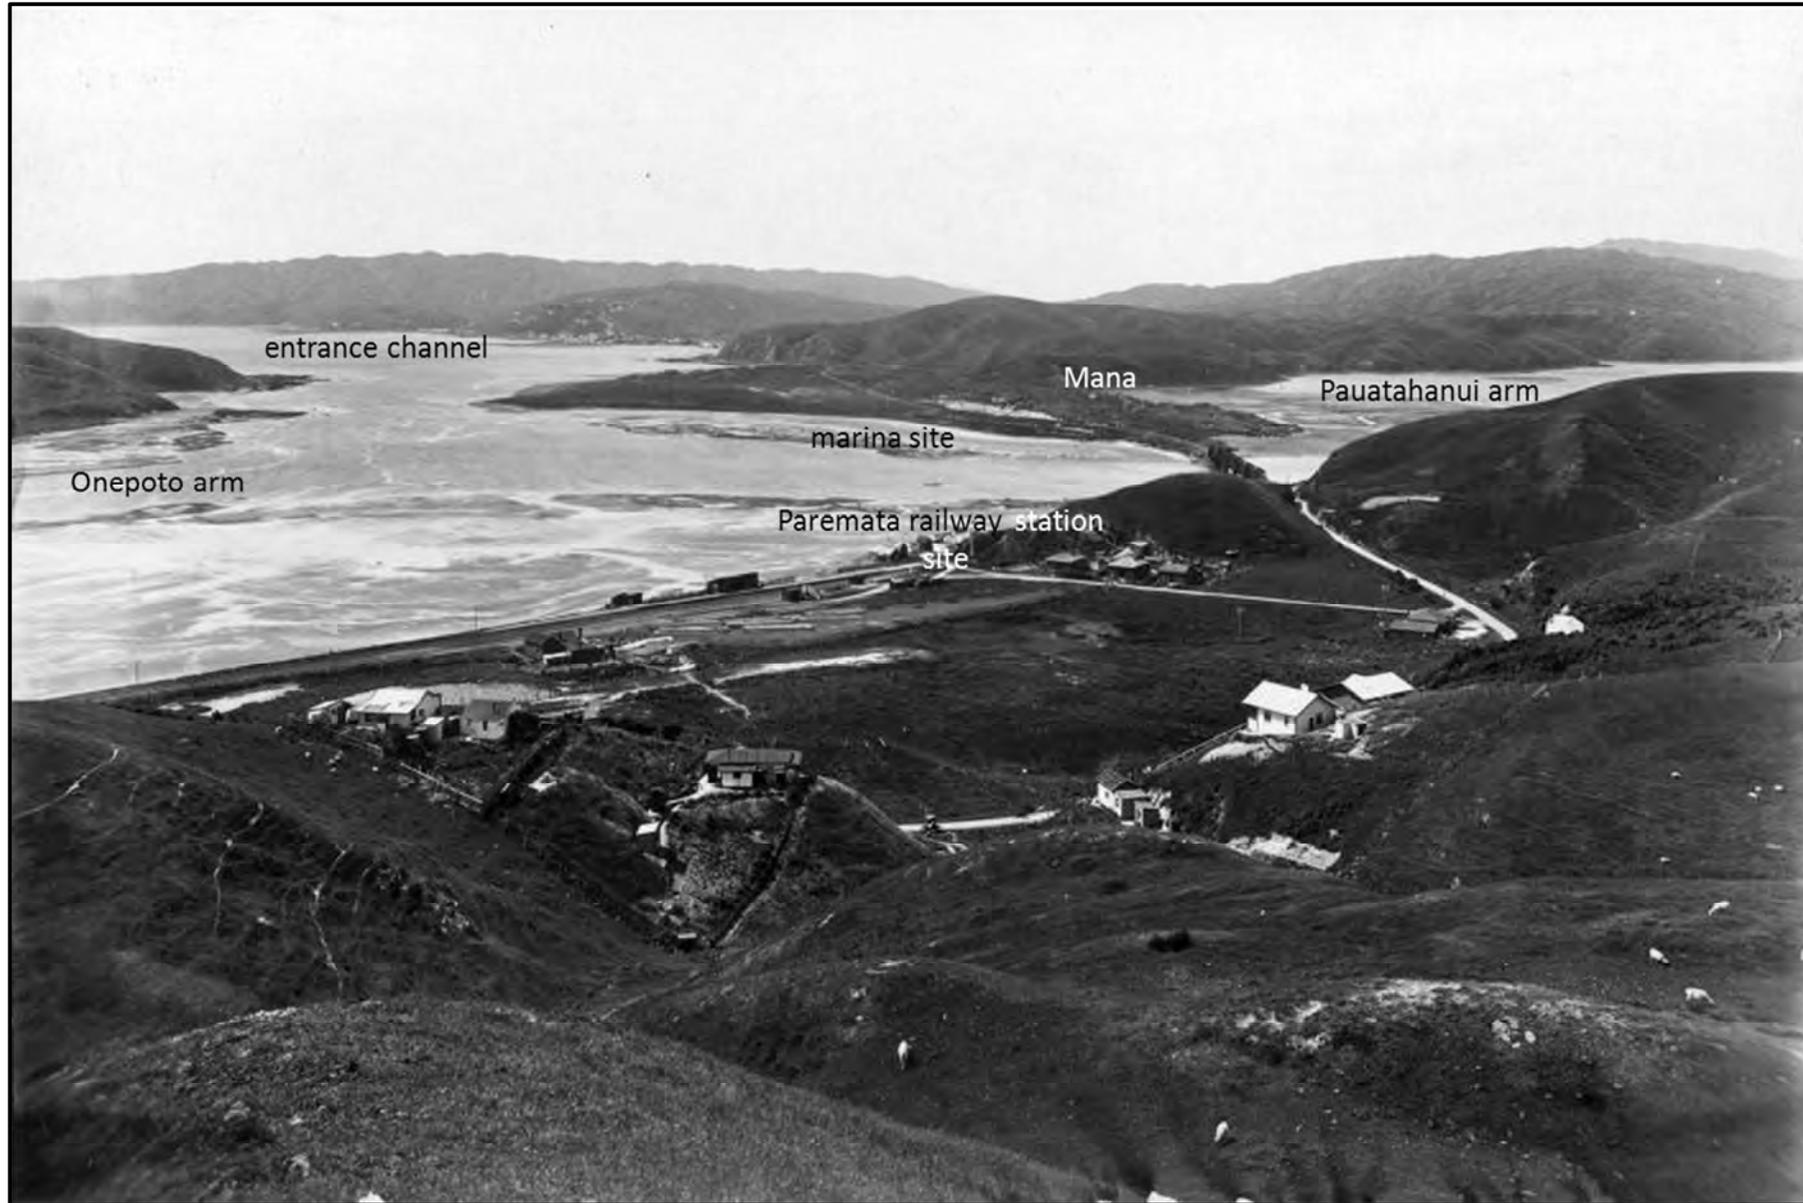
**Figure 3-1: Early photograph of the outer Onepoto arm.** Dark patches on the exposed tidal flats are intertidal seagrass beds.

An early photograph looking north over the outer Onepoto arm (date unknown, probably early 1900s) suggests that there were beds of intertidal seagrass on the tidal flats adjacent to the current Paremata railway station site, on the western side at Mana at the current marina site, and on the tidal flats on the western side of the Onepoto arm (Figure 3-1).

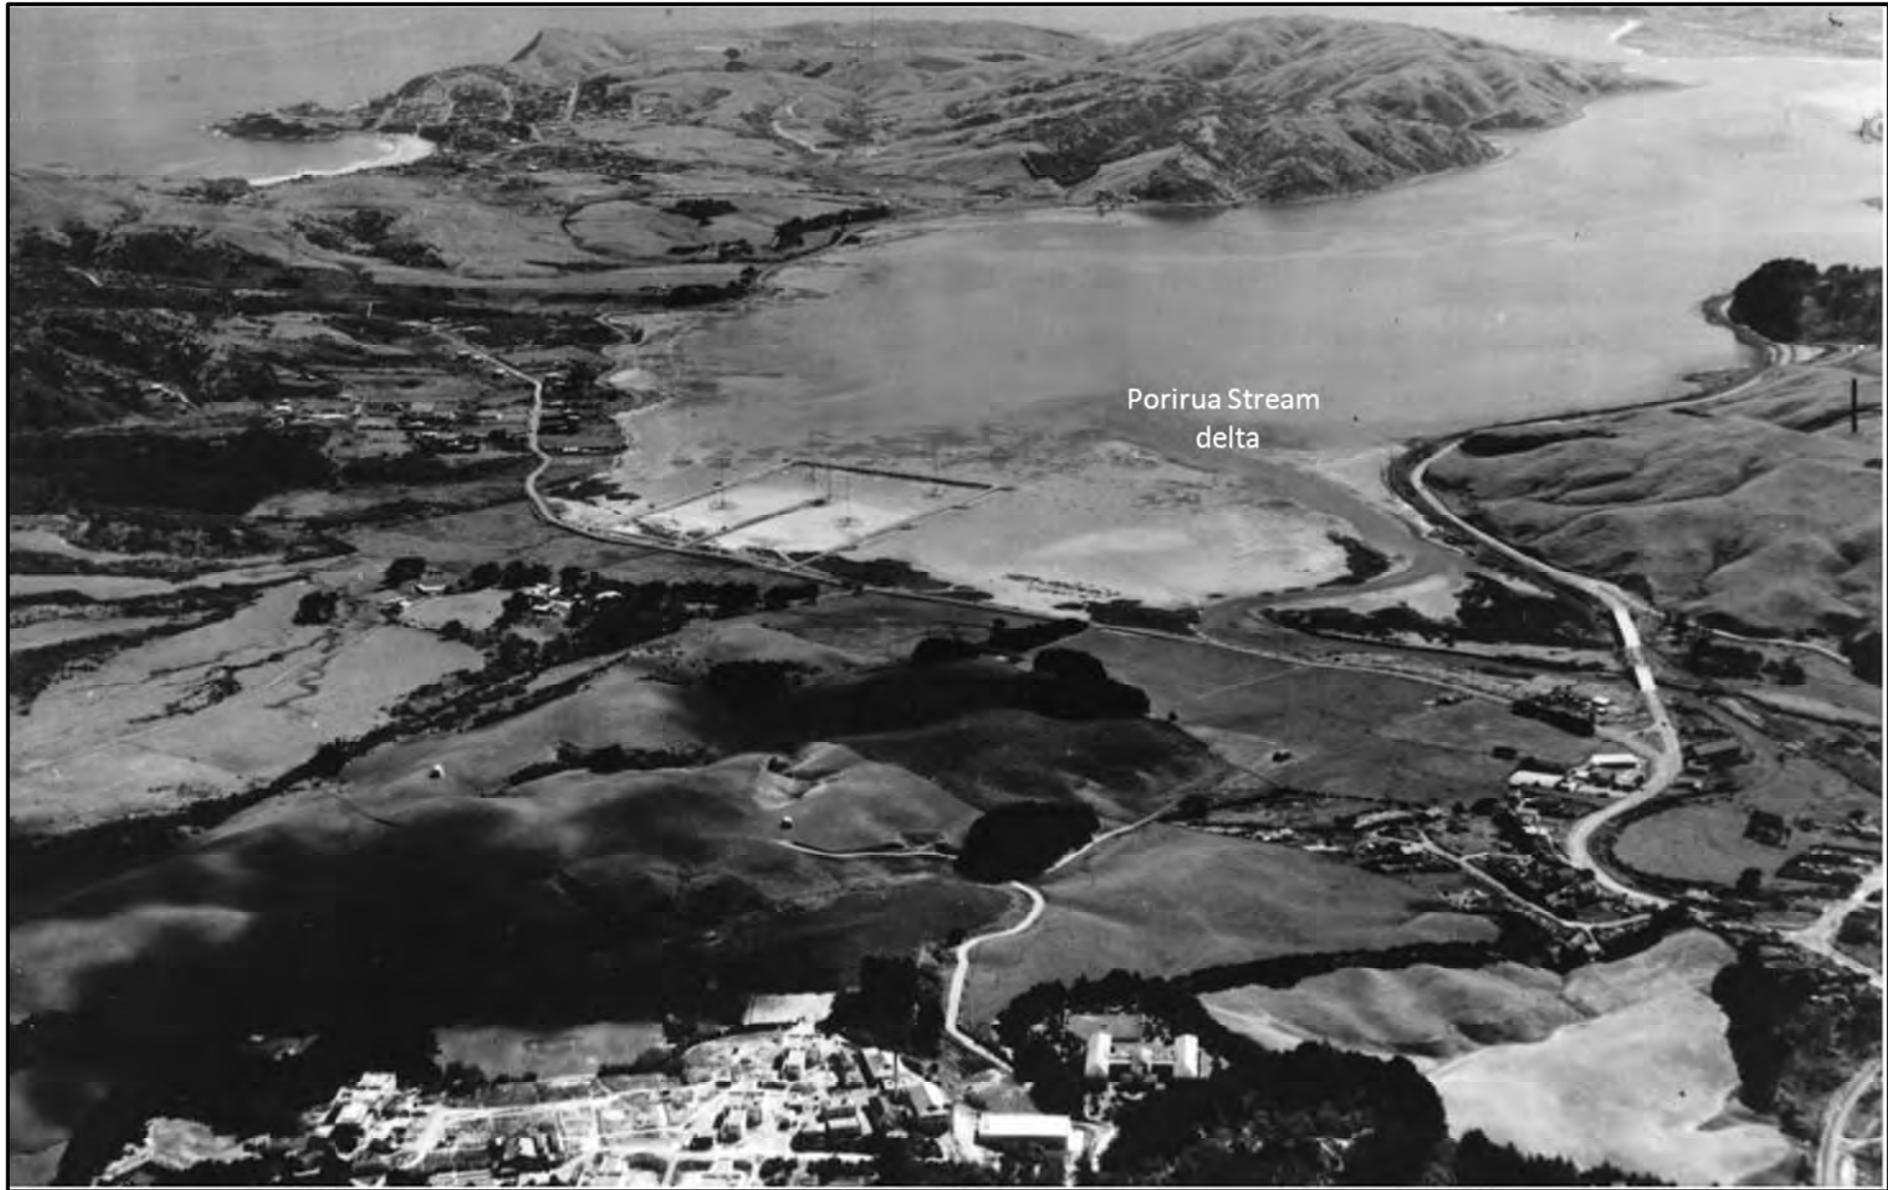
**Figure 3-2: 1920s photograph of the Onepoto arm.** Dark patches on the exposed tidal flats are probably intertidal seagrass beds.

A photograph taken during the 1920s looking north over the head of the Onepoto arm shows what appears to be seagrass beds on the exposed tidal flats to the left of the Porirua Stream delta and along the western shoreline (Figure 3-2).

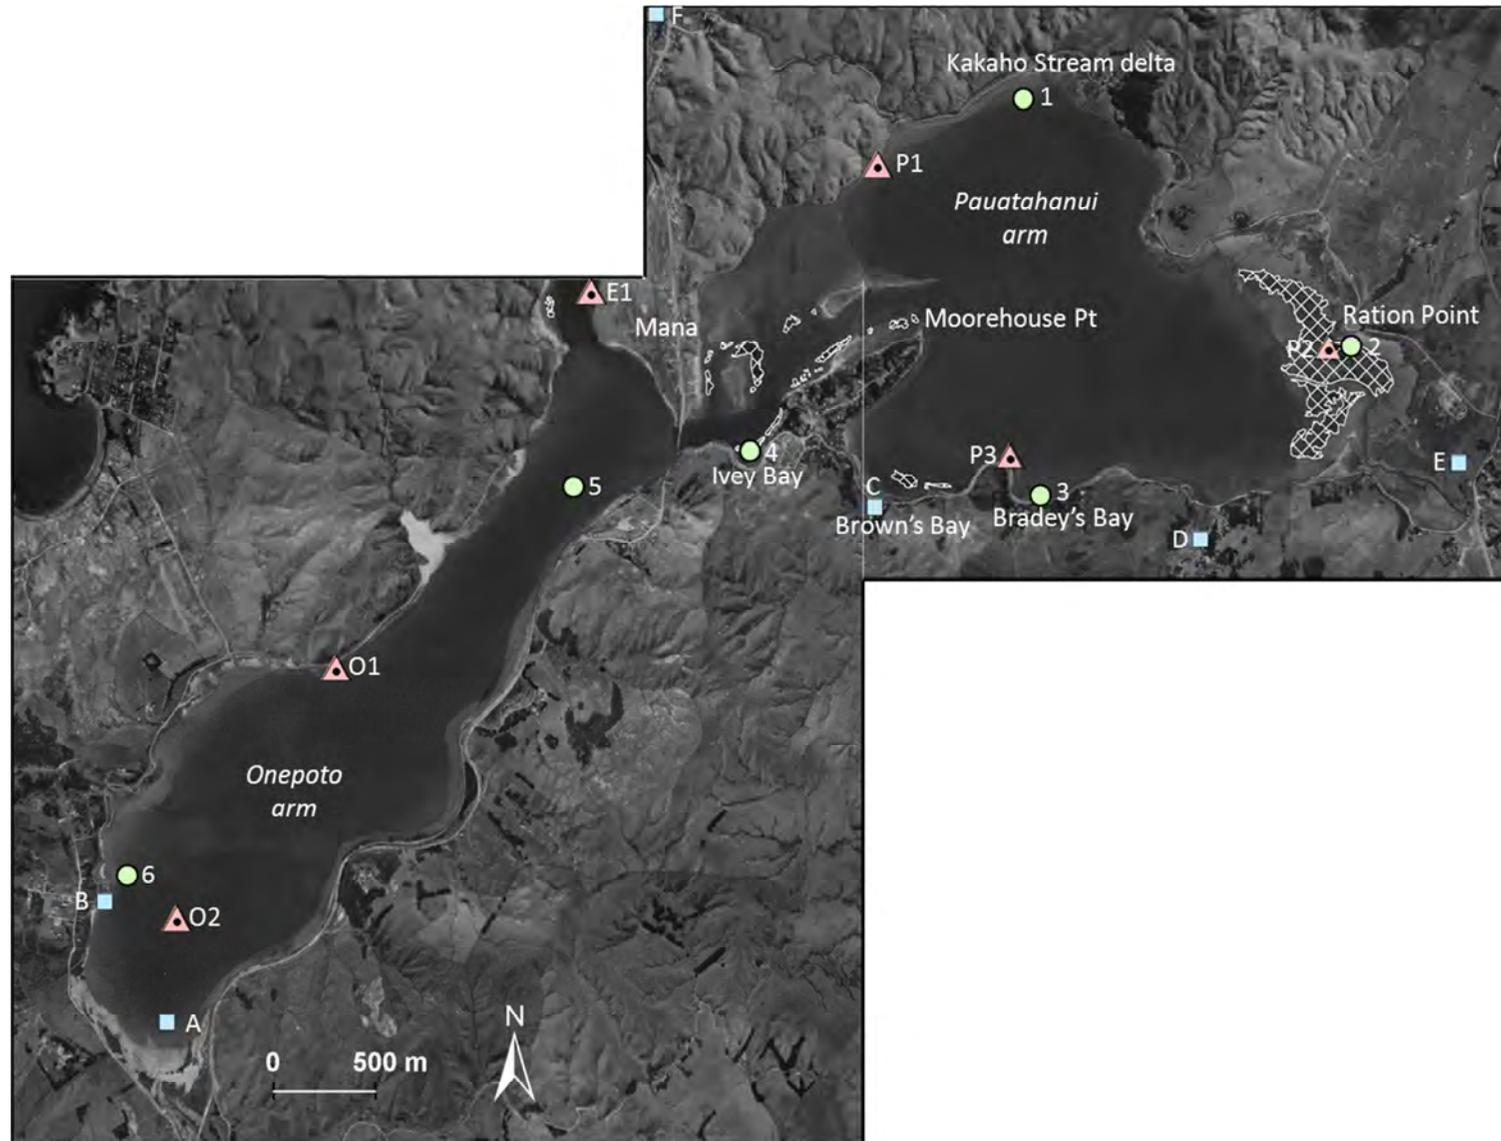
**Figure 3-3: Seagrass extent in Pauatahanui arm in 1942.** Poor photograph quality prevented identification in the Onepoto arm. White cross-hatched areas are seagrass beds. Circles (1-6) are our sampling sites. Triangles (E1, P1-3, and O1-2) are Greater Wellington Regional Council water quality monitoring sites. Squares (A-F) are Porirua City Council stormwater monitoring sites.

In the 1942 aerial photographs, we identified approximately 24 ha of seagrass beds in Porirua Harbour, mostly in the Pauatahanui arm (Figure 3-3, Table 3-1). Extensive areas of seagrass were present on the tidal flats around Ration Point (near sites 2 & P2), with smaller beds also evident around Mana, from Ivey Bay to Moorehouse Point, and in Browns Bay. Some small beds were also identified in a small bay on the western shore of the harbour, close to the entrance channel (opposite site E1). No beds could be identified in the Onepoto arm; however the aerial photograph quality is not sufficient to be certain that seagrass was absent from this arm at this time. In fact, both earlier and later photographs (see above and below) suggest a seagrass presence in this arm so it is likely that these beds were present in the 1940's.

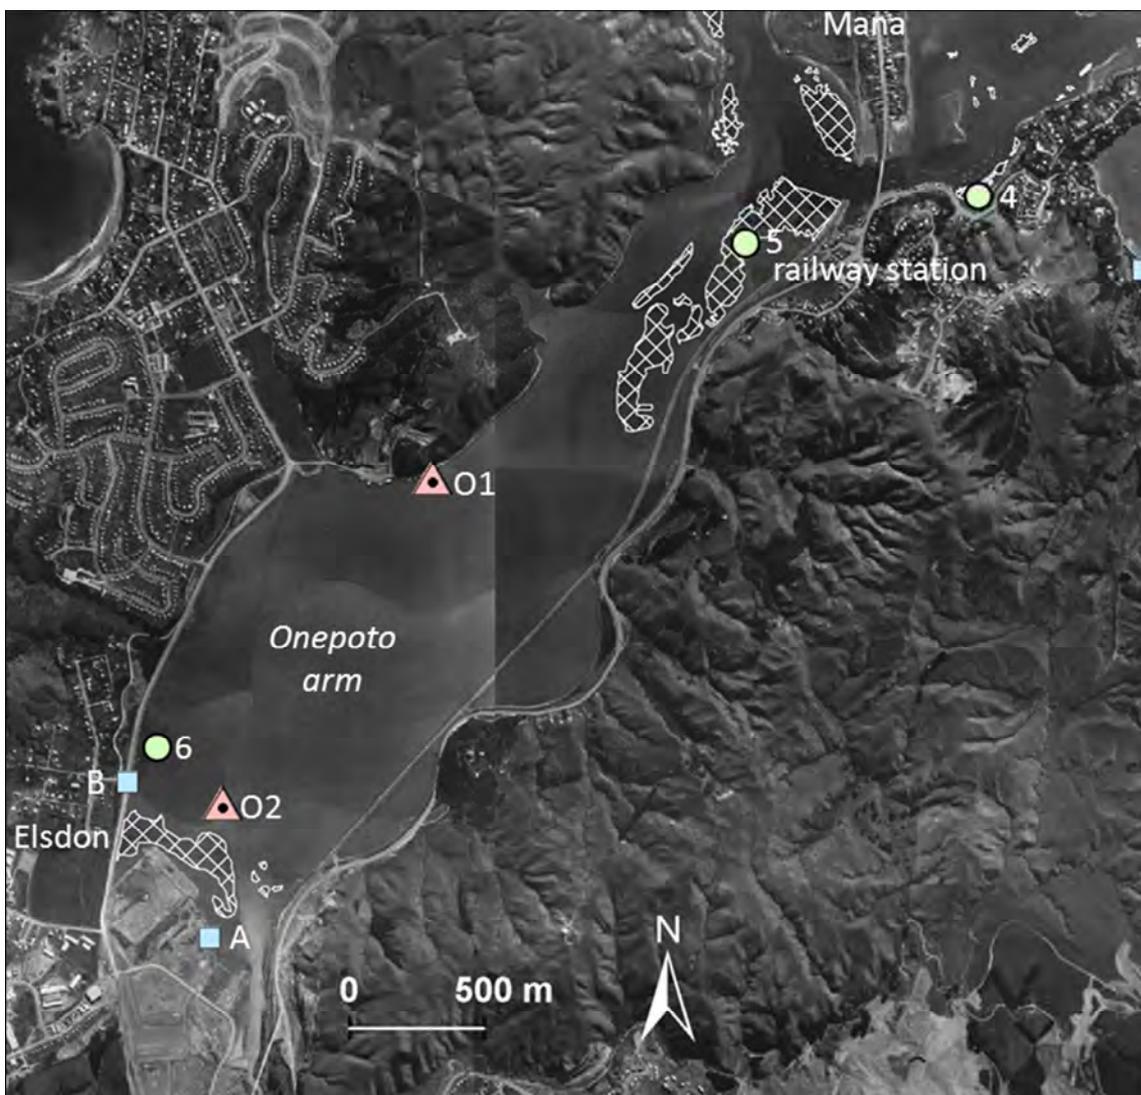
**Figure 3-4: Seagrass extent in Onepoto arm, outer Pauatahanui arm and entrance channel in 1962.** White cross-hatched areas are seagrass beds.

We identified approximately 21 ha of seagrass in the 1962 aerial photograph (Figure 3-4, Table 3-2). This photograph covers the Onepoto arm but only part of the entrance channel area and the Pauatahanui arm. Extensive areas of seagrass were present on the tidal flats west of the Paremata railway station (around site 5). A large area of seagrass was also present on the western side of Mana (where the marina is located today) and at the head of the Onepoto arm (near Elsdon). Smaller beds were evident in the two bays on the western side of the entrance channel, on the banks east of Mana and from Ivey Bay (site 4) to Moorehouse Point. There may also have been some narrow beds on the western side of the Onepoto arm, north of Elsdon (as seen in the 1920s photograph); however the quality of the 1962 photograph is not sufficient to delineate these areas with certainty.

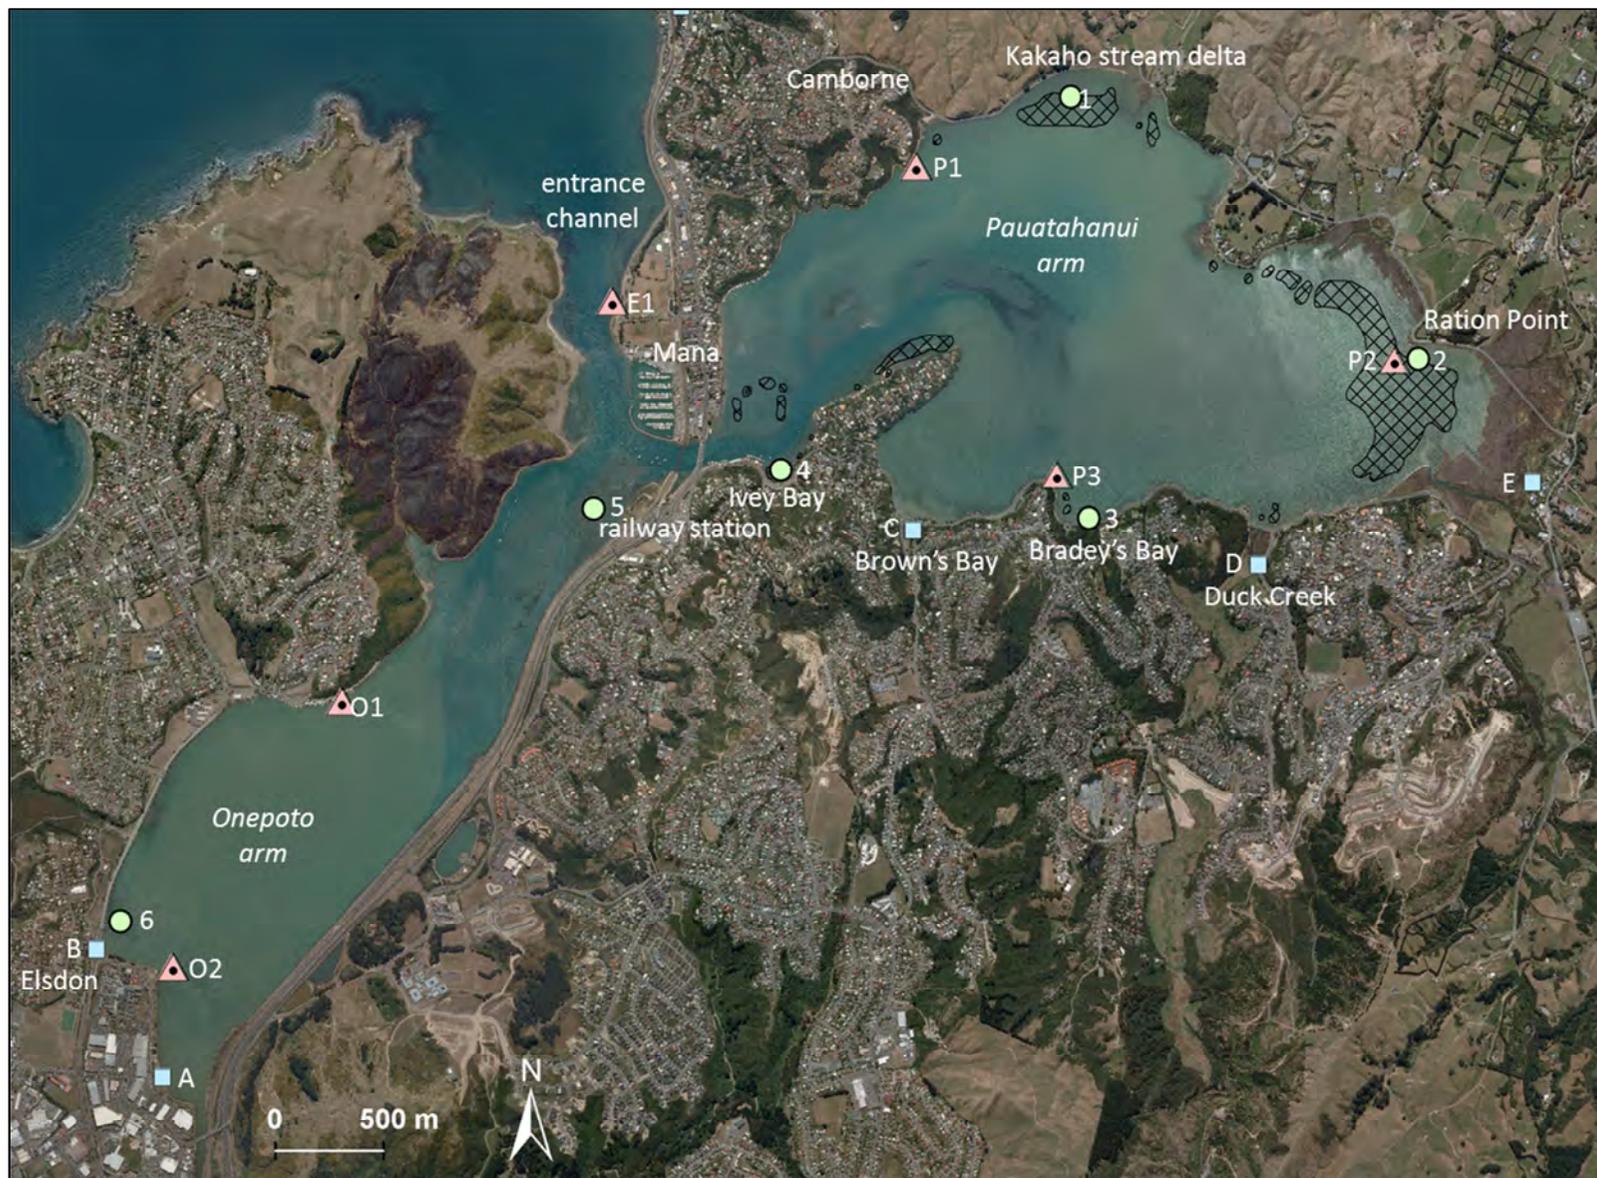
**Figure 3-5: Seagrass extent in Pauatahanui arm in 1980 (from Healy 1980).** Black cross-hatched areas are seagrass beds, shown on a 2010 aerial photograph.

Seagrass extent in the Pauatahanui arm was mapped by Healy (1980) which he recorded as low tidal areas dominated by *Zostera*. He estimated that there were around 38 hectares of seagrass at this time. The areas he identified are shown and summarised below (Figure 3-5, Table 3-3). The largest area was around Ration Point in the deltas of the Horokiwi and Pauatahanui Streams. However, substantial beds were also recorded around the Kakaho Stream delta and near Moorehouse Point. Other smaller beds were found at Camborne, Duck Creek, Bradey's Bay, Ivey Bay and the Mana area. Healy (1980) also noted that large areas of the tidal banks east of Mana supported "a luxuriant growth" of seagrass; however, these areas were not mapped.

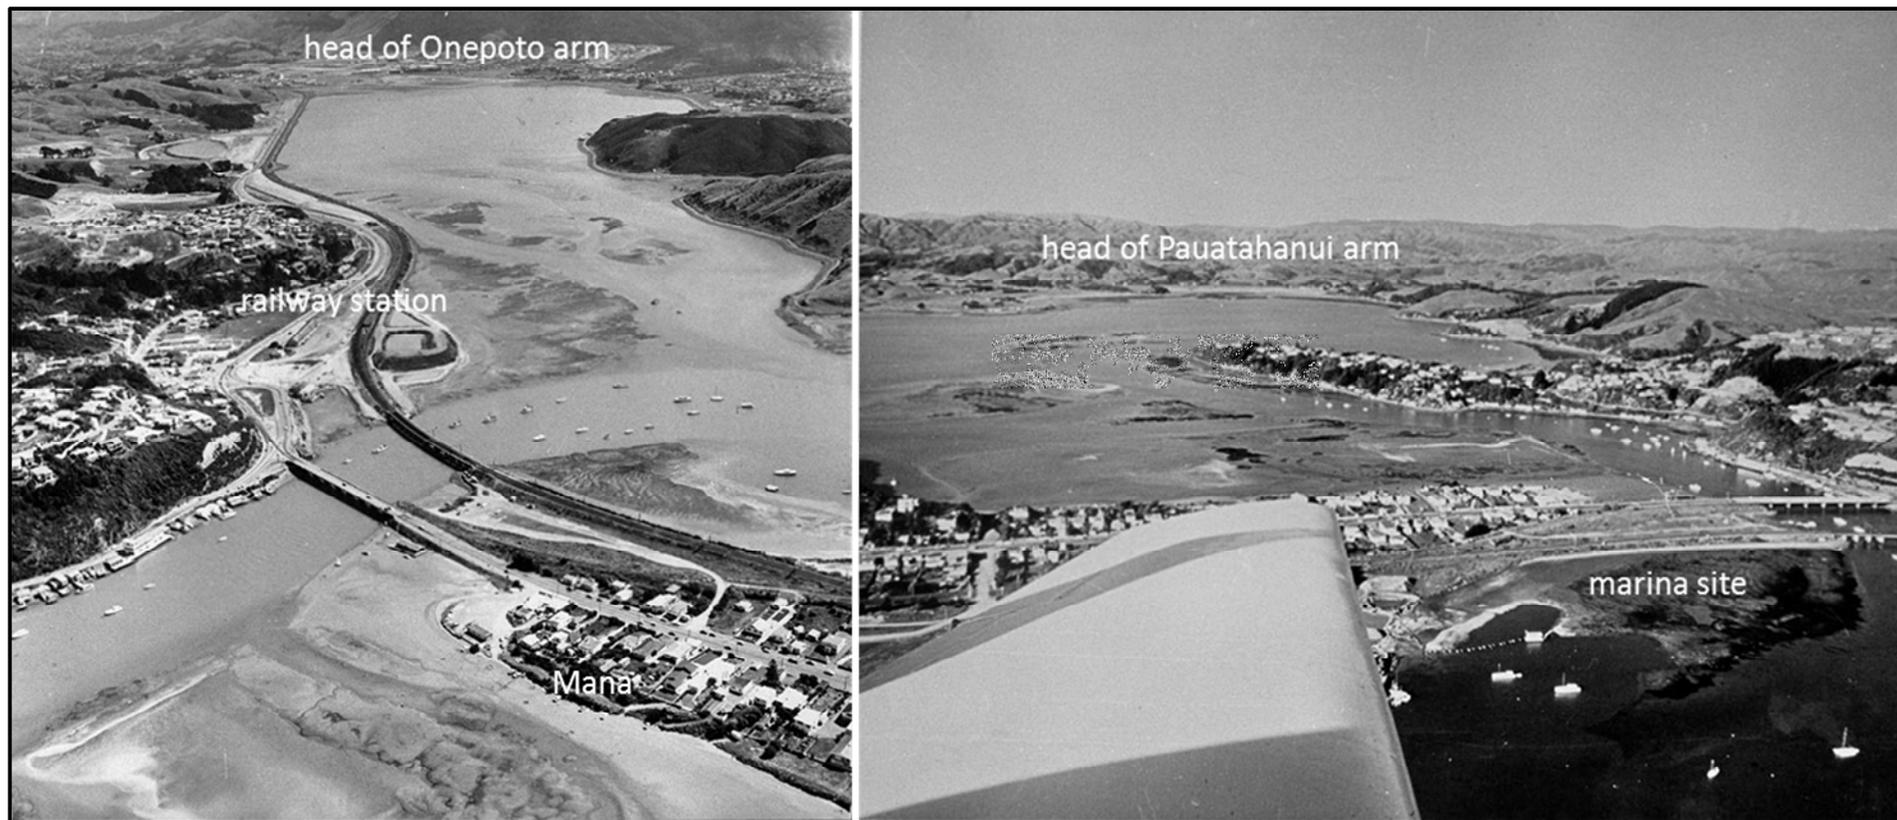
**Figure 3-6: Two other historical photographs (dates unknown).** Left photograph shows Mana, the Paremata railway station and the Onepoto arm. Right photograph shows Mana and the Pauatahanui arm. The dark patches on the tidal flats are intertidal seagrass beds.

The dates of two further historical photographs (Figure 3-6) are unknown but Paremata Road Bridge is evident in both, and this was opened in 1936. The first photograph shows a large area of intertidal seagrass beside the Paremata railway station site, on adjacent mid-channel banks in the Onepoto arm and at the current marina site. The second photograph, which looks east over Mana and the Pauatahanui arm, shows very dense seagrass beds at the marina site, dense seagrass patches on the tidal banks east of Mana and narrow beds along the Golden Gate Peninsula (Ivey Bay to Moorehouse Point) shoreline. Dark bands can be seen in the distance in Brown's Bay, Bradey's Bay and across the tidal flats at the head of the arm, which are also likely to be seagrass beds.

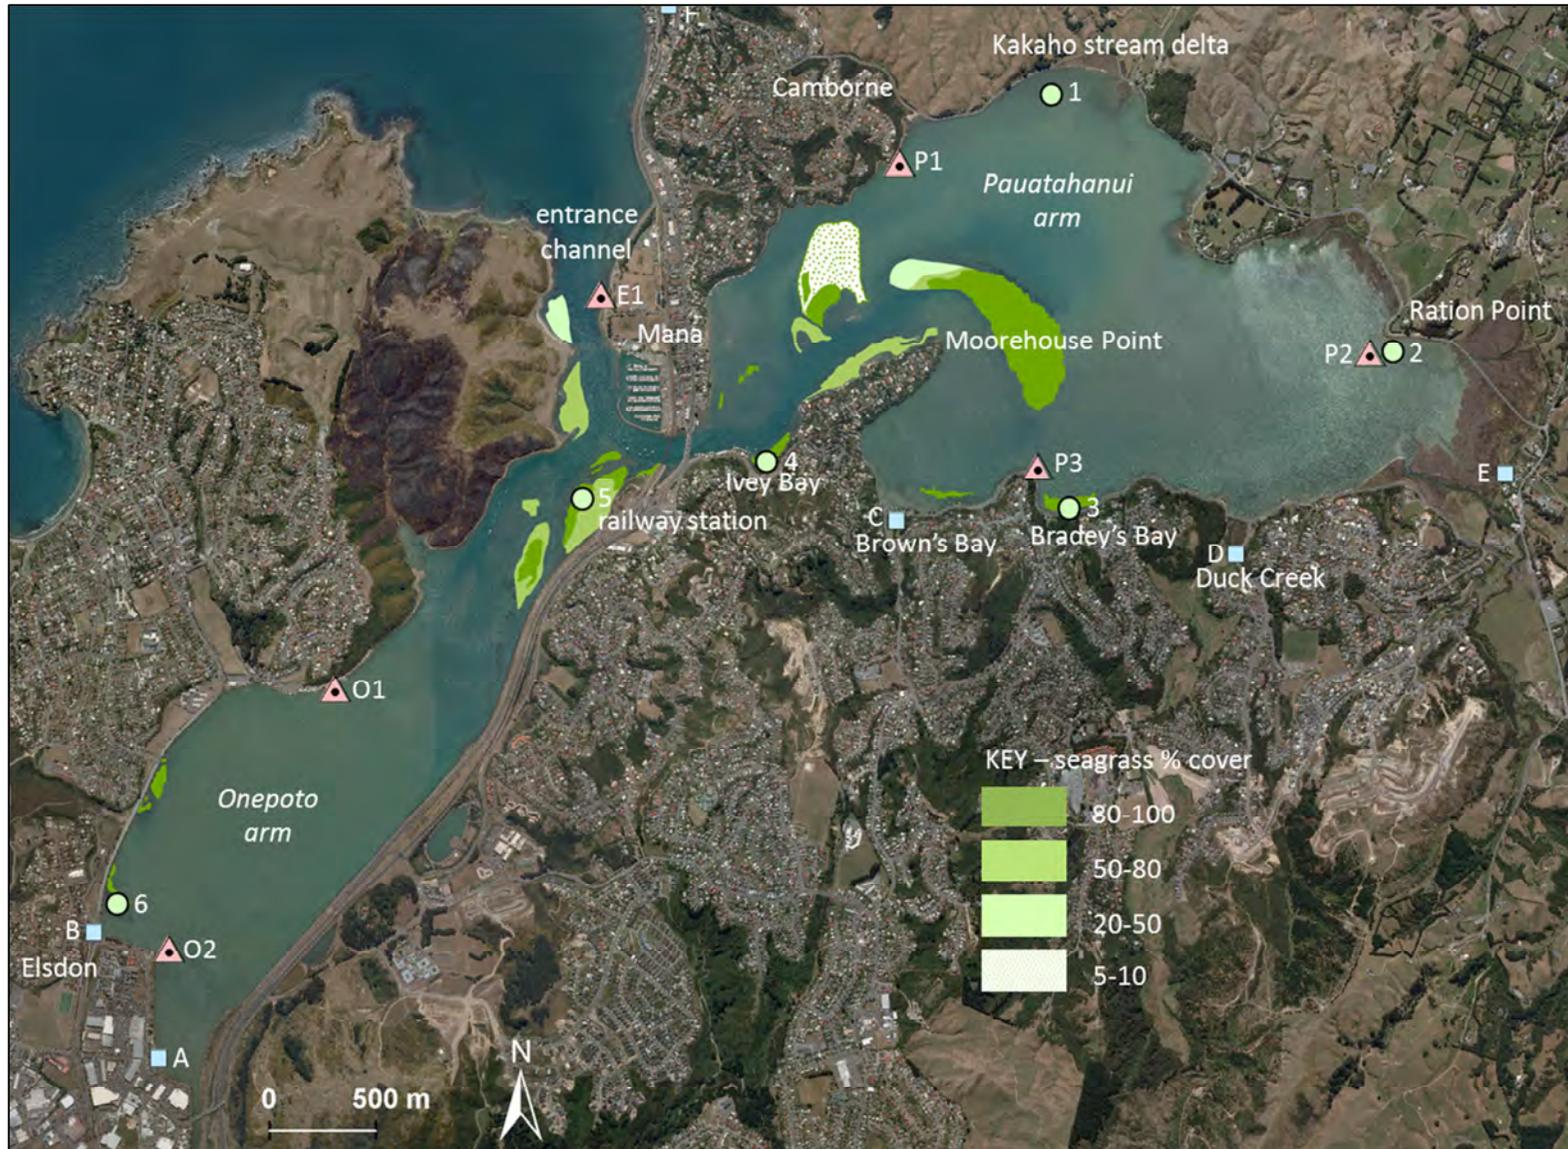
**Figure 3-7: Seagrass extent in Porirua Harbour in 2007–2008 (from Stevens and Robertson 2008).** Beds are shown on a 2010 aerial photograph.

In the summer of 2007–2008, habitat mapping was undertaken in both arms of the harbour (Stevens and Robertson 2008), which included identification of seagrass beds and their characterisation into different percentage cover classes (Figure 3-7, Table 3-4). Notably, the extensive areas of seagrass that existed around Ration Point and the Kakaho Stream delta in 1980 were no longer present, nor were the smaller patches at Duck Creek and Camborne. However, seagrass beds of moderate to high density (i.e. 50–100% cover) persisted at many of the other former sites (i.e., the tidal flats adjacent to the Paremata railway station, from Ivey Bay to Moorehouse Point, Brown’s and Bradey’s Bays, and in the harbour entrance channel). The survey also showed an extensive area of seagrass on the two mid-harbour banks near Moorehouse Point. Some small, dense seagrass patches were also recorded along the shoreline around Elsdon in the Onepoto arm (north of site 6).

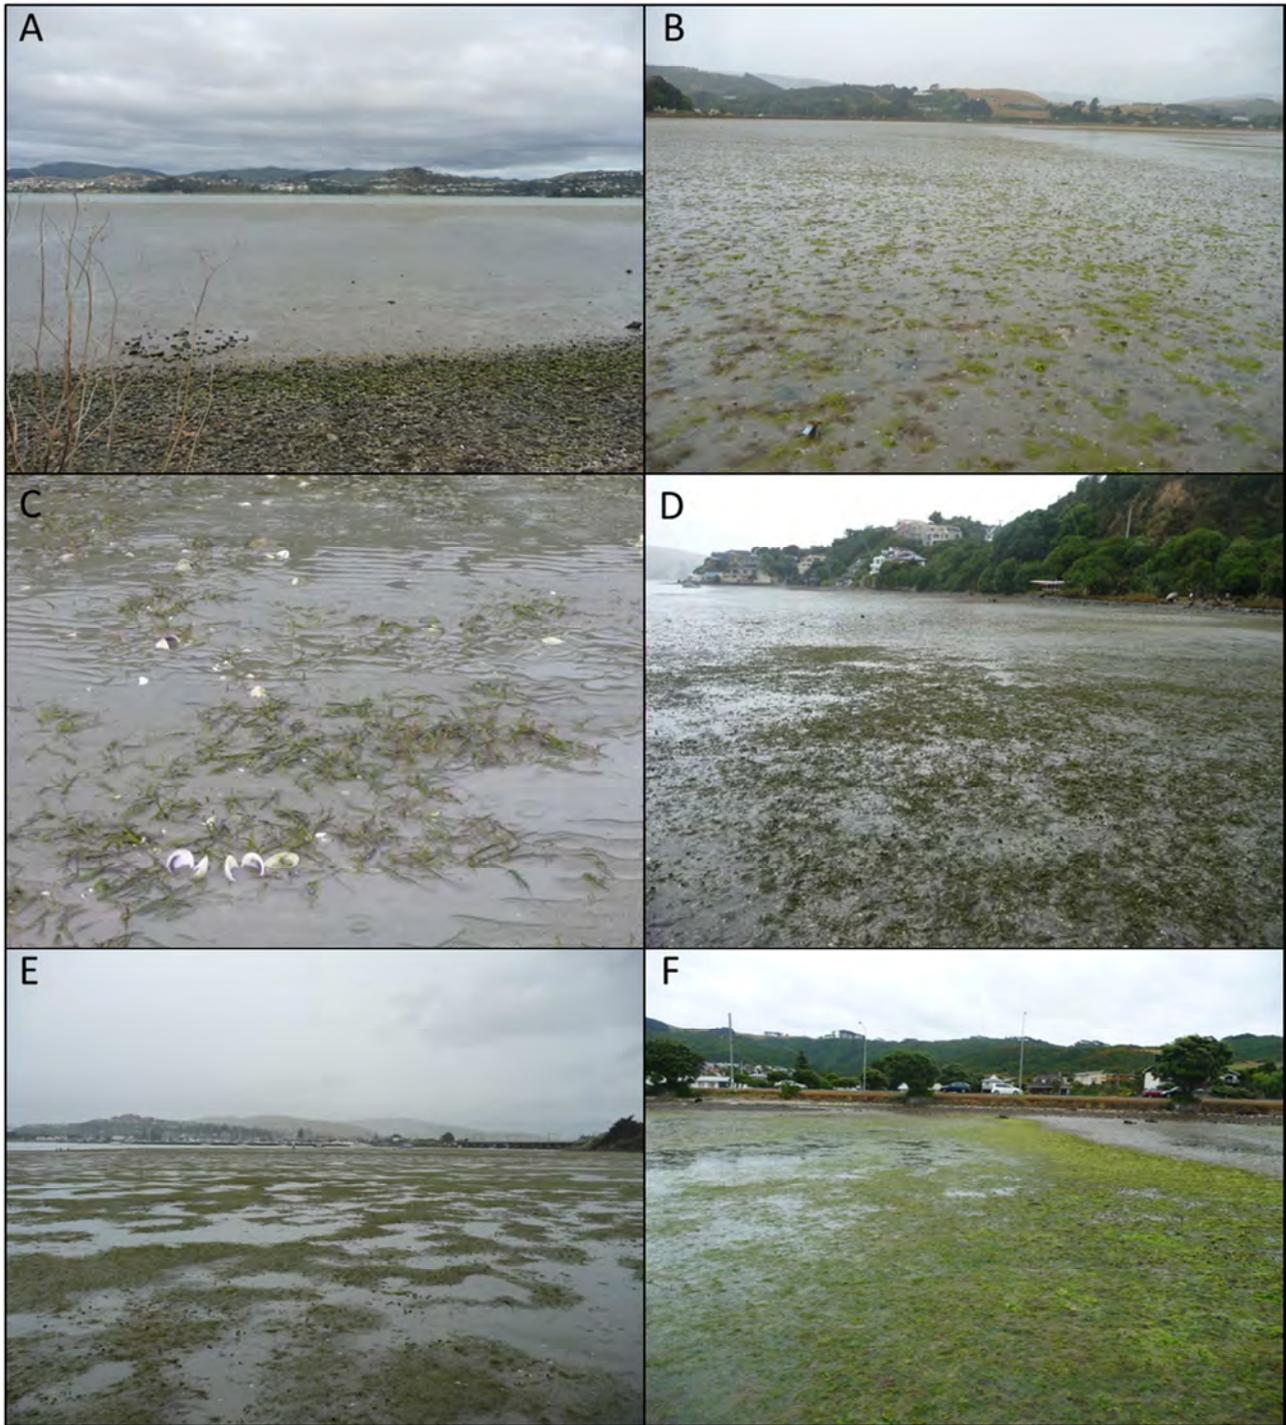
**Figure 3-8: Sampling site photographs.** A, Kakaho Stream Delta (site 1); B, Ration Point (site 2); C, Bradey's Bay seagrass patch (site 3); D, Ivey Bay (site 4); E, Paremata railway station (site 5); F, Elsdon (site 6) (Photos: Megan Oliver & Shyam Morar).

Seagrass was found at four of the six sites we sampled (i.e., Bradey's Bay, Ivey Bay, Paremata railway station and Elsdon) (Table 3-5, Figure 3-8). However, there was insufficient plant material at Elsdon to sample for biomass. We found that the patches of seagrass at Ivey Bay (site 4) had the highest average cover, biomass and leaf size of the three sites assessed. While the area of seagrass adjacent to the Paremata railway station (site 5) was much more extensive than at other sites, plant cover and biomass was relatively low.

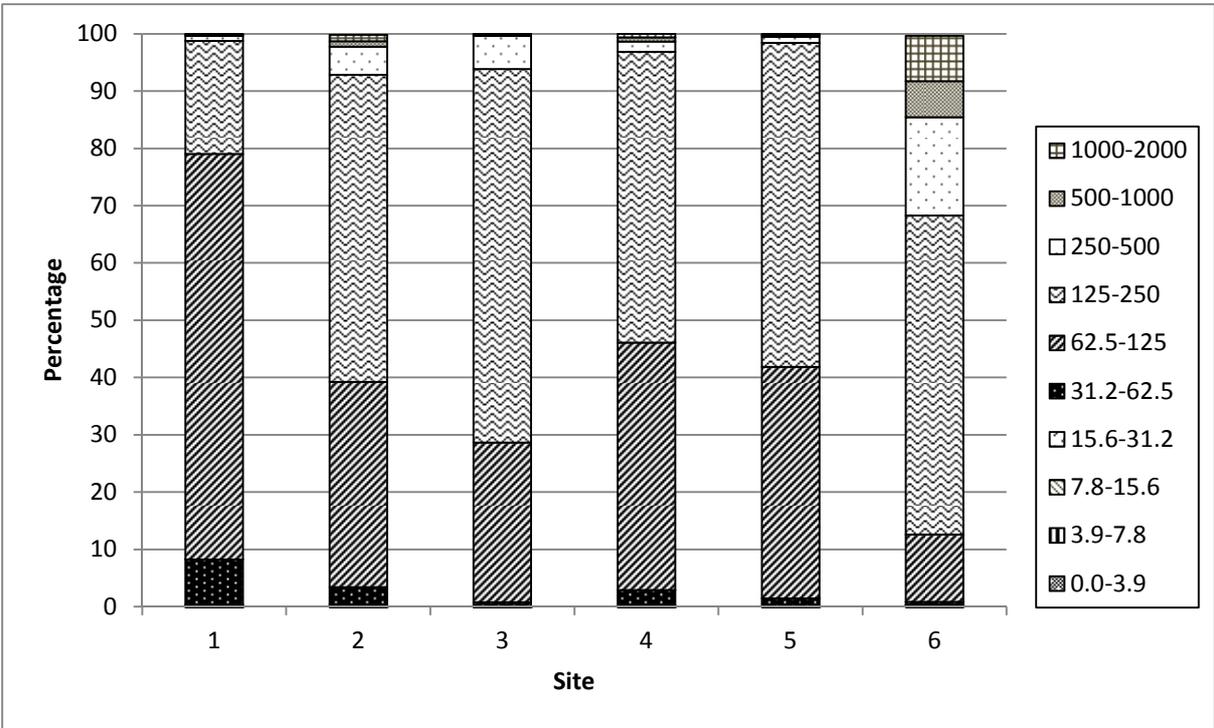
Figure A-1: Overall sediment particle size distribution for sample sites in July 2011.

**Table 3-10: Summary of sediment particle size results.** Mud = clay + silt fractions. A graph showing a more detailed breakdown of the sediment particle size classes can be found in Appendix A.
