Castlepoint Beach

Fine Scale Monitoring 2007/08

Prepared
for
**Greater
Wellington
Regional
Council**
May
2008

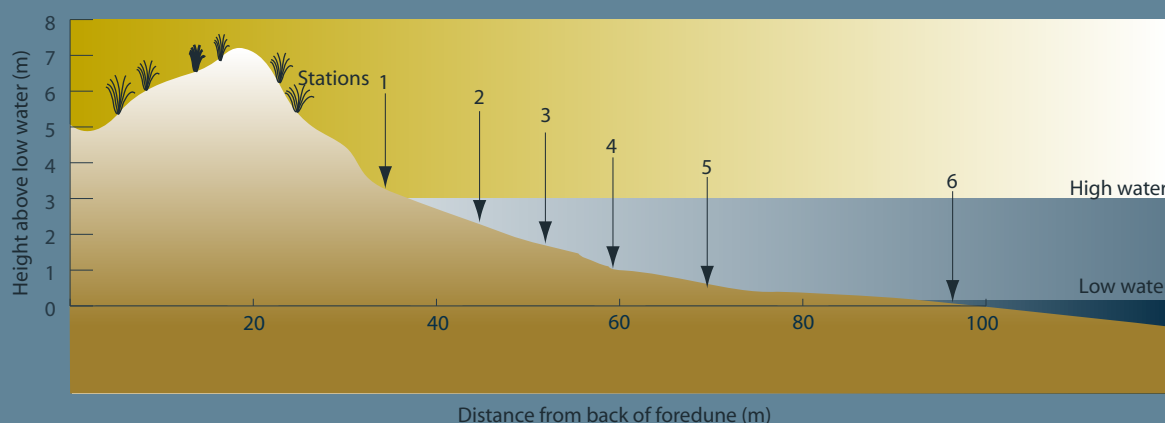
Figure 2 Cross-section of transects at Castlepoint Beach, January 2008.

The general layout of the Castlepoint beach transects is presented in Figure 2. It shows that the beach was backed by a 4m high foredune which was covered with marram grass vegetation. The intertidal area was 65m wide, with a very gradual slope in the lower half and steeper in the upper. A summary of the results of the fine scale monitoring of Castlepoint Beach is presented in Tables 3 and 4. Detailed results are presented in Appendix 2. In order to facilitate understanding, the results and discussion section is divided into subsections based on the key beach issues or problems that the Castlepoint fine scale monitoring is addressing: habitat modification, eutrophication and sedimentation. The issues of toxicity and disease risk were not addressed in this monitoring programme. Toxicity was considered to be at such a low risk it was not considered necessary to monitor and the presence of disease risk indicators on the Wairarapa coast is assessed in a separate programme. A summary of the condition ratings is presented in the accompanying figures.

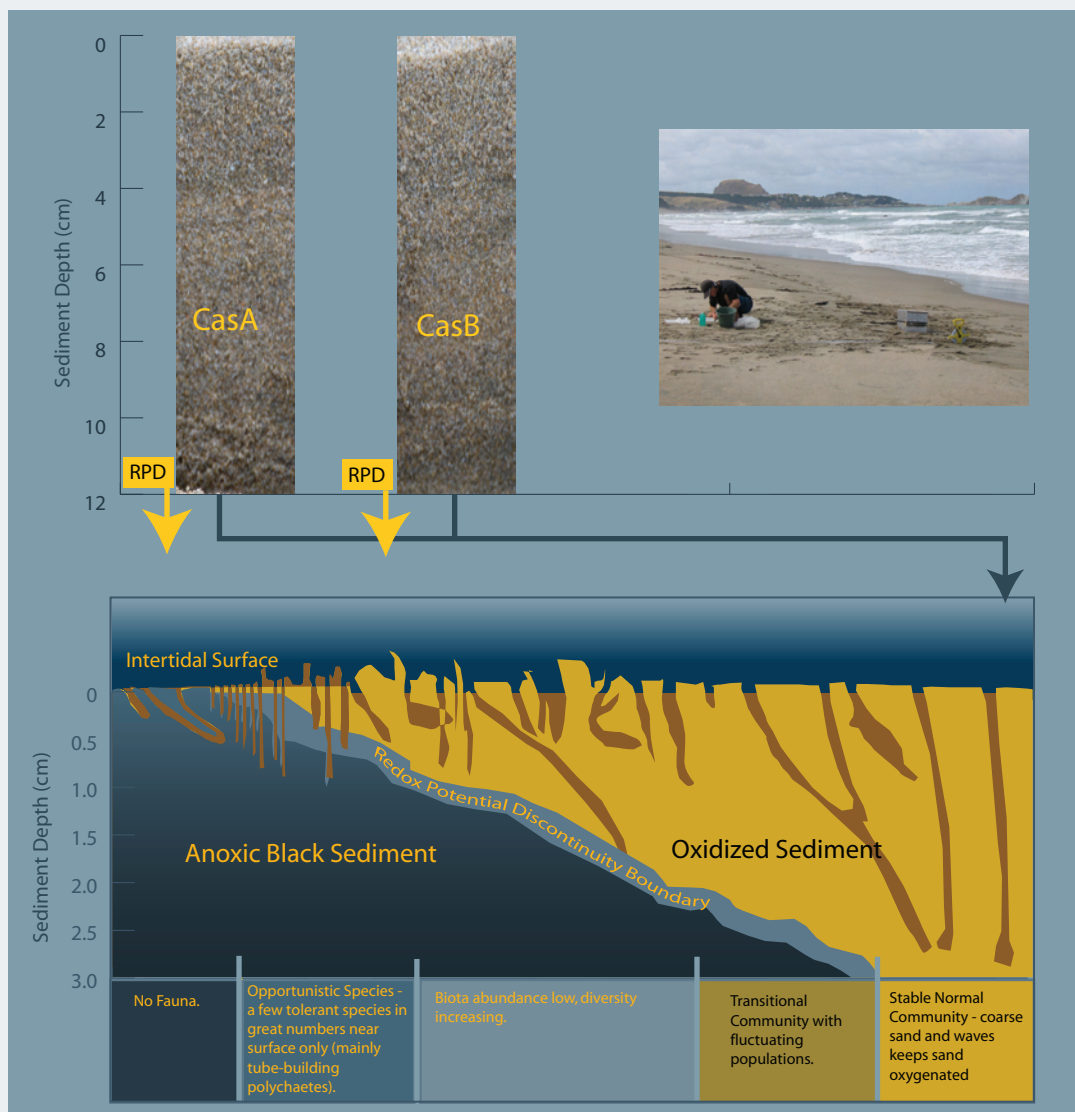
Figure 3 Sediment profiles, depths of RPD and predicted benthic community type, Castlepoint Beach.

Figure 3 shows the sediment profiles and RPD depths for the Castlepoint Beach transect sampling sites (also Table 4) and indicates the likely benthic community that is supported at each site based on the measured RPD depth (adapted from Pearson and Rosenberg 1978). The RPD results showed that the depth of the RPD at Castlepoint Beach was deep at >15cm depth at all sites and therefore likely to be well oxygenated. Such low RPD values fit the “very good” condition rating and indicate that the benthic invertebrate community was likely to be in a “normal” state.

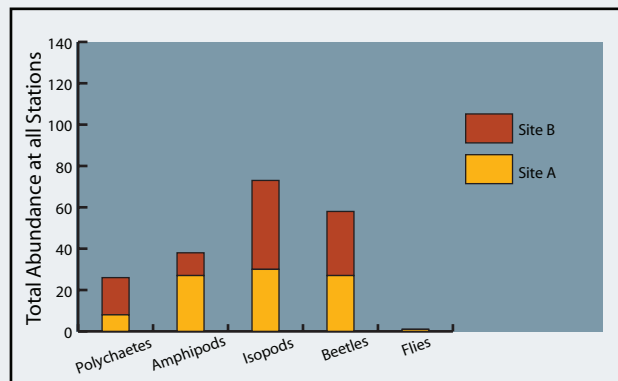
Figure 4 Total abundance of macrofauna at Castlepoint Beach (sum of all 6 stations at each site)

The benthic invertebrate community condition at Castlepoint Beach was a “normal” exposed beach community in that it was dominated by crustaceans (mainly isopods, and smaller numbers of amphipods) and insects (in this case beetles), but also included two species of polychaete (Figure 4).

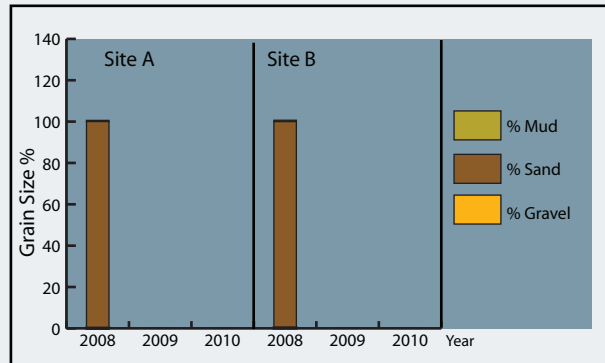
Figure 5 Grain size at Castlepoint Beach (mean values at each transect)

Soil erosion is a major issue in New Zealand and the resulting suspended sediment impacts are of particular concern in many coastal areas. The northern Wairarapa coastal environments are especially at risk in that the erosion ratings for inland catchments feeding the coast are moderate to severe. As a consequence, the waters bathing the coastal areas tend to have a high suspended solids content. Deposition of these solids tends to be offshore, or in sheltered embayments, beaches or estuaries. Castlepoint, being an exposed beach is not expected to be at risk from excessive sedimentation of fine sediments. This was confirmed by the 2008 grain size monitoring results which show that all sites were dominated by sandy sediments (greater than 99% sand) (Figure 5).
