Toxic benthic cyanobacteria proliferations in Wellington's rivers in 2005/06

Juliet R Milne
Laura Watts

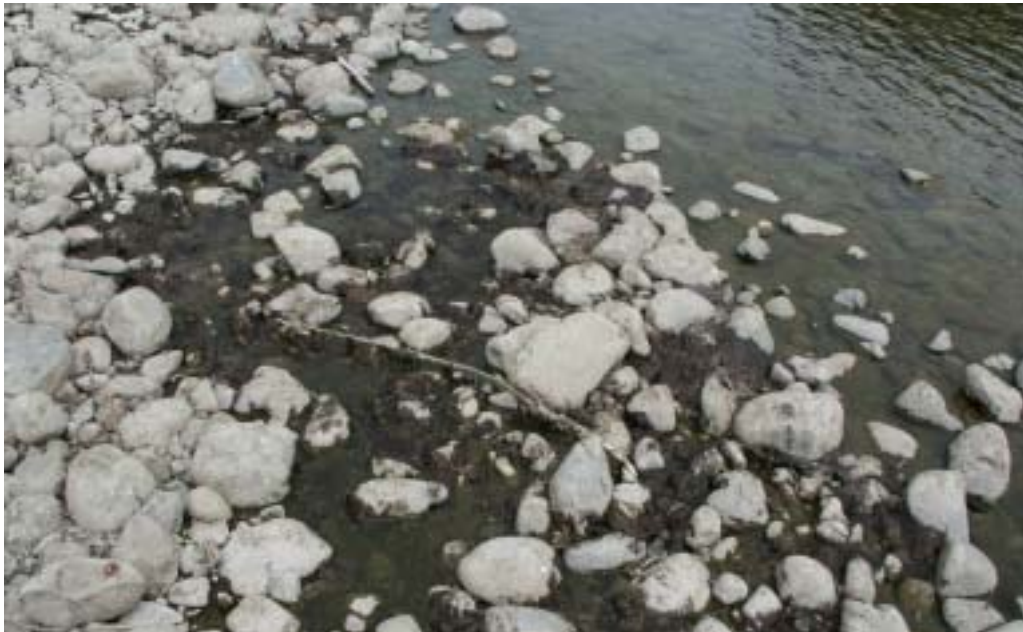
Figure 1.1: Exposed mats of cyanobacteria in the Hutt River, November 2005.

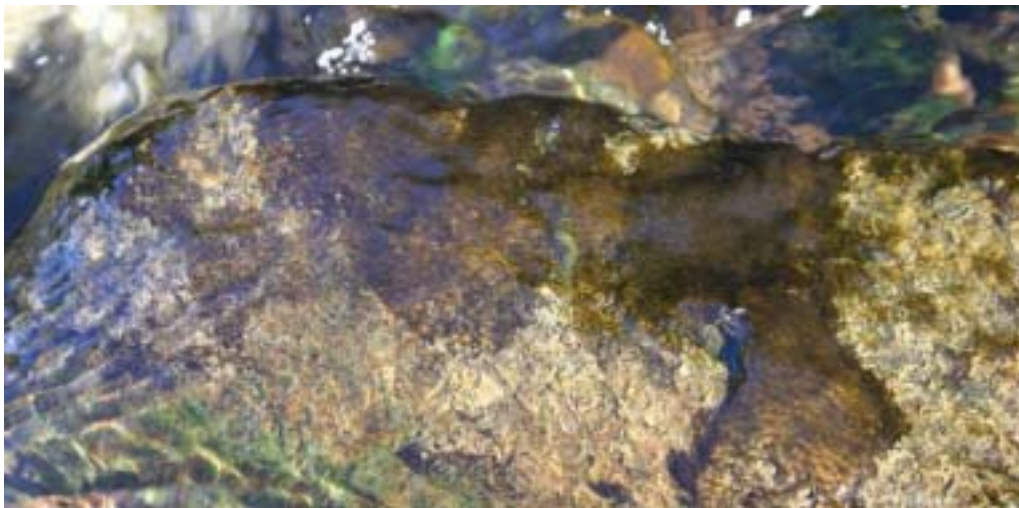
Figure 2.1: Mat-forming cyanobacteria (*Phormidium* sp.) on cobble substrate in the Wainuiomata River, February 2006.

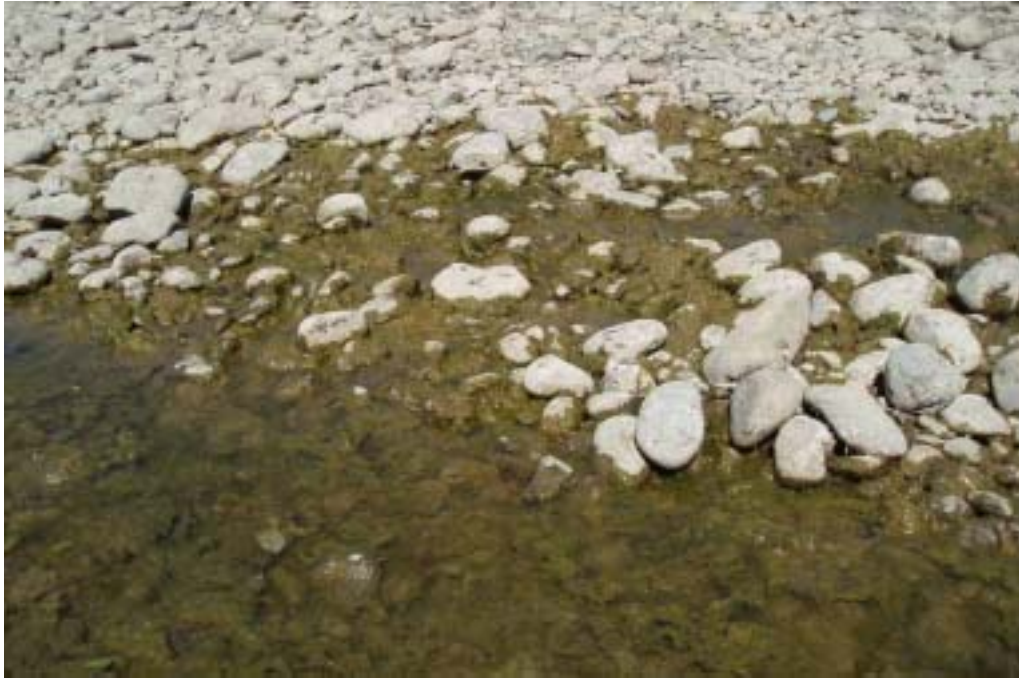
as scums along the river edge, particularly if water levels drop (Figure 2.2). The mats may also form floating 'rafts', which become caught in other debris in the river (Wood et al 2006). When the cyanobacteria mats die and dry out they may become light brown or white in colour.

Figure 2.2: Exposed mats of cyanobacteria in the Hutt River, November 2005.

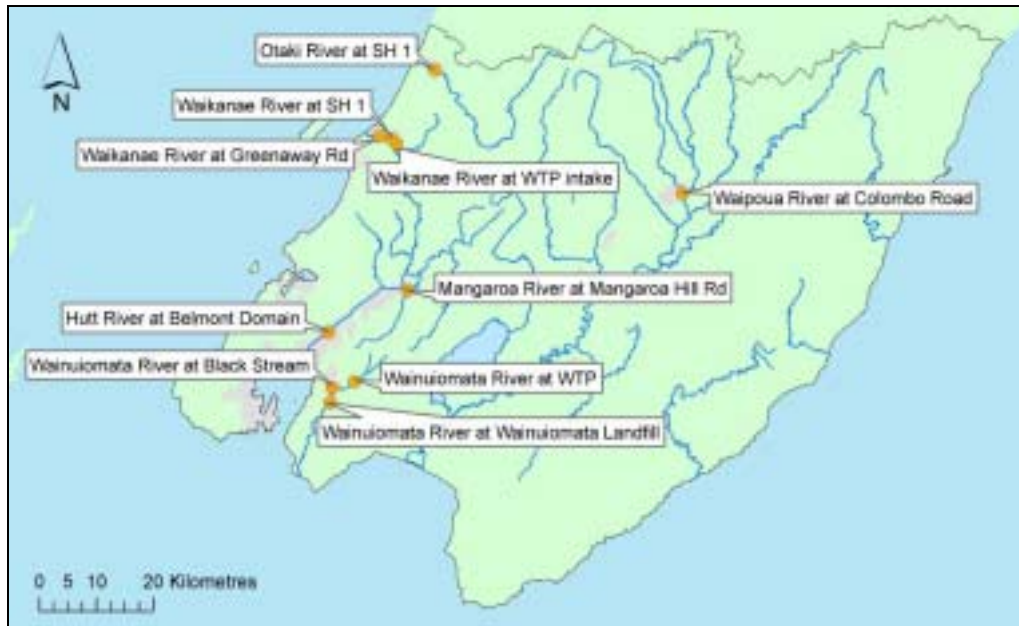
During spring 2005, thick mats of benthic cyanobacteria became established in several of Wellington region's rivers commonly used for contact recreation (Figure 3.1). The Hutt River was affected for much of the spring and summer, with thick, dark brown-black mats found in the channel and exposed along the river margins in the Boulcott-Avalon area in early November 2005 (refer Figure 1.1, Figure 2.2). Although this was the only reach of a river where exposed mats of this nature were observed, stretches of the Otaki, Waikanae, Mangaroa and Wainuiomata rivers also had significant coverage of benthic cyanobacteria mats around the same time. Dense mats were also found in the lower reaches of the Waipoua River in March 2006.

Figure 3.1: Locations where prolific growths of benthic cyanobacteria were observed at some stage during 2005/06. Prolific growths are likely to have been present in other rivers and streams not routinely monitored by Greater Wellington.

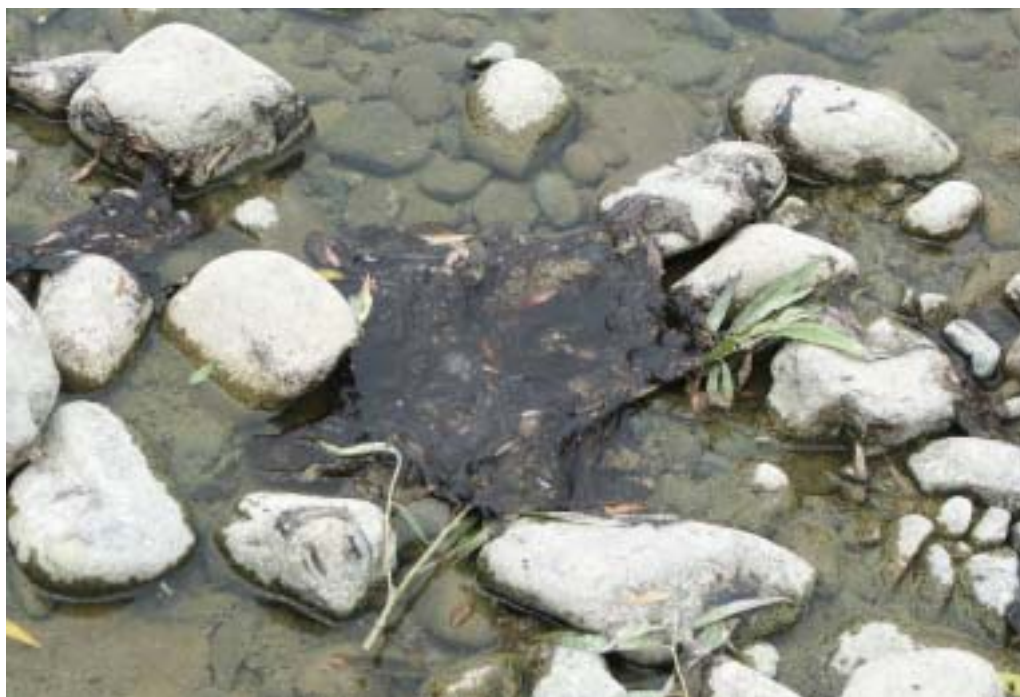
At least five dogs were reported to have died (and others to have become ill) suddenly and dramatically after coming into contact with the cyanobacteria mats in the Hutt River catchment during November and December 2005. Greater Wellington was first alerted to a potential cyanobacteria toxicity problem on 8 November 2005 when a vet advised that a dog had suddenly become sick after consuming some dark 'algae-like' material from the Hutt River adjacent to the Belmont Domain (Figure 3.2). Samples of the material were collected from the river that day and later sent to the Cawthron Institute for identification. The material was found to contain the potentially toxic cyanobacterium *Phormidium* sp. (originally identified as *Oscillatoria* sp.⁸) at high abundance.

Figure 3.2: Cyanobacterial mat amongst stones in the Hutt River adjacent to the Belmont Domain in November 2005.

Further samples of the *Phormidium* sp. mats were subsequently collected from the Hutt River at Belmont Domain and analysed for a range of cyanotoxins. Two neurotoxic cyanotoxins (homo-anatoxin-a and anatoxin-a) and their degradation products (dihydro-anatoxin-a and dihydro-homo-anatoxin-a) were detected in the samples (Table 3.2), which corresponded with toxins identified in the stomach contents of one of the dead dogs. This is the first report of

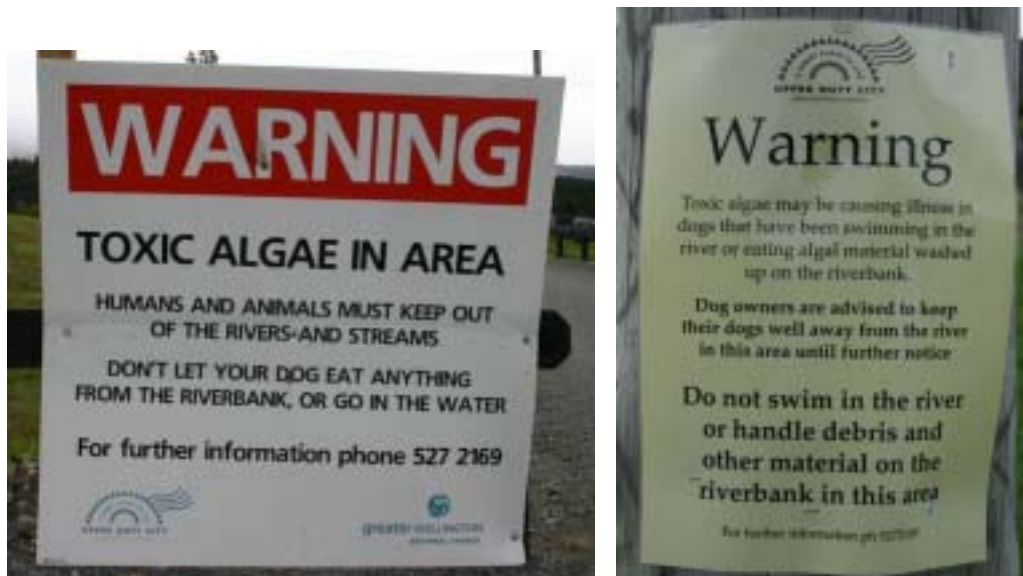
Figure 3.3: Examples of warning signs erected at access points to the Hutt River in 2005.

Following the identification of toxins in cyanobacteria samples from the Hutt River in November 2005, an inter-agency response team was established comprising Greater Wellington, Regional Public Health and local councils. Media releases were issued and up to 80 health warning signs erected by Upper Hutt City and Hutt City councils, advising against the use of a large part of the Hutt river system (Figure 3.3). Warning signs were also erected at popular access points to other affected rivers. Low river flows and the persistence of cyanobacteria mat proliferations in the Waikanae River led the Kapiti Coast District Council to switch its potable water supply from river water to bore water in January 2006.

From mid November 2005, Greater Wellington's Pollution Control Team and local council environmental health officers commenced weekly visual inspections of cyanobacteria growth at a selection of popular recreational access points to the Hutt River and other affected rivers in the western part of the region. These inspections were *in addition* to the routine weekly visual assessments of periphyton cover undertaken at 23 popular freshwater bathing spots as part of Greater Wellington's summer recreational water quality monitoring programme (1 November to 31 March inclusive). The increased number of inspection points was necessary because the extent of *Phormidium* sp. in the Hutt River away from popular bathing sites was unknown and there was significant coverage of *Phormidium* sp. mats in rivers not represented in

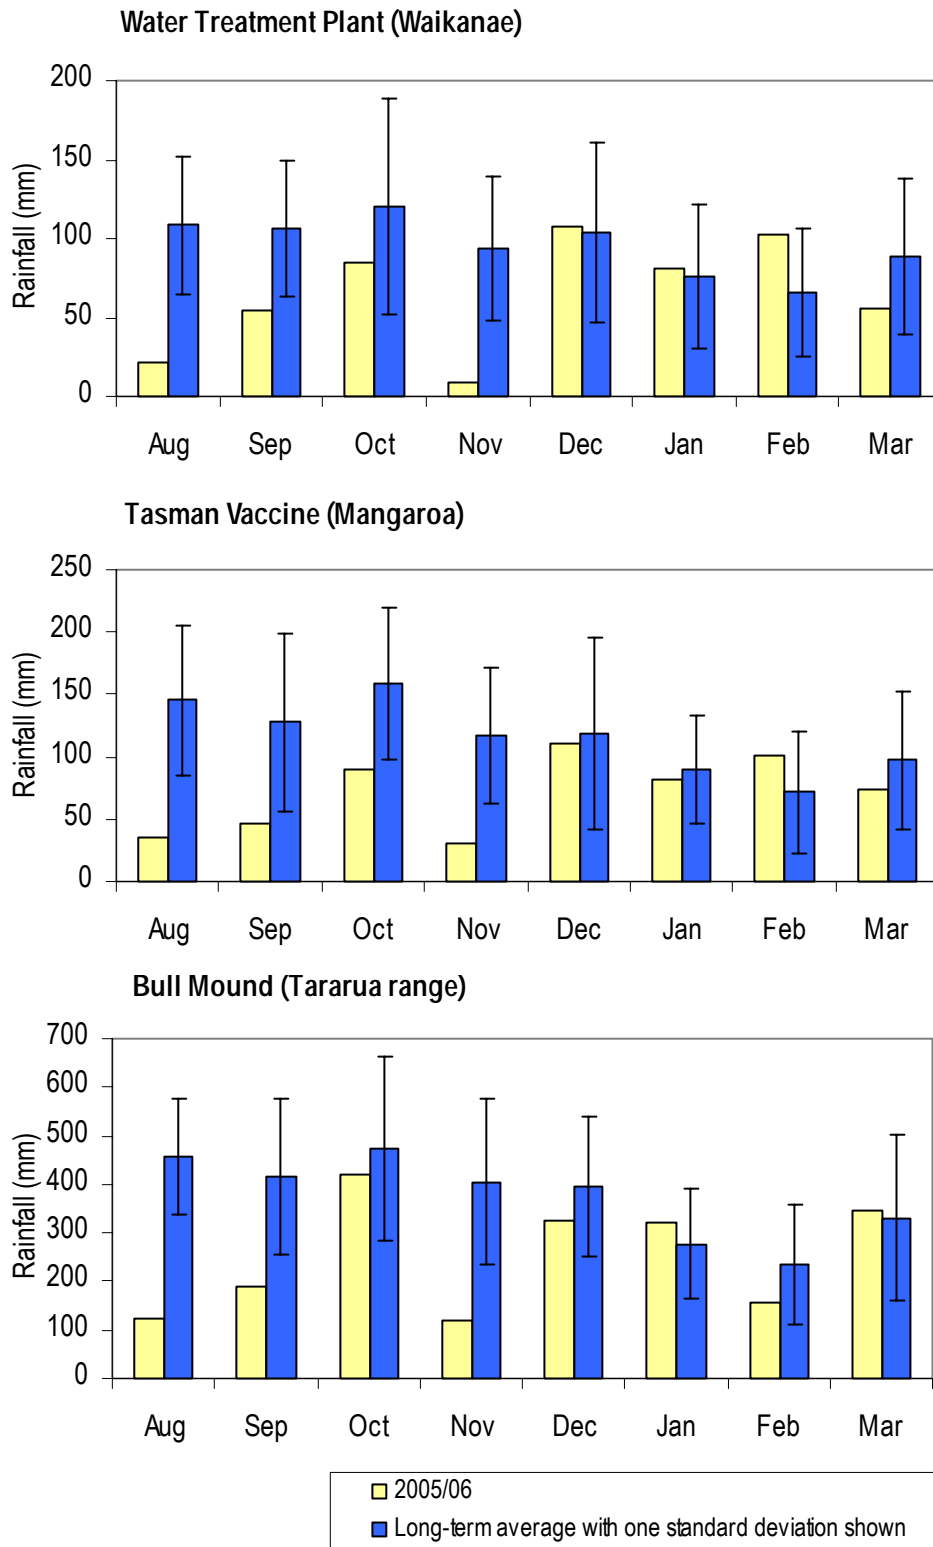
At the representative stations monthly rainfall totals were below average for August and through spring 2005, with August and November being particularly dry (Figure 4.2). It was the driest August on record at Otaki, Waikanae, Hutt, Mt Bruce and in the Tararua Range (Bull Mound), and the second driest in Mangaroa, Wainuiomata (115 years of record) and Paraparaumu (60 years of record). November saw record-low rainfall at Otaki, Waikanae, Paraparaumu,

Mt Bruce, Bull Mound and Kaitoke Headworks (54 years of record). In other parts of the Hutt catchment (Tasman Vaccine and Wallaceville), November was the driest since 1970. Rainfall was generally about average for the months December to March.

Figure 4.2: Monthly rainfall totals, August 2005 to March 2006 inclusive, compared to long-term average rainfall, at selected recording stations in the Wellington region.

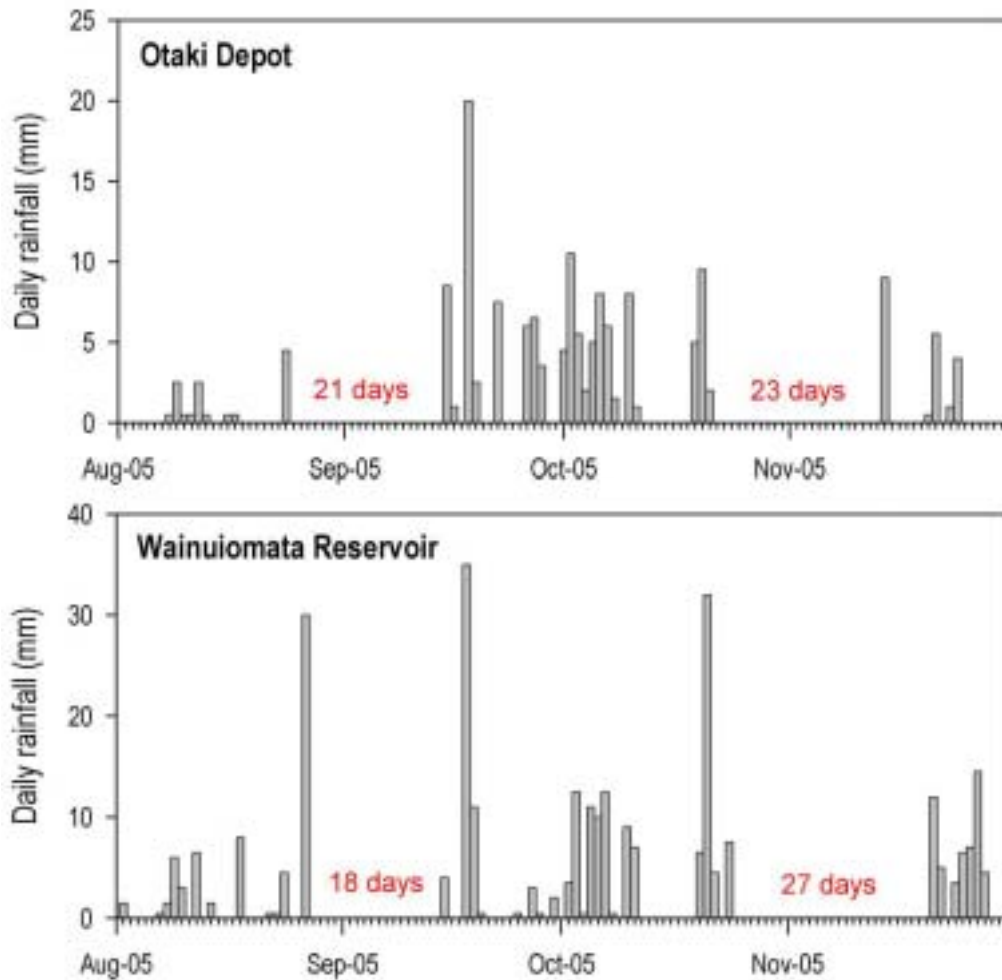
The driest periods were from late August to mid-September, and from late October to mid or late November (Figure 4.4). The 27 day dry spell recorded at

Wainuiomata Reservoir was the longest dry spell during spring since records began at that site in 1890¹⁰.

Figure 4.4: Daily rainfall during August to November 2005 at representative rainfall stations, with length of significant dry spells labelled in red.

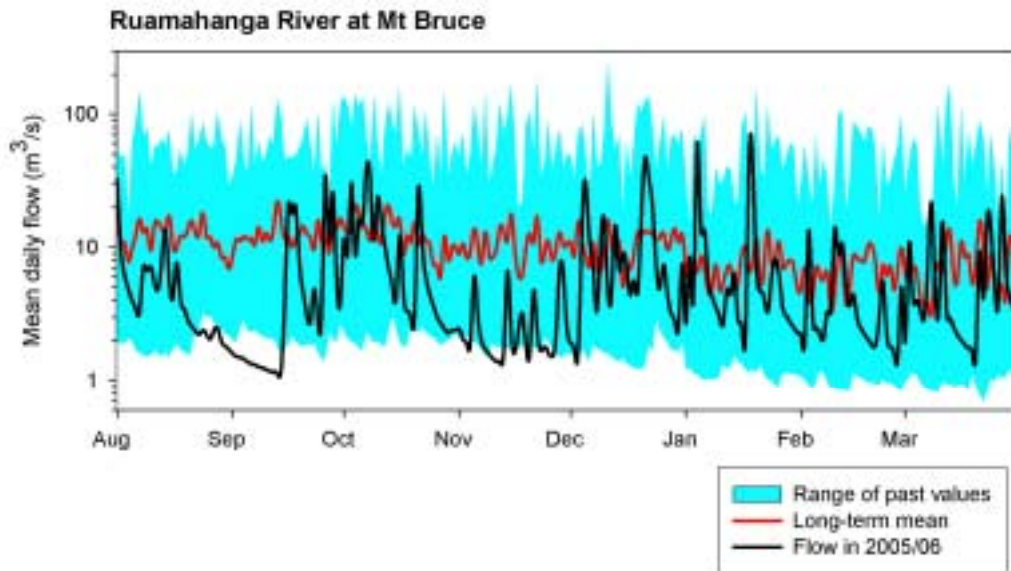
Although extensive benthic cyanobacteria mats were not apparent in the Waipoua River until March 2006, daily mean flows – inferred from the Ruamahanga River at Mt Bruce – were at their lowest in September and were generally very low compared to the long-term mean throughout spring 2005 (Figure 4.8). River flows generally remained below average during January to March 2006 but there were no long periods of stable river flows as occurred during August and September 2005.

Figure 4.8: Daily mean river flows in Ruamahanga River, August 2005 to March 2006 inclusive (note logarithmic scale on the y-axis). The lowest flows on record for a given day are indicated by the black line (flow in 2005/06) dropping below the blue shaded area.

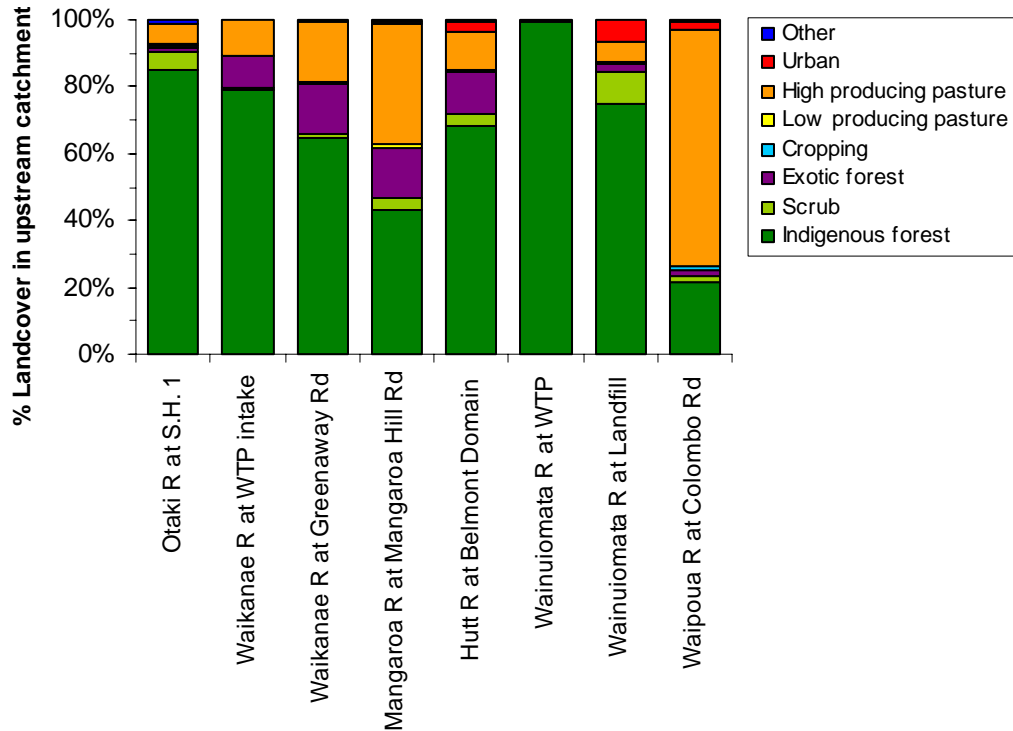
Figure 4.10: Predominant land cover types in the catchment area upstream of selected locations where significant and/or toxic growths of *Phormidium* sp. were observed during spring and/or summer 2005-06.
