Report 10.602
Date 28 November 2010
File Z/01/04/19

Committee Civil Defence Emergency Management Group
Authors Rian van Schalkwyk, Manager, Emergency Management
Murray Kennedy, General Manager, Utilities and Services

Darfield (Canterbury) earthquake observations and relevance to the Wellington region

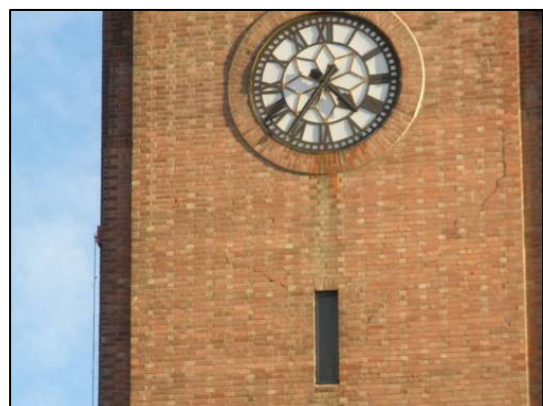
Clock tower of the previous Christchurch Railway Station, note cracking. Photo: M. Kennedy

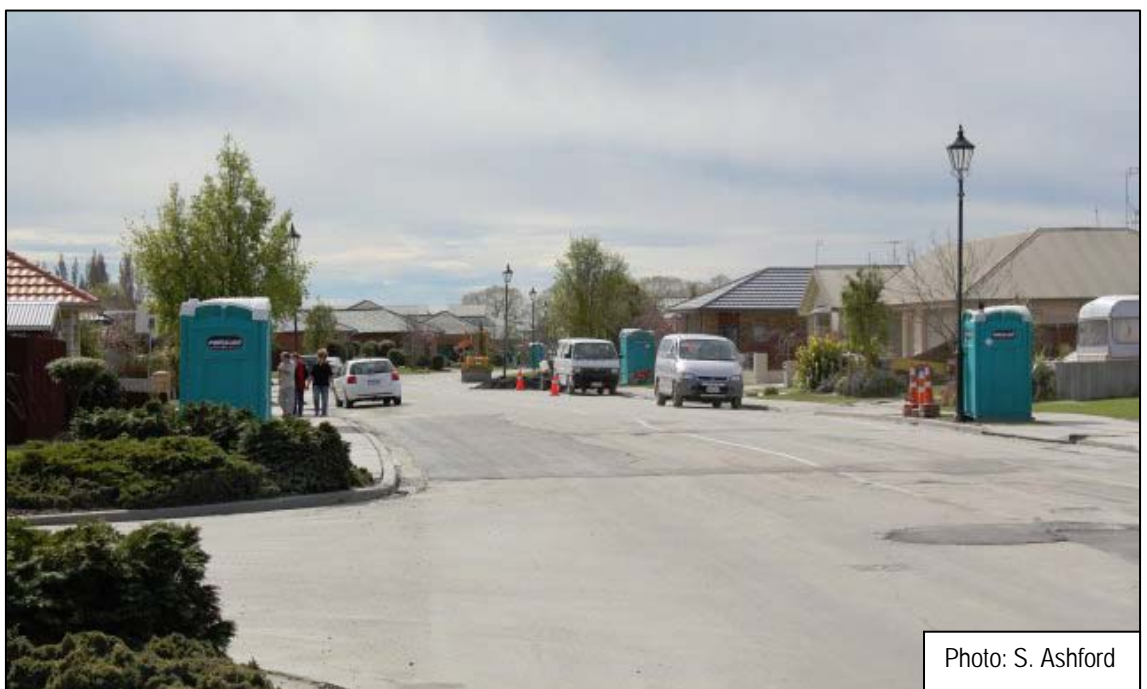
Photo: S. Ashford

During the first days these toilets were not serviced regularly turning them into unacceptable smelly cubicles and resources allowed the toilets to be more evenly spread..

Residents were advised to follow the instructions and public health advice regarding portaloos and sanitation that was put up inside the toilets (many people placed plastic bags in the portaloos which caused blockages, thus leading to the odour issue).

The situation was rectified shortly after several complaints were lodged with the respective councils.

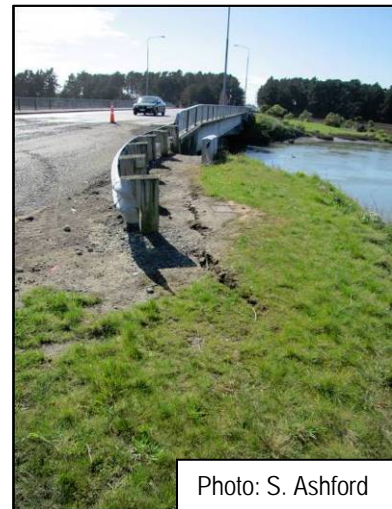
Photo: S. Ashford

Where the fault surface crossed roads, the lateral movement was quite evident. Lateral spreading has caused extensive damage to roads in areas where there was liquefaction. This combined with buried services breakages means that in time, a number of roads will need to be rebuilt. There was a slip in the Rakaia Gorge on SH77 and photos of some fallen rocks on the Port Hills have been published.

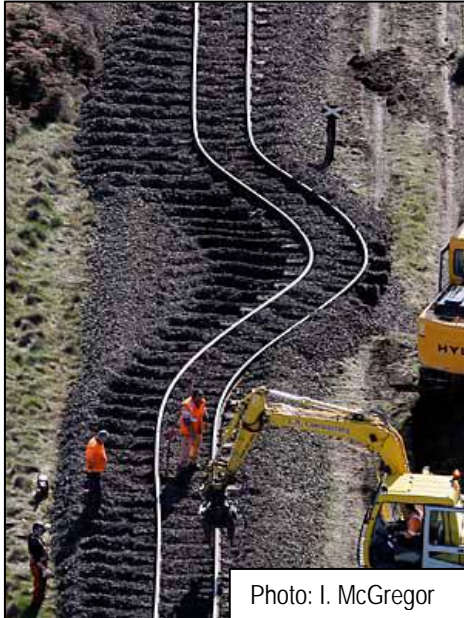
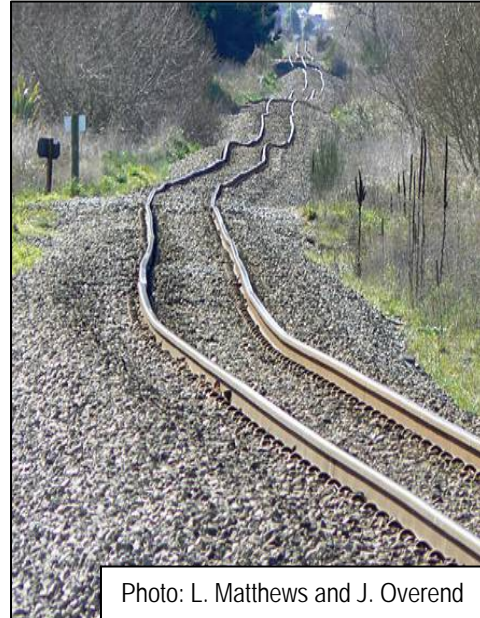
A 5km section of track was damaged near Kaiapoi (Main North Line) and there was lesser damage at Rolleston and near Belfast. The Main South line opened on the evening of 4 September, the Midland Line on 5 September and the Main North Line on 7 September.

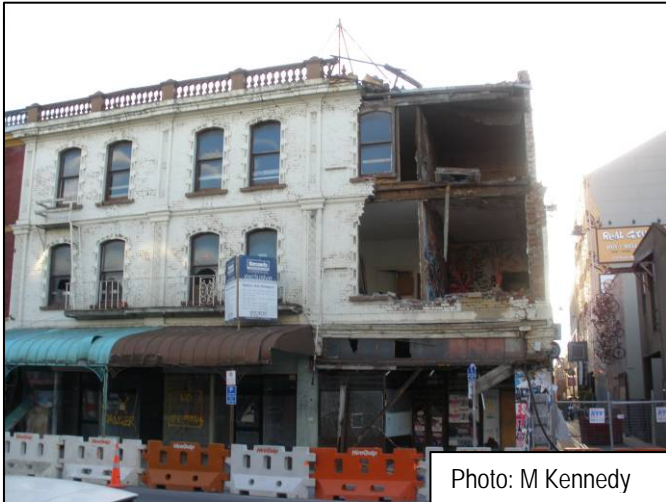
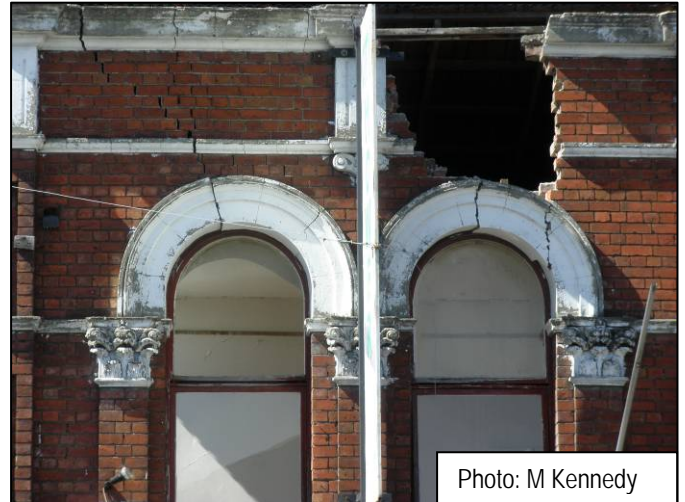
Commercial buildings in central Christchurch and Kaiapoi that were constructed of unreinforced masonry and were not seismically strengthened appear to be the most damaged. About 125 buildings collapsed, will have to be demolished or were extensively damaged. (This number is still subject to confirmation.)

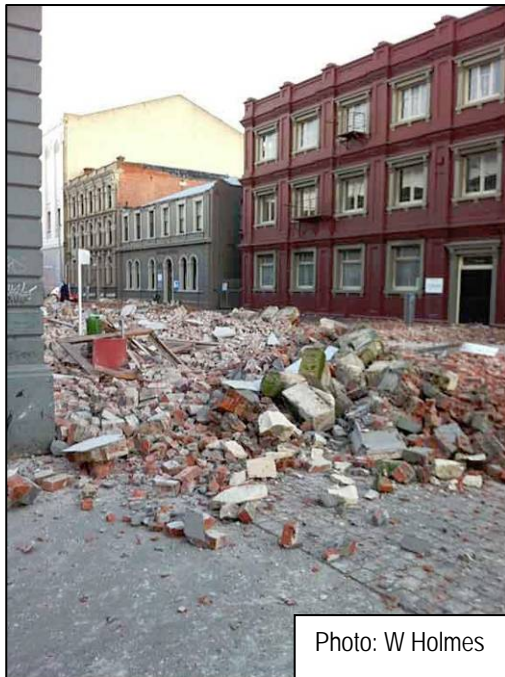
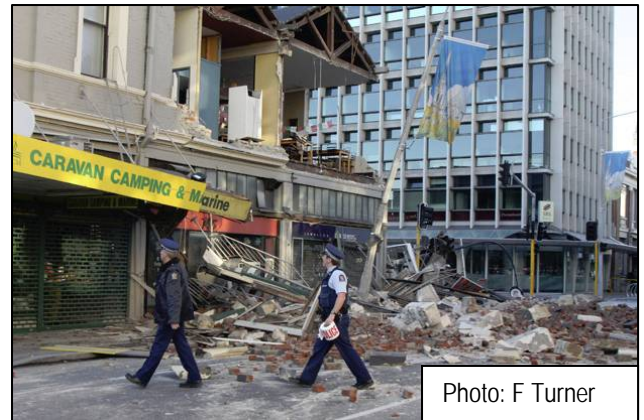
- Extent to which bricks/stone blocks were thrown. Anyone moving to the centre of a road to escape collapsing verandas would have stood a good chance of being hit by flying masonry.

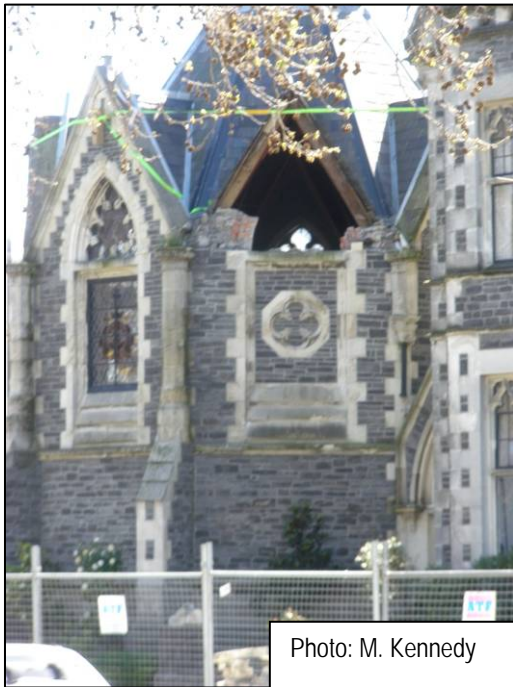
Photo: M. Kennedy

There was damage to a considerable number of gables.

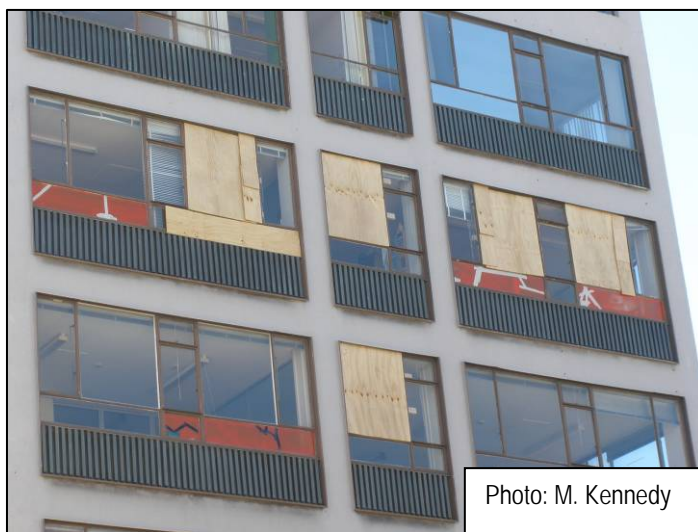
Photo: M. Kennedy

These could be defined as buildings constructed to a seismic standard following the 1931 Napier earthquake. What is not known is to what extent, if any, these buildings have been strengthened since they were built. Observations from street level within the Christchurch CBD suggests that, with the exception of some glazing systems, the buildings have suffered no or only minor damage. For a number of multi-storey buildings there was broken glass in the steel casement-style windows (non structural damage).

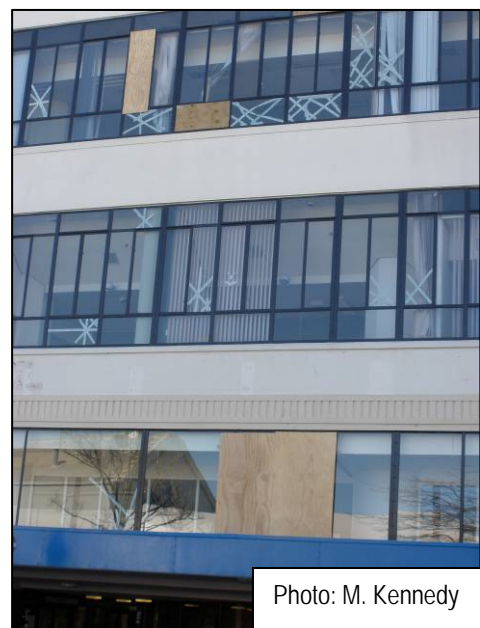
Photo: M. Kennedy

11.2 Middle aged commercial buildings

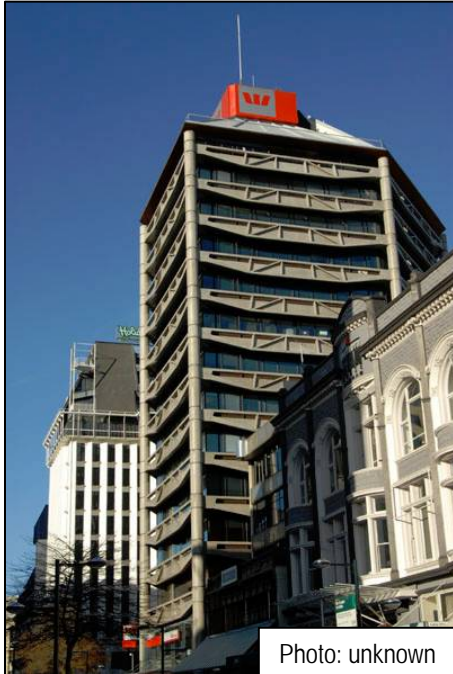
Photo: unknown

Most modern buildings show no external signs of damage. There are exceptions. Such as the concrete cover on the exterior column in the photograph below.

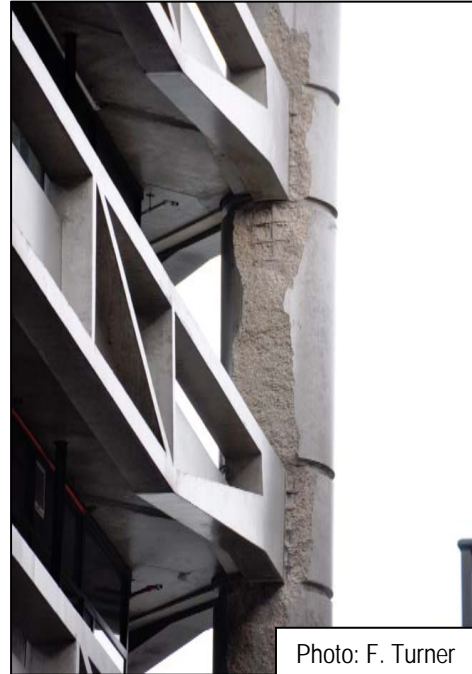
Photo: F. Turner

Limited information is known about the interior of some buildings as they are privately owned. One hotel was closed due to issues in the basement. Failure of concrete stairs was observed in another hotel. In fact, it appears a number of stairways were damaged in some buildings.

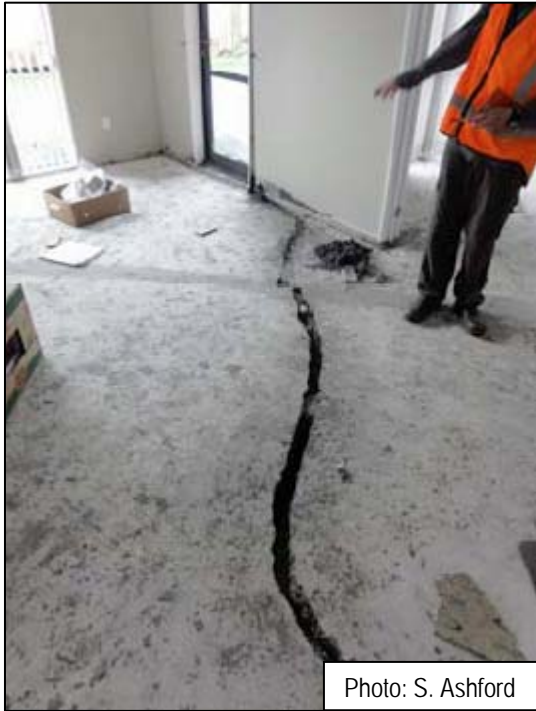
Photo: S. Ashford

In areas where there was severe liquefaction, there was also damage to houses, even if they were built to current standards. A report for the EQC indicated there was land damage recorded to 6855 properties as at 1 October, and a slight increase in this number is expected. In other areas, damage was variable. The media has well documented the damage to modern houses. Many of those severely damaged had unreinforced concrete floors not tied to the perimeter foundations.

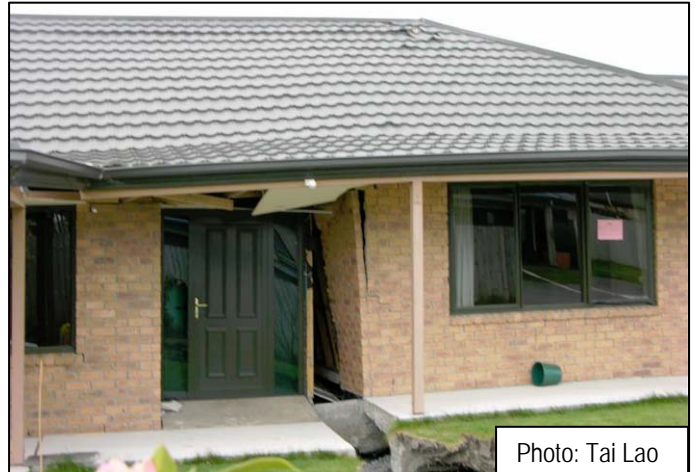
Photo: Tai Lao

Very old properties with unreinforced masonry suffered, as did houses with brick chimneys. An unconfirmed report suggested damage to 14,000 chimneys.

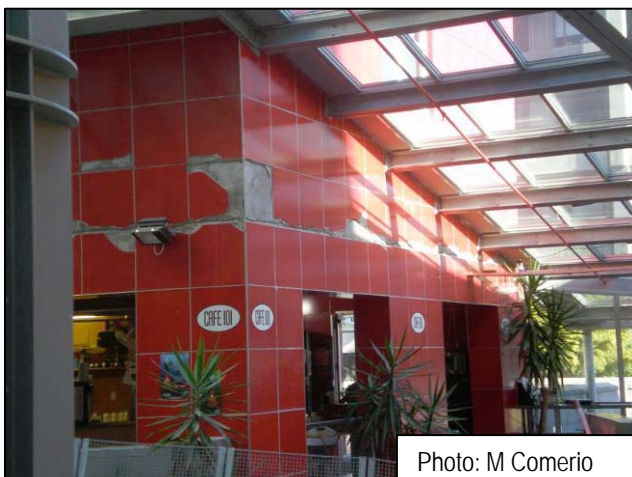
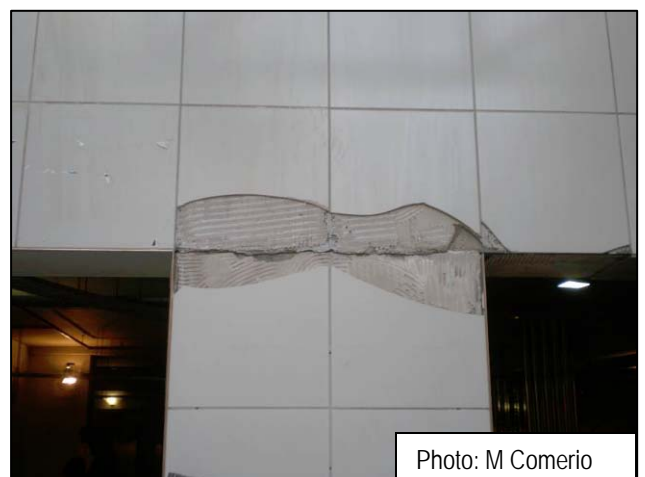
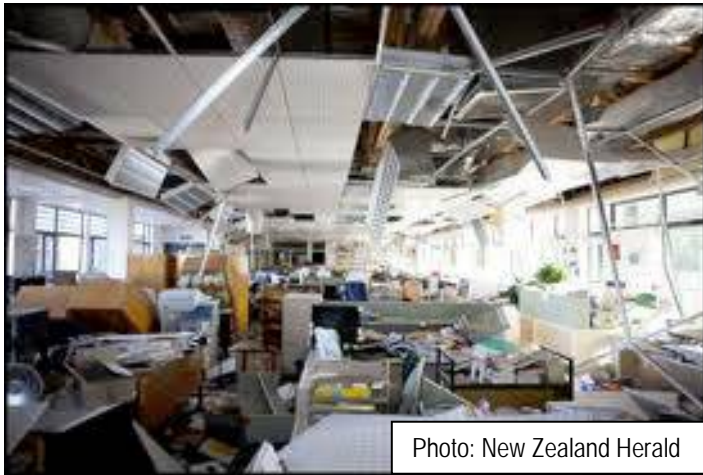
Photo: New Zealand Herald

In many cases, damage is inside buildings and not accessible for general inspection. However, examples of some types of non structural damage have been reported at the University of Canterbury complex at Ilam, about 4km from the Christchurch CBD.

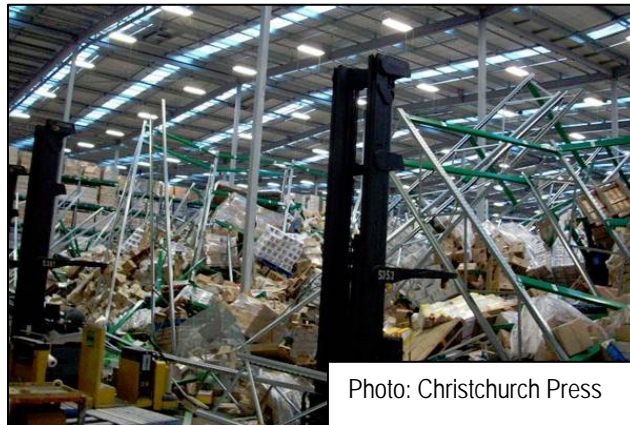
Photo: Christchurch Press

Some failures of storage racks in warehouses have been reported.

It is understood the Department of Labour is considering making NZ Standards mandatory for storage racks.

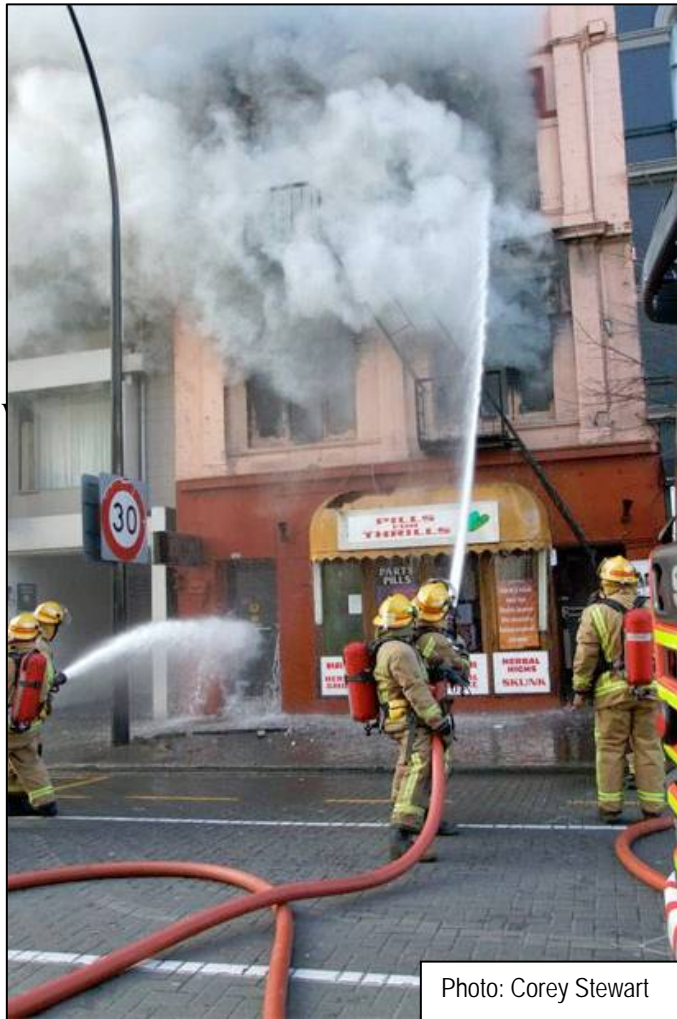
One fire was reported after power was turned back on in a Christchurch CBD building where LPG was leaking.

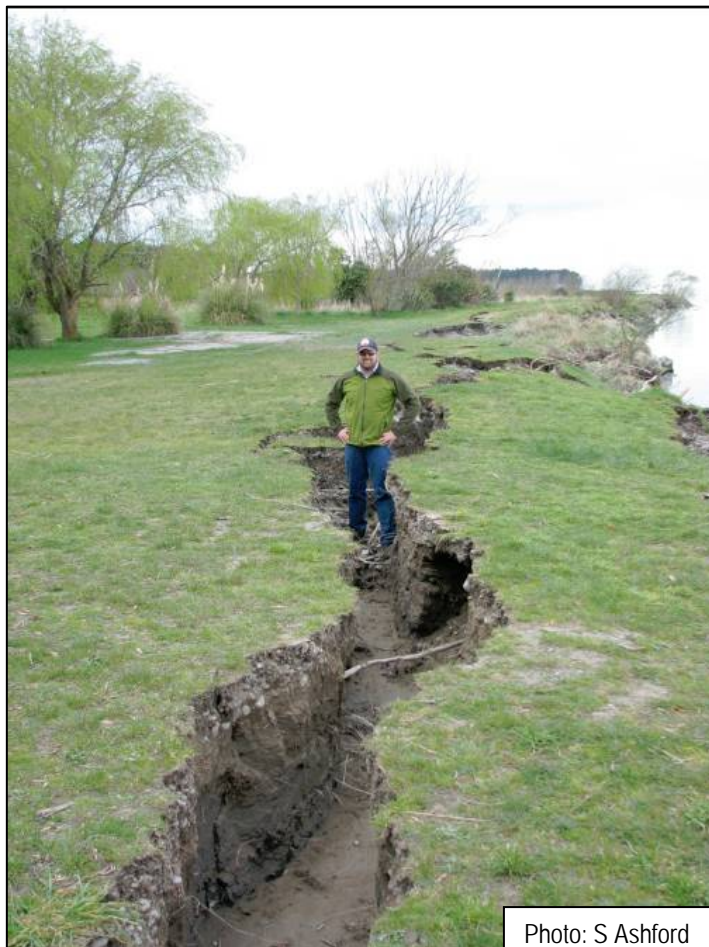
Photo: S Ashford

Extensive stop banks on the sides of the Waimakariri River were put in place to prevent flooding of Christchurch. Stop banks also protected the Kaiapoi area. As a result of the earthquake, there was slumping in some areas and the degree of protection dropped to a 1 in 15 year flood. Repairs raised this to a 1 in 30 years by mid October. It is expected that within a short period, 1-2 years, the 1 in 500 year flood protection standard will be restored. The most difficult damage to repair will be where there are major concrete structures passing under the stopbanks or embedded in them. These include culverts and headwalls for draining stormwater under the stopbanks and into the river and pump stations for both stormwater and wastewater. Retaining walls, used to minimise the width of the stopbank where space was a constraint, have also failed and will be expensive to repair.
