# On the beaches 2010/11

Annual recreational water quality monitoring report for the Wellington region

Shyam Morar Summer Warr

Environmental Monitoring and Investigations Department

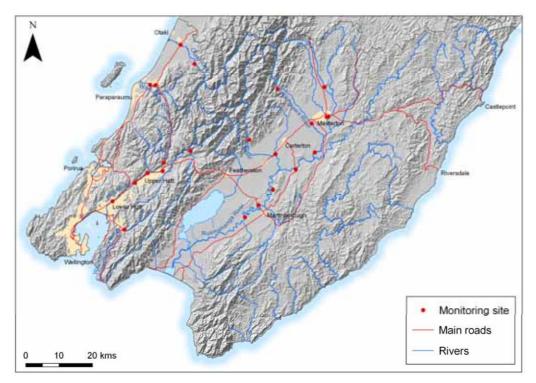
Figure 3.1: Freshwater recreation sites monitored over 2010/11

Recreational water quality was monitored at 23 river sites across the Wellington region over 2010/11 (Figure 3.1, Appendix 1), as follows:

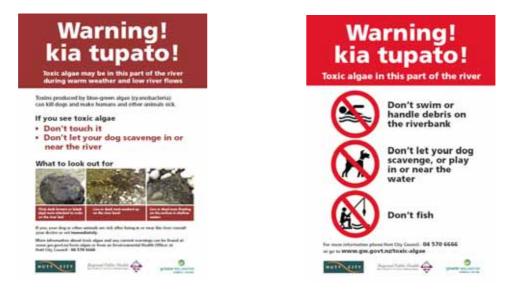
Figure 3.2: Alert (left) and action (right) level warnings signs used to inform the public of the health risk from cyanobacterial mats in rivers in the Wellington region

In 2009, interim New Zealand guidelines for cyanobacteria in recreational lakes and rivers were released (MfE/MoH 2009) for trial by monitoring and health agencies<sup>6</sup>. The interim guidelines for rivers identify a three-tiered alert level framework for benthic cyanobacteria (Table 3.2) which was based on a system that has been applied in the Wellington region for the past two years. Alert and action level signs used to warn the public of the risk from benthic cyanobacteria are shown in Figure 3.2.

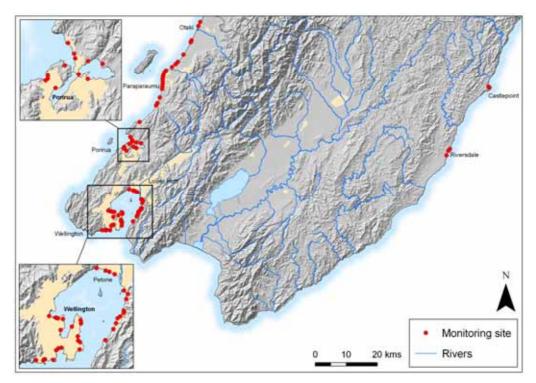
Figure 4.1: Marine recreation sites monitored over 2010/11

Recreational water quality was monitored at 74 marine sites across the Wellington region over 2010/11 (Figure 4.1, Appendix 1), as follows:

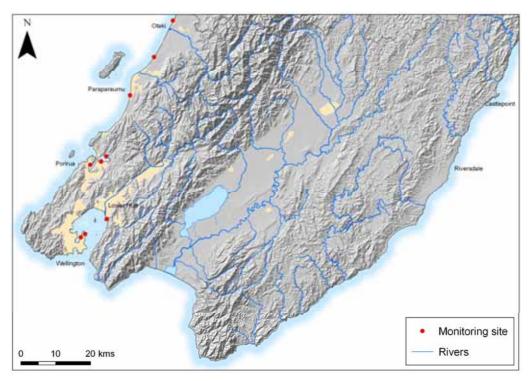
Figure 5.1: Recreational shellfish gathering water quality monitoring sites, 2010/11

Recreational shellfish gathering water quality was monitored at nine marine sites across the Wellington region over 2010/11 (Figure 5.1, Appendix 1), as follows:
