Living with the River

Hutt River Floodplain Management Plan:
Phase One Summary Report

November 1996

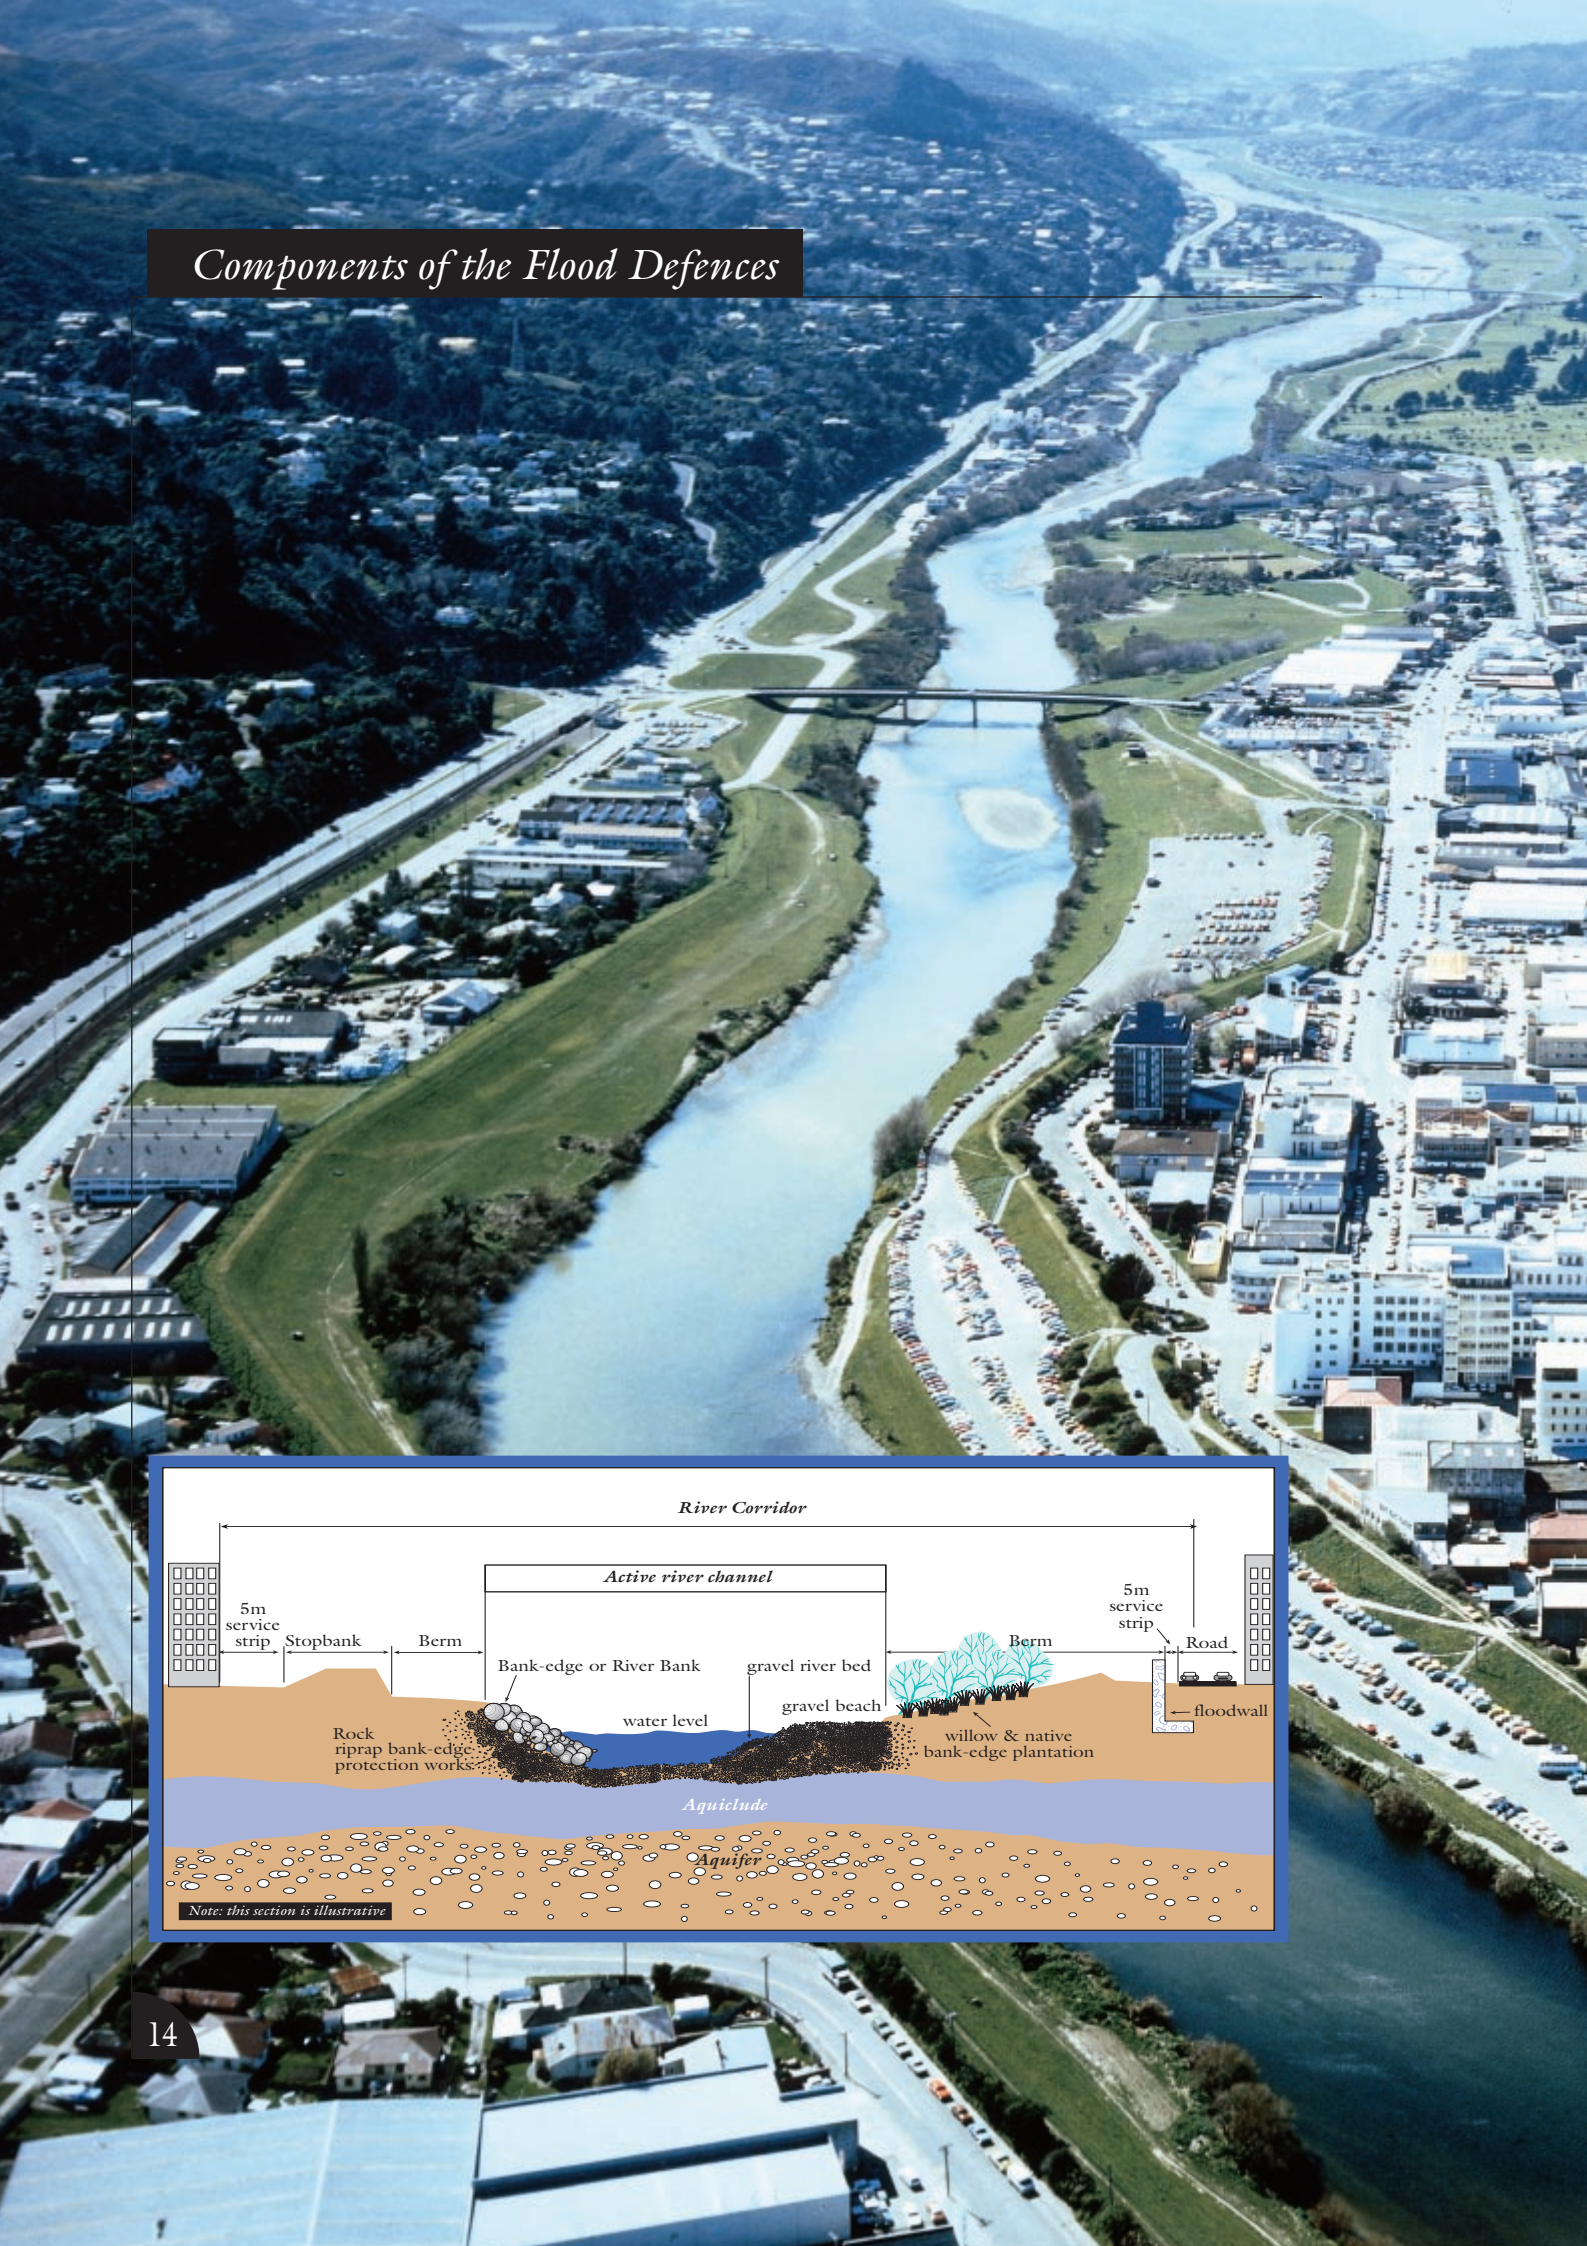
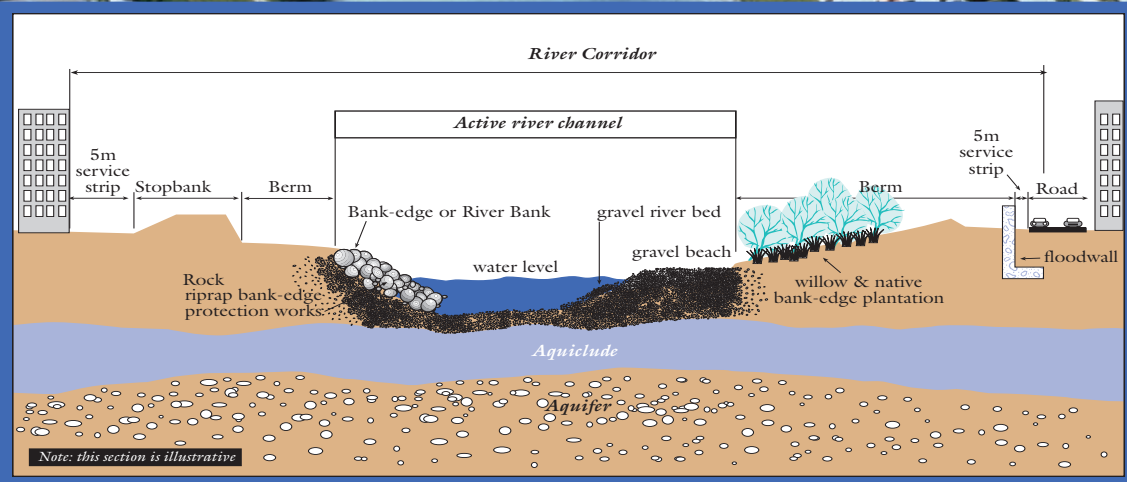
Components of the Flood Defences

Principal Components of the Floodway

Shingle Management. The bed of the river is made up of silts, sands and gravels eroded from the river banks and upper catchment and transported by the river to the sea. The processes of erosion and transportation form the ever-changing patterns of pools and rapids in the river bed. If the river had not been confined and the channel deepened, the river would meander over the floodplain, following its natural patterns of erosion and deposition. Now that it is confined, it must be managed so that it remains within the artificial constraints. If the beach deposits build up too high they must be lowered otherwise the river will divert into the opposite bank and erode berms and stopbank foundations. If the bed scours too low, banks become undermined. The way the shingle bed is managed has a fundamental influence on the design and management of the floodway.

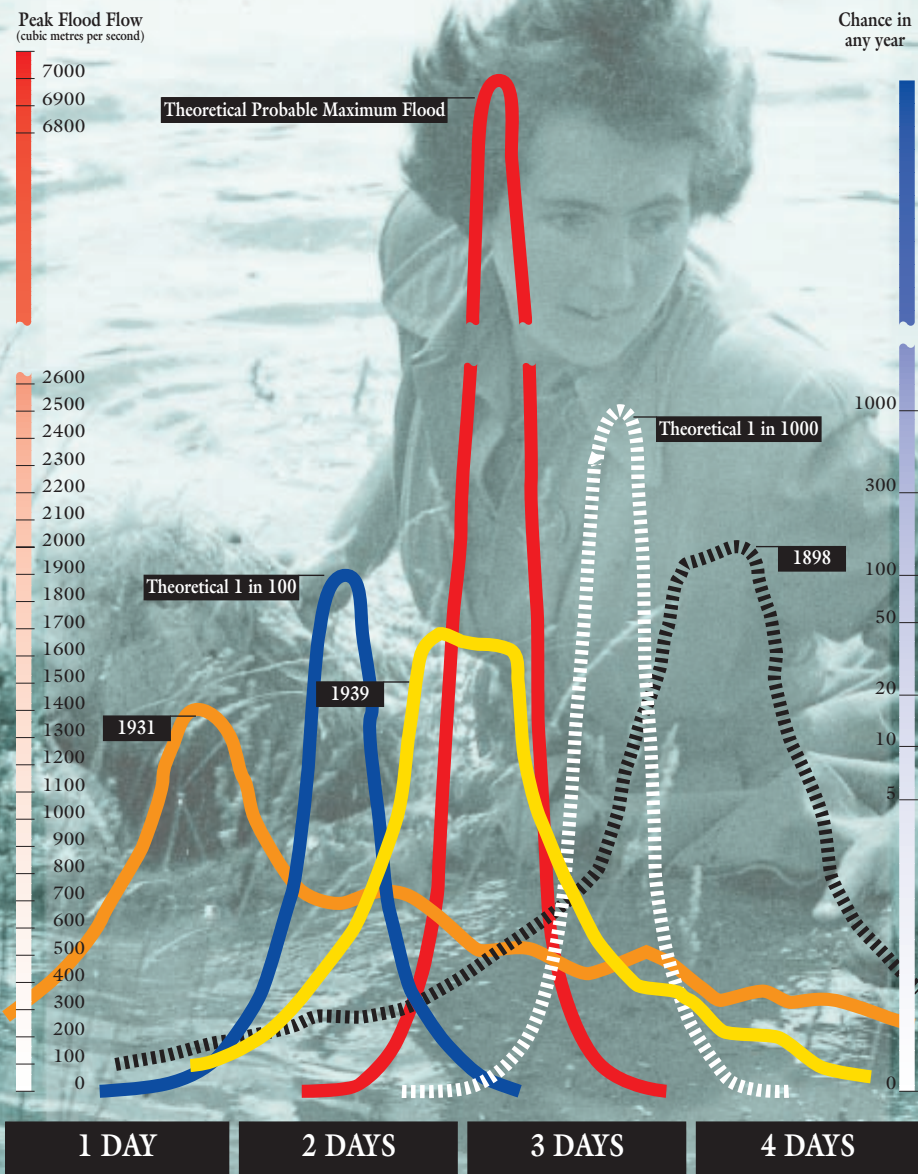
The hydrographs illustrate three of the largest recorded floods; 1898, 1931 and 1939, and theoretical floods: 1 in 100, 1 in 1000 and Probable Maximum Flood.

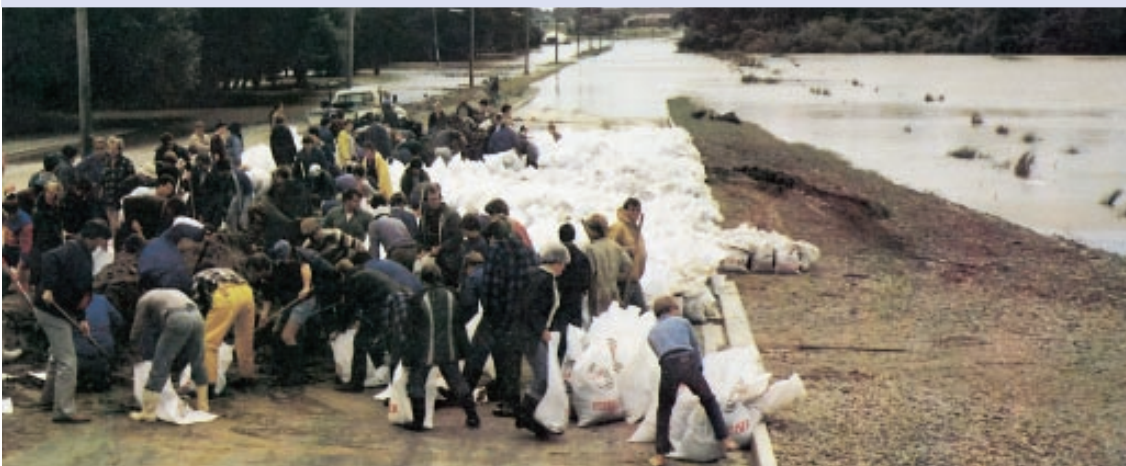
Assessments have been made of the way the stopbanks may fail. The size and shape of a breach determines the likely flood flow onto the floodplain. Various physical factors are considered, including bank stability, height, width, erosion potential and seepage potential. To simulate the progressive development of an opening in a stopbank during a flood the theoretical openings are increased with time. Emergency efforts to contain a breach of the Waihopai River stopbank, Invercargill, January 1984 are illustrated below. Photo courtesy Ministry of Civil Defence.

The theoretical assessment of breaches that may result from stopbank failures is somewhat arbitrary, but appropriate in view of the other assumptions and uncertainties in the analysis of the risks of flooding. The analysis provides a comparative model for assisting with the selection of options for upgrading the flood defences or for implementing planning provisions in the potentially flood-prone areas.
