# APPENDIX TEN

## ECOLOGY ASSESSMENT - FRESHWATER

**Subject:** Freshwater Ecological Assessment – Shelly Bay culvert inlet

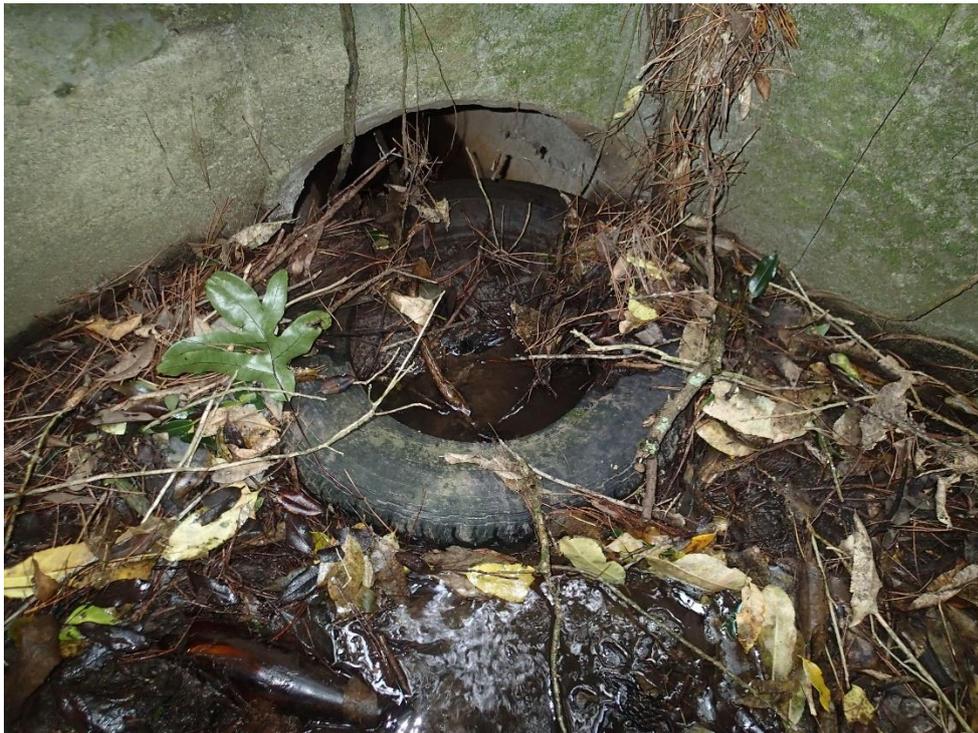
**Figure 1. Culvert inlet (partially blocked) with wingwalls**

The stream banks to about 4m upstream of the inlet structure were steep and vertical (1.5m), forming a bowl above the current inlet with the concrete apron and wing walls. Upstream of the inlet, the stream formed a shallow run within a shallow channel.

Broken pieces of a marble headstone and domestic rubbish, comprised of beer bottles, polystyrene, plastic, a washing line, a tyre and mussel shells were all present within the stream and embedded within the banks within 4m of the outlet (Figure 1, Figure 2 and Figure 5). Beer bottles were also common (and in greater numbers) in and immediately adjacent to the stream in the upper reaches.

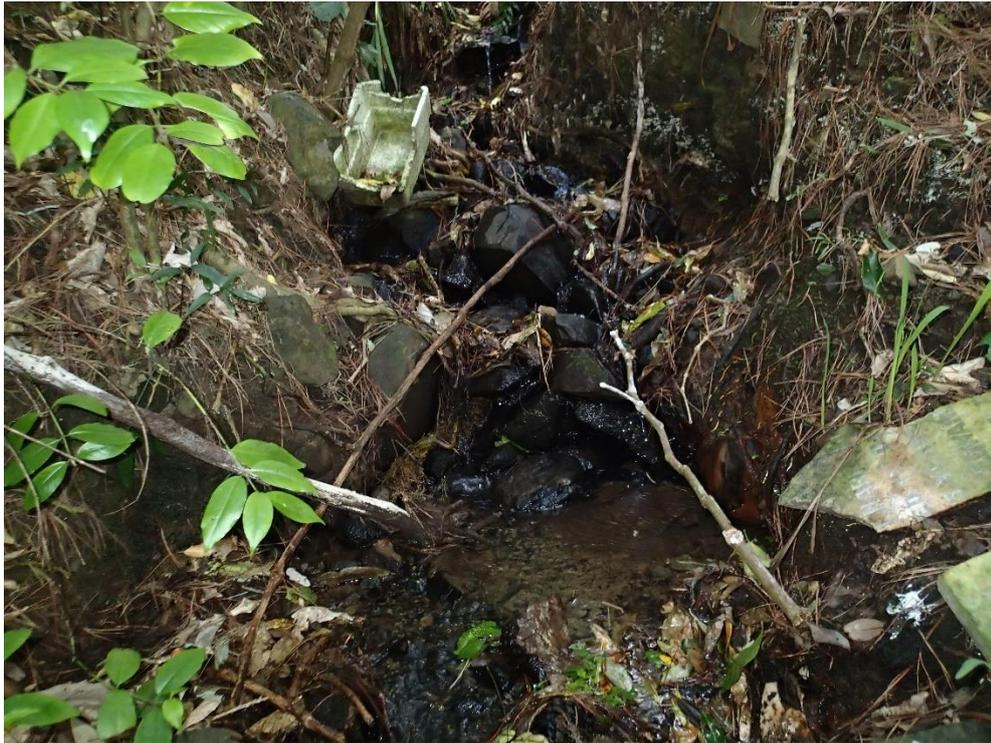
The water flow entering the culvert was a narrow shallow intermittent stream. The average width of the lower stream near the culvert was 0.35m (n=10), with an average depth of 0.02m (n=50). There were no significant pools present with the deepest water, 0.08m, recorded within the inlet pool at the partially blocked culvert mouth (Figure 1 and Figure 2). The substrate was a mix of medium to large gravels, cobbles and bedrock, although the upper sections of the stream, more than 10m above the inlet structure, were softer with a higher component of silt and small gravels (Figure 3).

*Figure 2. Stream inlet pool (note part of headstone on photo left)*

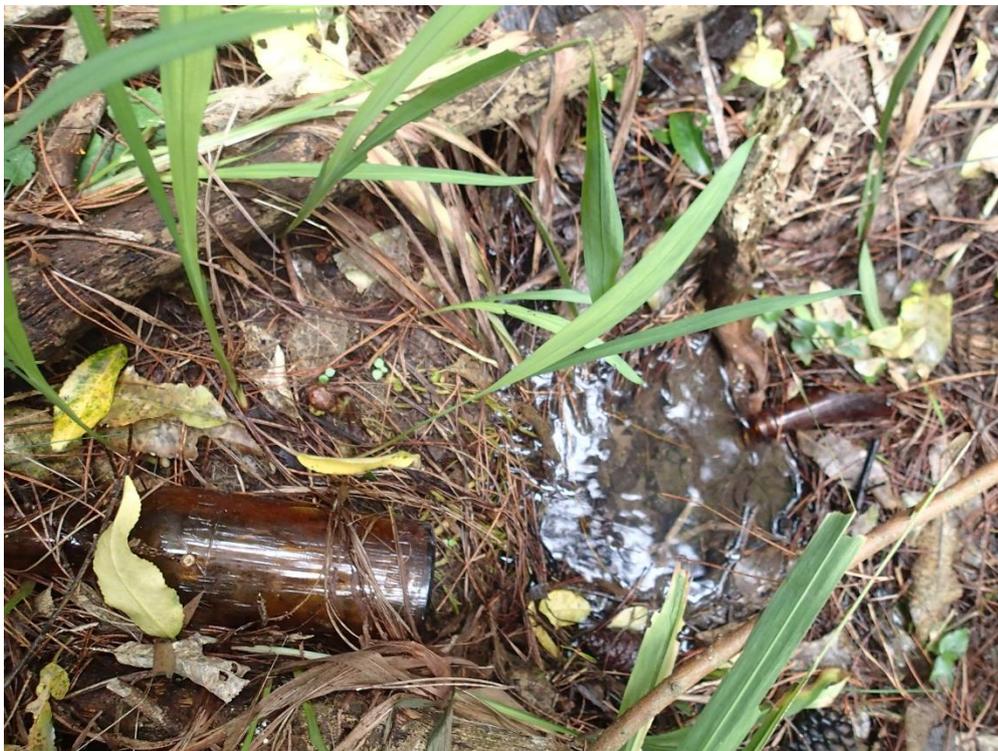
*Figure 3. Intermittent stream channel upstream of proposed works area.*

The riparian vegetation was showing the effects of land use changes, comprised of a mix of early regenerating native shrubs, dominated by kawakawa, rangiora and māhoe, and exotic weed species, broom, gorse, and Montbretia (refer to Appendix 3 for the species list), and surrounded by pine. The ground was a mix of bare ground and leaf litter and pine needles. (Figure 3 and Figure 4).

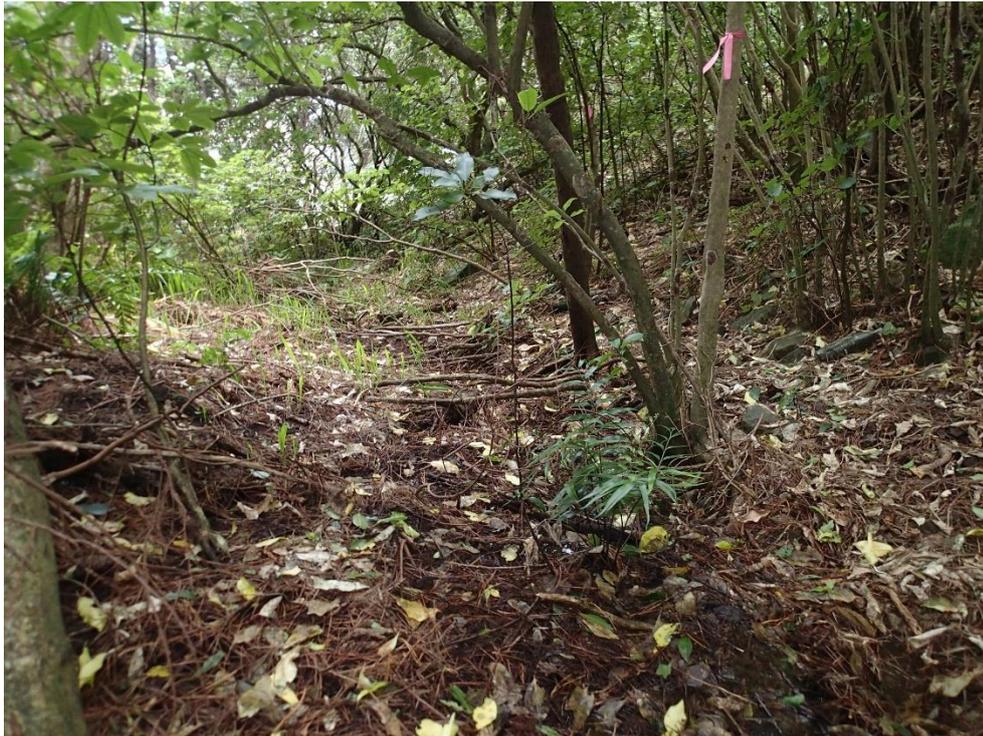
**Figure 4. Upper section of intermittent stream, view towards inlet.**

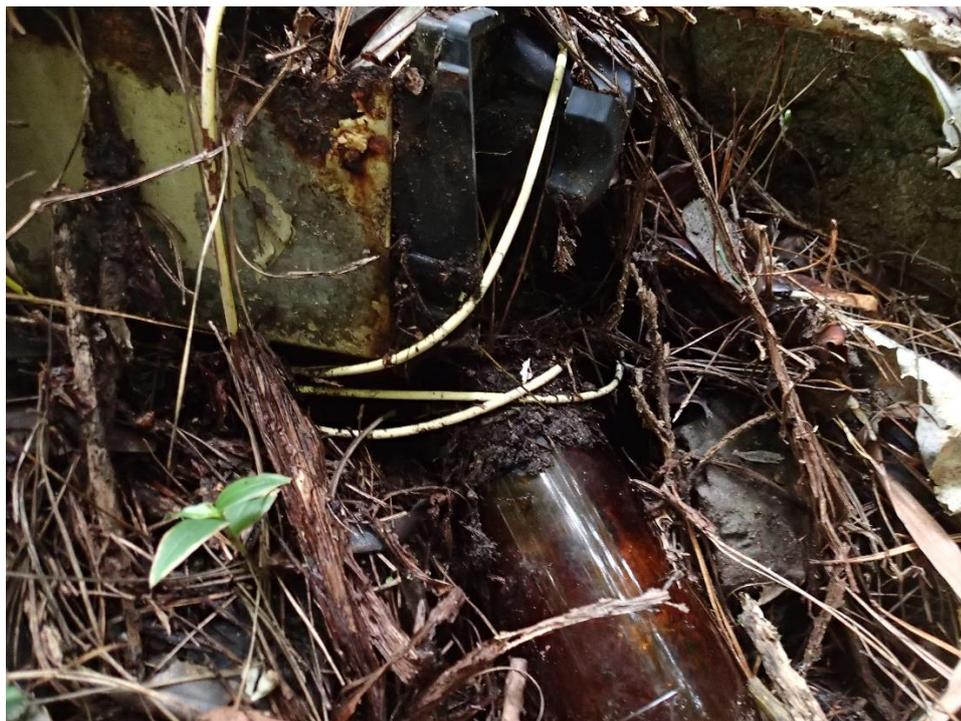
**Figure 5. Rubbish in stream embankment within proposed works area**
