## **Baring Head, Ōrua Pouanui**

### **Archaeological Survey for Wellington Regional Council**

Kevin L. Jones  
Kevin L. Jones Archaeologist Ltd

25 June 2010

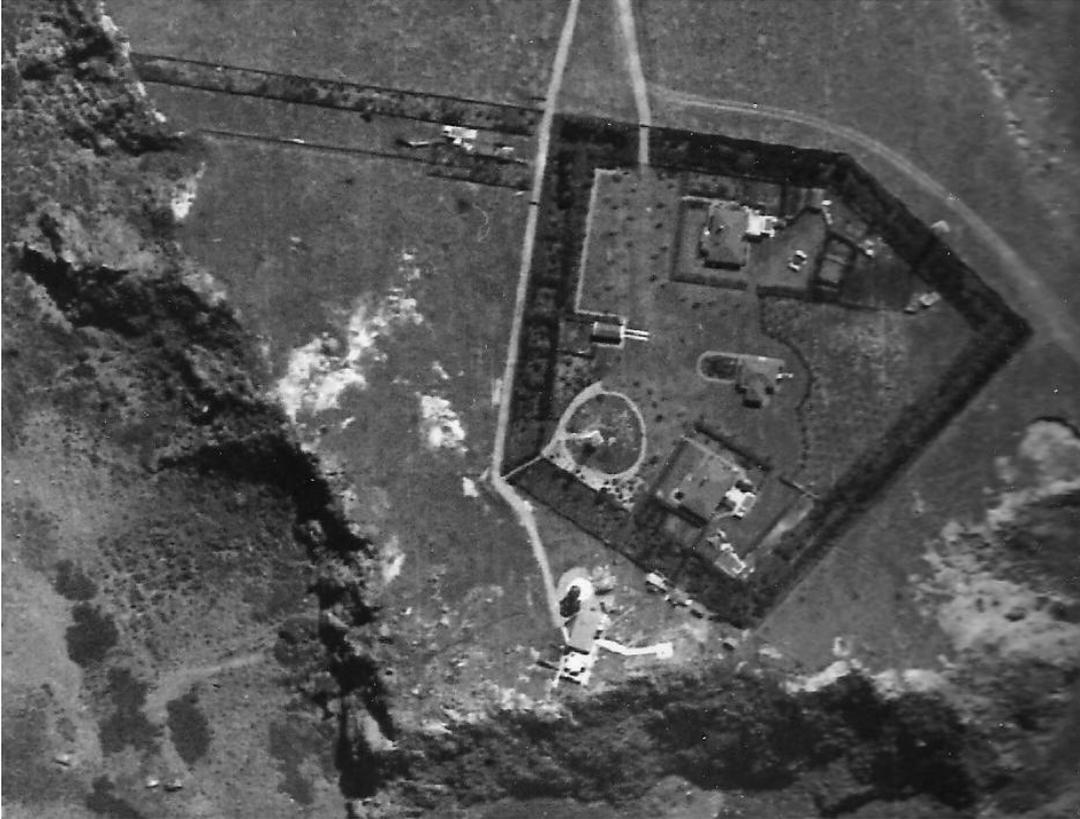
Fig. 2. Baring Head lighthouse reserve area 17 February 1941. North is to the top. Crown copyright photo New Zealand Aerial Mapping no. 24773. Note the waste rock at the foot of the cliff below the signal mast platform.

This information allows the true scale of the vertical photograph (17 February 1941) (Fig. 2), purchased for this project, to be determined and from that mapping of the position of original features. In addition the GPS points will allow the plan to be registered on the regional council GIS system.

In 1941 there was a gravel road from the north into the lighthouse reserve (see Fig. 2). There was no road within the reserve but there was a garage (Fig. 14) with a double concrete pad. The northern road forked just north of the reserve and followed the western edge of the shelter belt past the lighthouse to the radar station buildings. The formation of this road is still visible on the western edge of the shelter belt. The barracks built post-1941 is beside this road.

In 1941 there was a prominent horse-shoe shaped path to the west of the generator shed which passed around what is now an elevated mound with a succulent cover (see Fig. 2). The path and the mound may relate to the installation of the radio aerial which passed overhead.

In 1941 there was also a circular path about 25 m in diameter around the mound on which the south-western radio mast is sited (see Fig. 2). This leads out to the south-western corner of the shelter belt to the radar station road. It presumably relates to the raising and lowering of the aerial.

Immediately south of the lighthouse, the 1941 photograph (Fig. 2) shows a grey-roofed building about 12 x 4.5 m in plan, probably a barracks.

In the 1941 aerial photograph, the south end of the concrete platform has a wall which is casting a distinct shadow. On the pad as we recorded it, there is a 100 mm wide concrete sill across the southern edge with light inset bolts and short lengths of returns on either side. Inside the returns in the concrete are shallow channels or gutters so that the pad would drain, i.e. there was no enclosed building over the pad.

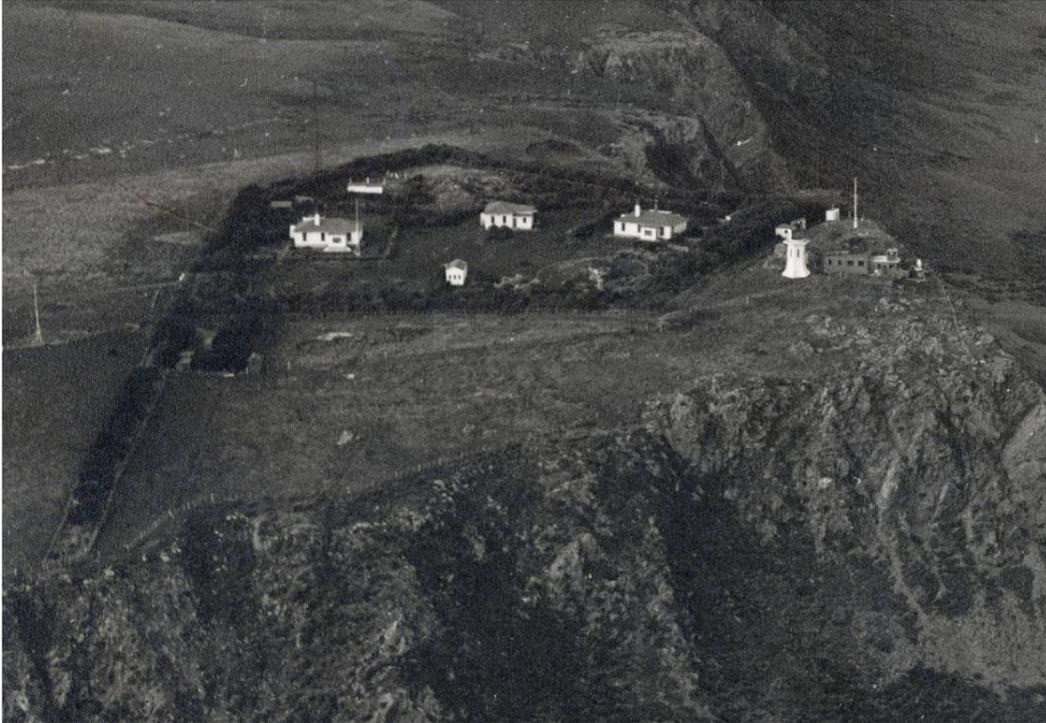
Fig. 3. Detail of Whites Aviation aerial oblique from the west. The date is estimated to be in the 1950s. Some salient features deserve note: 1) radar hut with possible aerial and barracks by the light, 2) signal mast, 3) signal hut (left of the mast)? 4) both no. 1 and no. 2 houses have small third bedrooms off the entry hall, 5) the second (WAAC?) barracks has been demolished. Courtesy National Library/National Archives ABPL W5221.

There is a useful Whites Aviation 1950s oblique aerial in Archives New Zealand which shows the reserve area (Fig. 3).

On the north-eastern pad are three sets of two 7/8-inch bolts set in a radial triangular pattern with an impression on the concrete surface of a short length of steel RSJ held down by the bolts. This is probably the ground bracket for the white-painted steel or wood *signal mast* about 12 m tall with crosstrees which can be seen in Figure 3.

The radar building can also be seen in the 1950s photograph (Fig. 3). There appears to be a radar transmitter and aerial still on the roof. The adjacent barracks is also visible in that photograph.

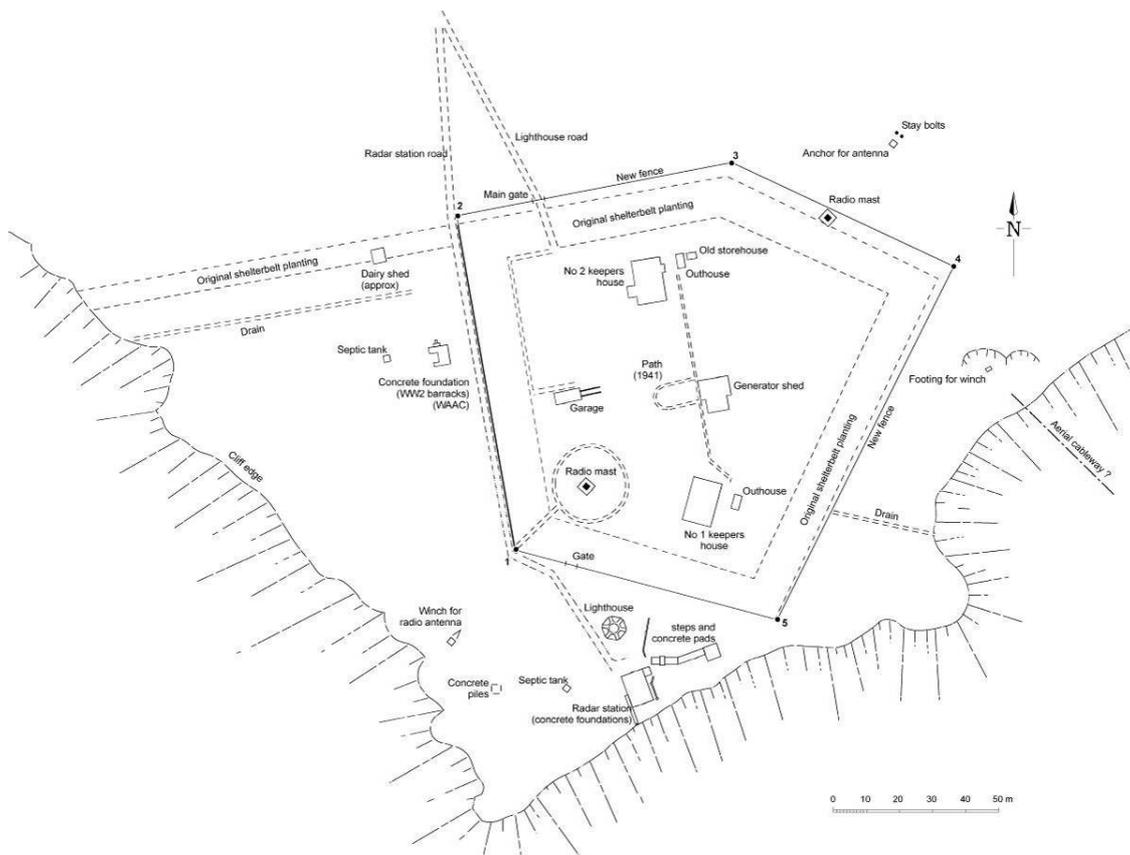
Fig. 4. The Baring Head lighthouse settlement area R28/48. Tape and compass plan, based on the 1941 aerial photograph (see Fig. 2). Numbered GPS points are in Appendix 1. The radar station area is shown in detail in Fig. 22. Kevin L. Jones and Chris Edkins May 2010.

The plan and orientation of the lighthouse base was mapped in and extended out to the current NIWA buildings (Fig. 4). The adjacent or underlying 1930s or WW II buildings and features were recorded. The small isolated barracks foundation off the south-western road alignment (outside the fence) was mapped in. Finally the plan details of the vehicle garage, the keepers' houses and outhouses, the generator house and the distance between the radio masts and their heights were measured. On another occasion the interior plans of the two houses and the generator (power) houses were recorded.

The plan outline of the *lighthouse base* was mapped (see Fig. 4) and the lighthouse photographed (see frontispiece). With its 12 m height, its fine hexagonal form and external curved concrete ribs, it is an essential visual element to the lighthouse settlement theme of the Baring Head Recreational Reserve. As noted it lies on its own reserve area vested in the Maritime Safety Authority. No further recording has been done on the lighthouse.

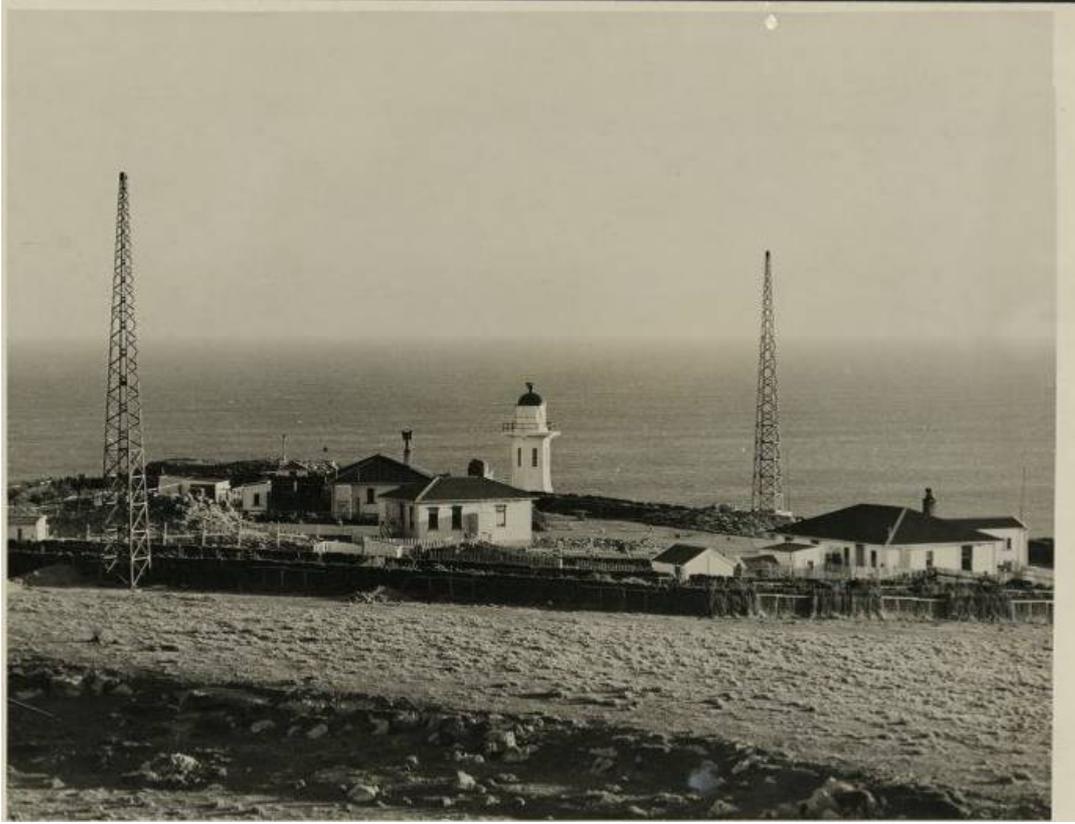
Fig. 5. A view from the north-east, 1937. National Library of New Zealand

Figures 5 and 6 show oblique views of the lighthouse taken six decades apart.

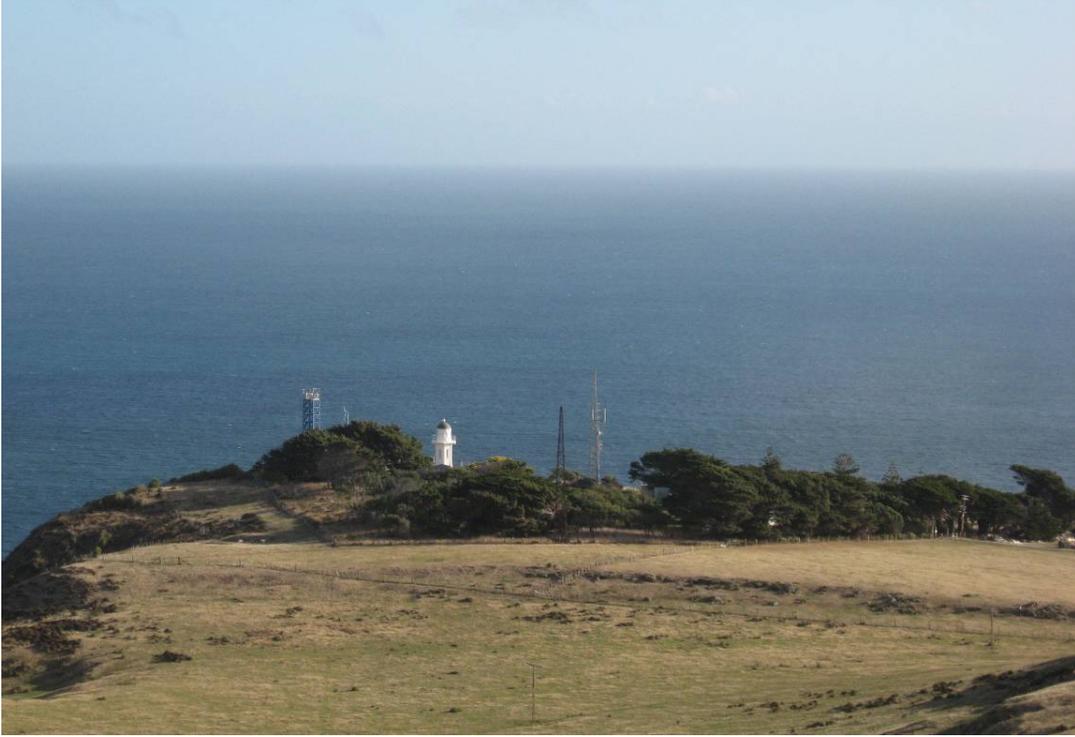
Fig. 6. Similar view May 2010.

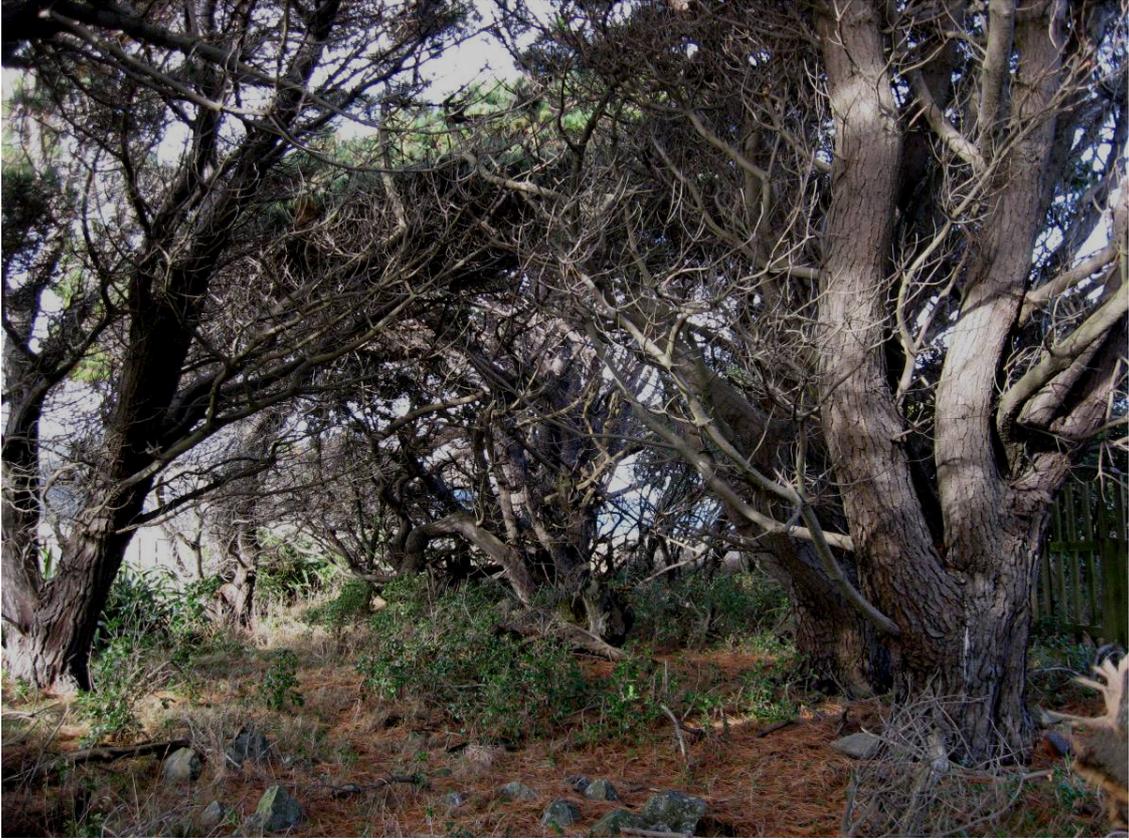
Fig. 7. Open *Pinus radiata* treeland with taupata and flax understorey in northern part of shelter belt. The trees are over 70 years old.

Tree species which appear to have been planted in 1937 and which have survived as an open tree land were macrocarpa (including a golden cultivar), *Pinus radiata* and pōhutukawa (Fig. 7). Norfolk pine may have been planted later. Significant specimen trees that survive today, such as the macrocarpa specimens, can be detected in the 1941 aerial photograph.

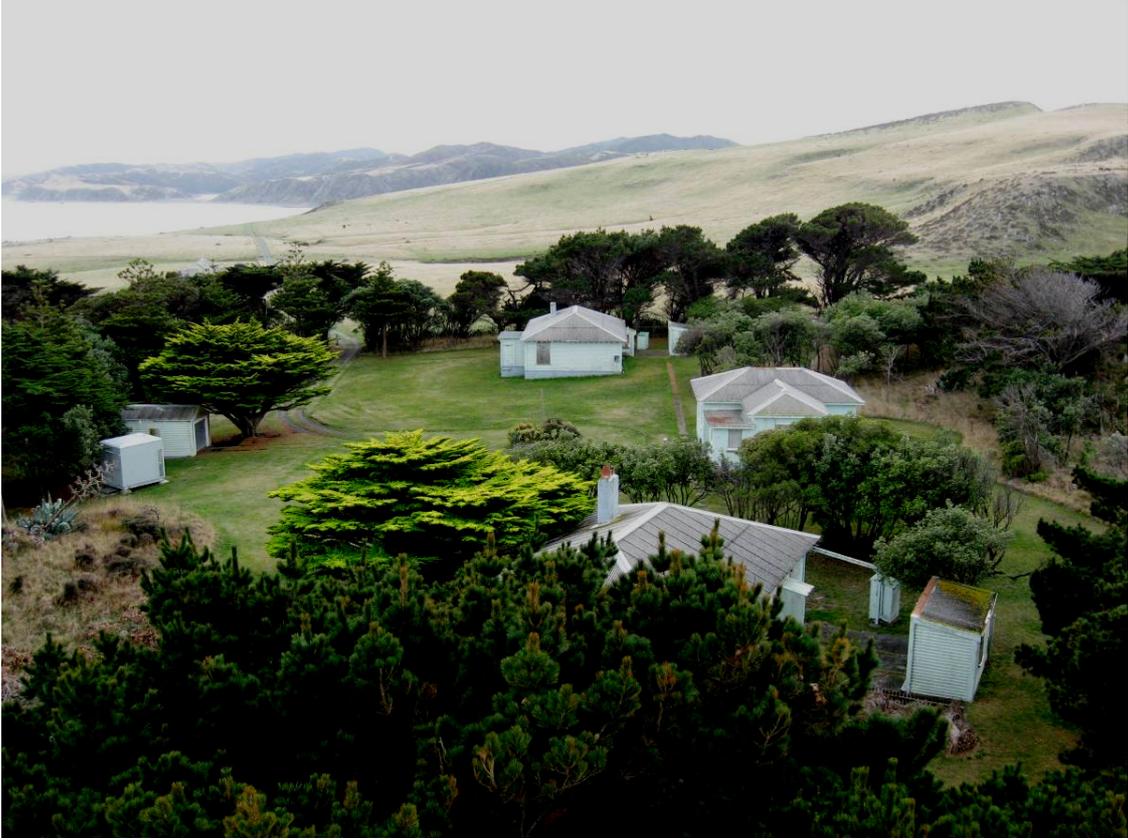
Fig. 8. Keepers' houses and the generator (power) building (centre right) from the south. The garage is at left.

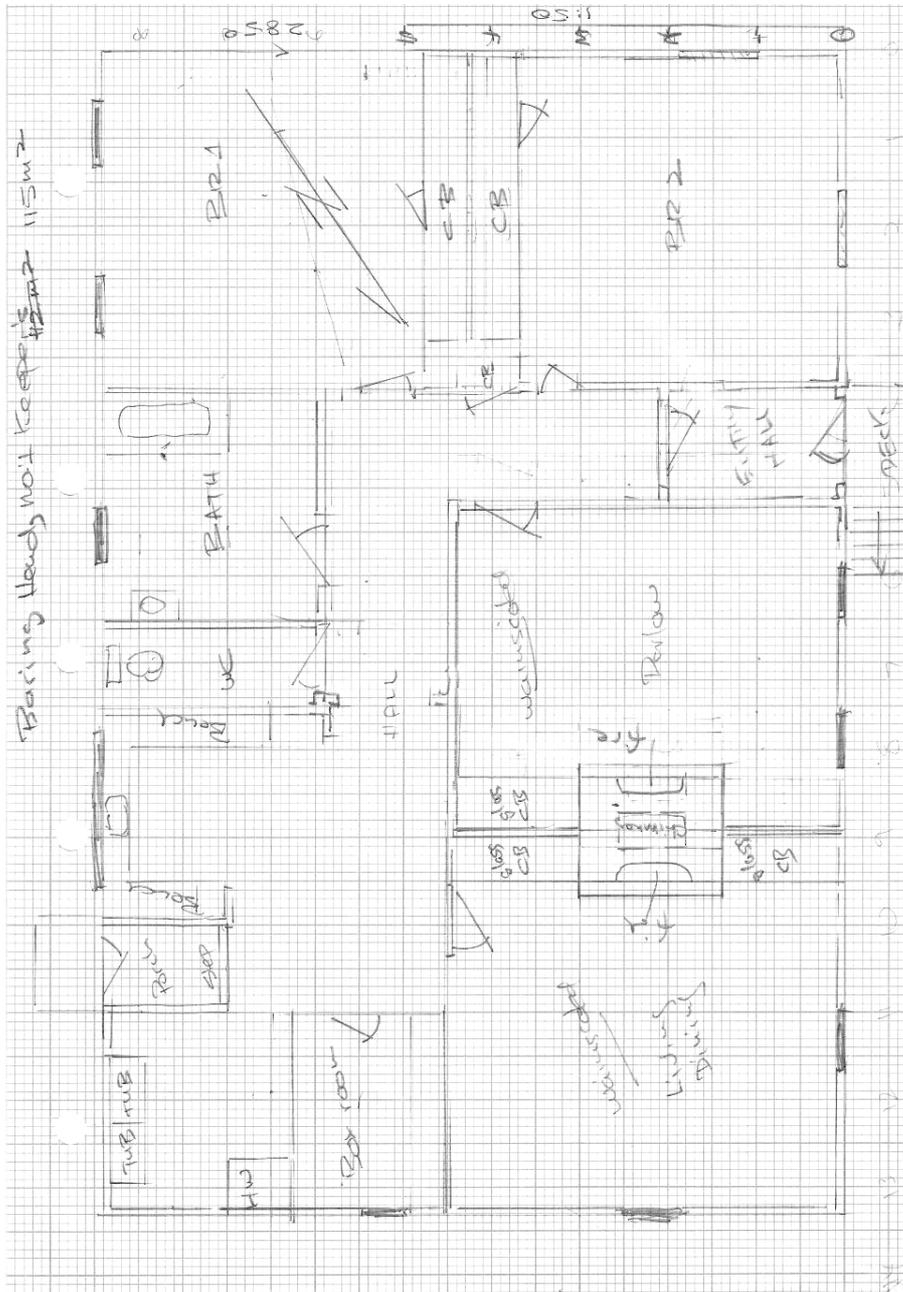
Fig. 9. Interior plan of the no. 1 keepers house.

The two *lighthouse keepers' houses* are bungalows with a floor area of about 115 m<sup>2</sup> and corrugated asbestos sheet hip roofs. The windows have double-hung sash joinery with six lights in the upper sash and two in the bottom. Each house has a small pumphouse to the north-east over a subterranean concrete cistern; these replaced water tanks originally sited under the eaves (see Figs 9, 10). Each building had a rear concrete yard and an outhouse.

The interiors are more or less identical and have two bedrooms, a parlour and a living/dining room, kitchen, W.C., bathroom, box room and a washroom. The no. 1 house still has the original varnished wainscoting (wood panelling) in the parlour and living room.

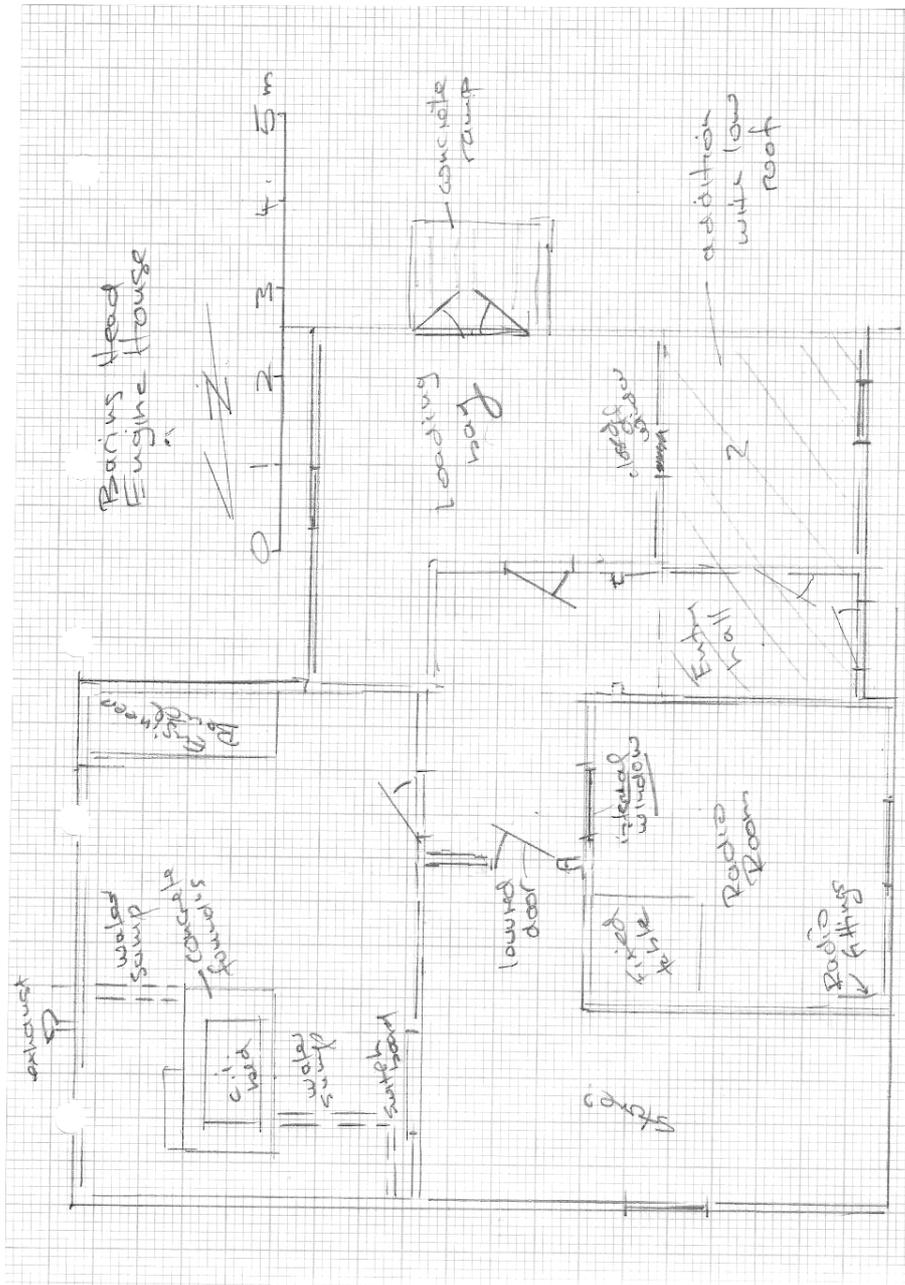
Fig. 10. The generator or power house incorporating the radio room.

The *generator house (power house) and radio room* is made of concrete poured into shuttering. It is a hip-roofed building of 70 m<sup>2</sup> with wooden window surrounds and the external appearance of a small bungalow (Figs 10, 13). The generator(s) fed accumulators/batteries for the light. Power in use included 110 volt DC and 240 volt AC. The interior has a loading bay, a radio room, a generator room and what is probably a battery and electrical equipment room (for ancillary equipment such as switch gear, converters, transformers and radiators for surplus power). There was also a radio room in the concrete power house.

The concrete construction may have been for fire protection and because the site had military functions. It is likely to have asbestos ceiling linings.

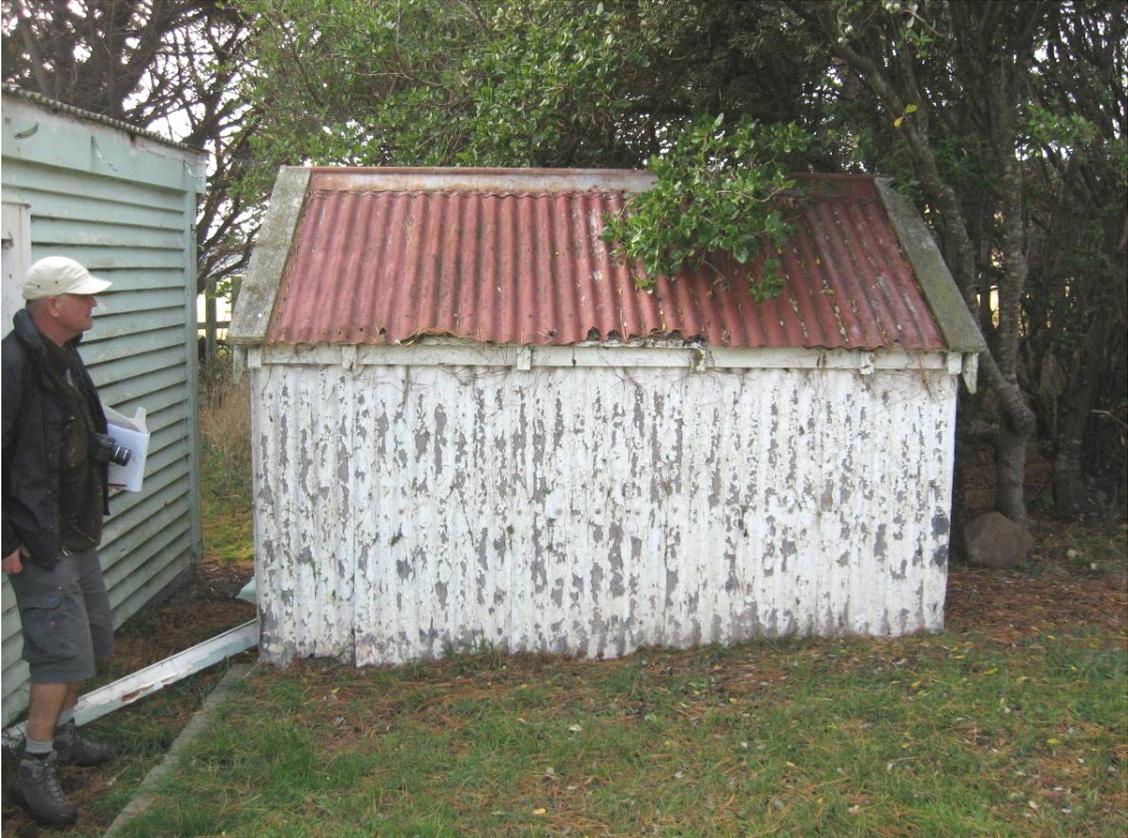
Fig. 11. The Marine Department type store behind keeper's house no. 2.

There is a small Marine Department type storehouse behind the no. 2 outhouse (Fig. 11); this is lined with dressed timber inside and clad with corrugated iron. It may have been

brought in complete and, given that it came from another place, it will be the oldest building on the reserve.

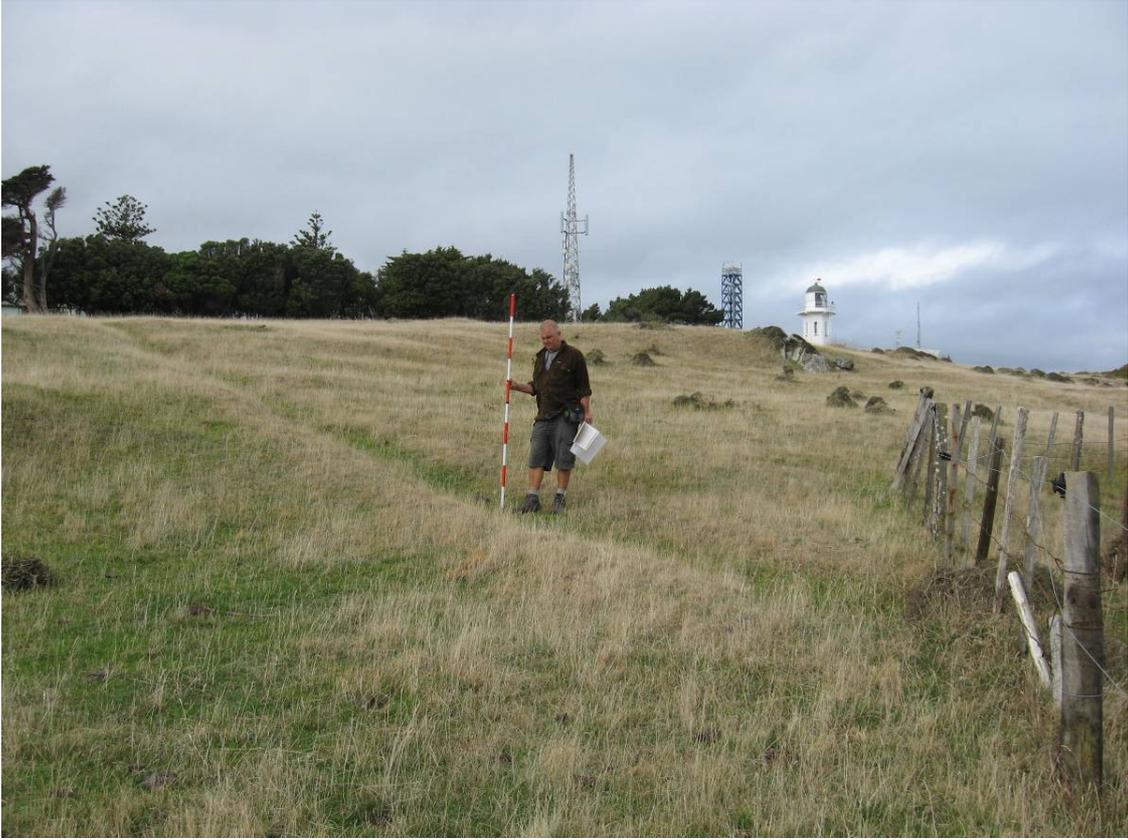
Fig. 12. The drain from the no. 2 keeper's house.

Waste water and possibly sewage from the no.1 house was piped south-east to the southern cliff edge. The no. 2 house was piped downhill west to the western cliff where there is still a substantial trench (Fig. 12).

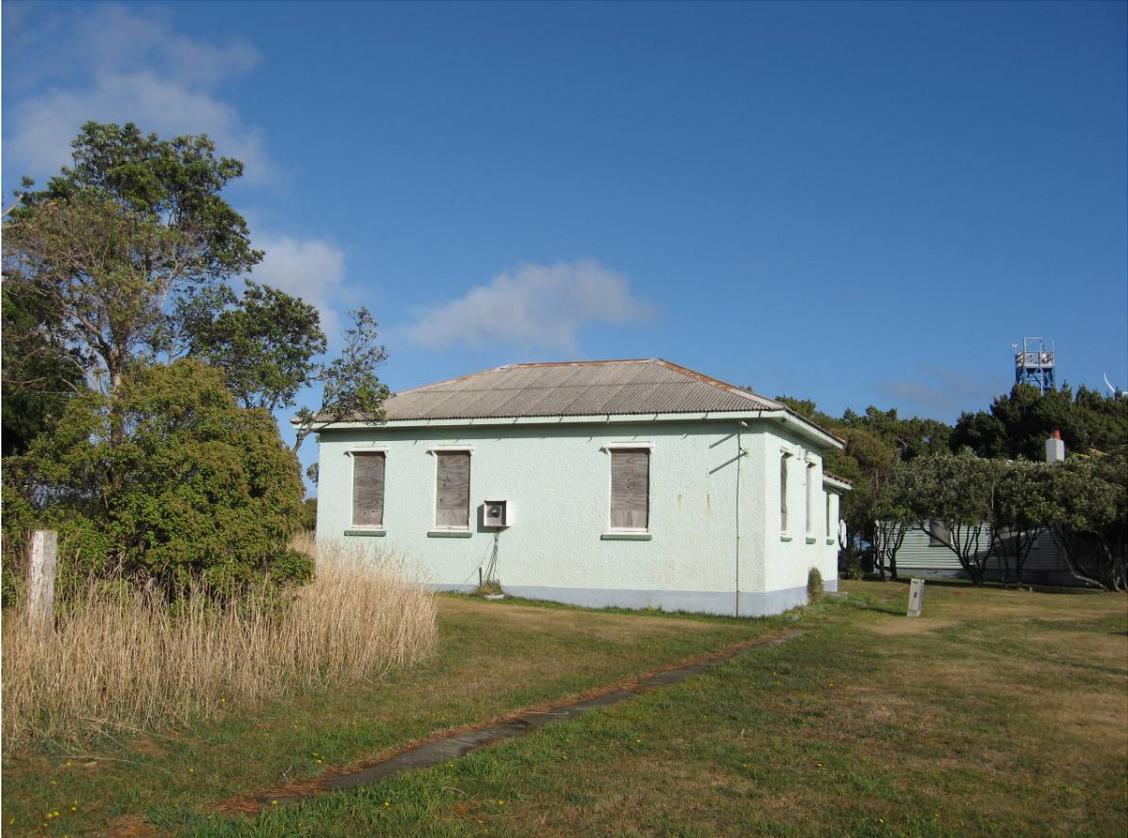
Fig. 13. North elevation of the concrete generator building. Note twin galvanized pipes under the eaves (upper right) which may have held a bracket for the feeder wire to the radio antenna.

room (another reason for disguising/camouflaging it as a keeper's house). There is a twin galvanised pipe bracket on the northern elevation (see Fig. 13) which may have secured the lower part of the feeder wire. Figure 19 shows part of the 1936 plan for the antenna.

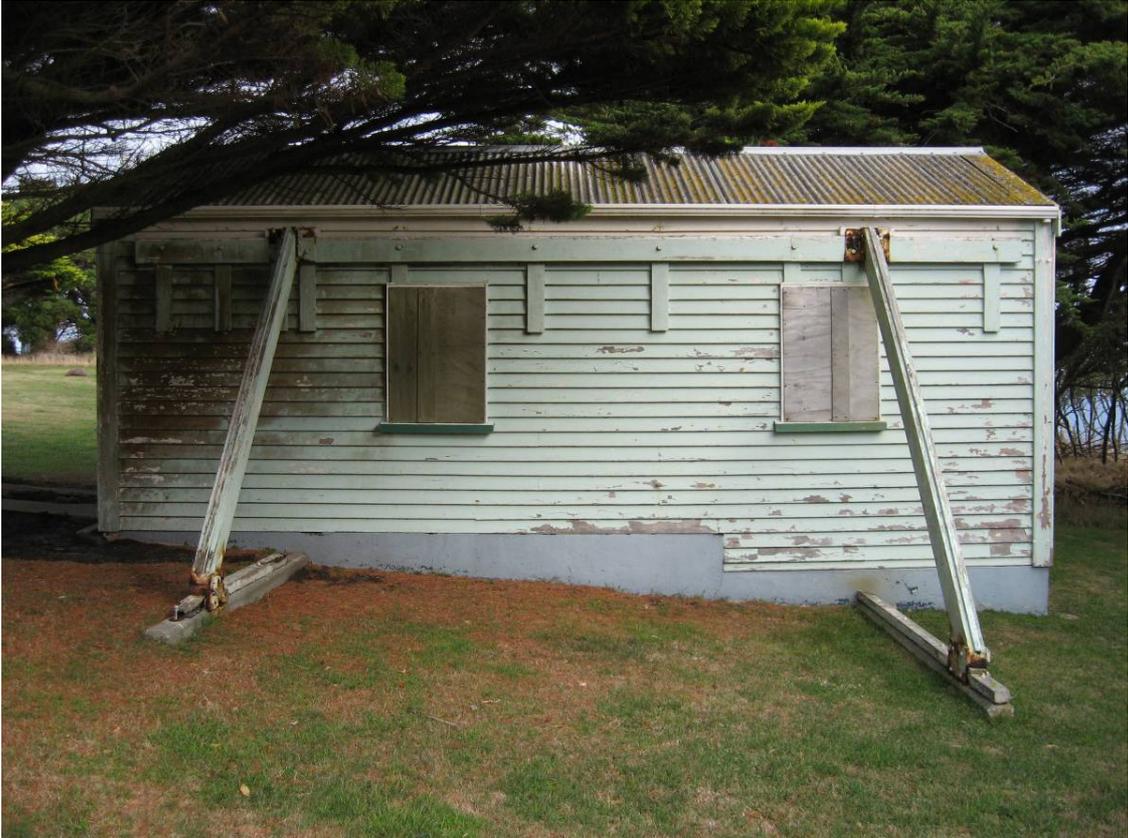
Fig. 14. North elevation of the garage with later buttresses.

The weather board *garage* has two substantial bracing timbers on the northern side (Fig. 14).

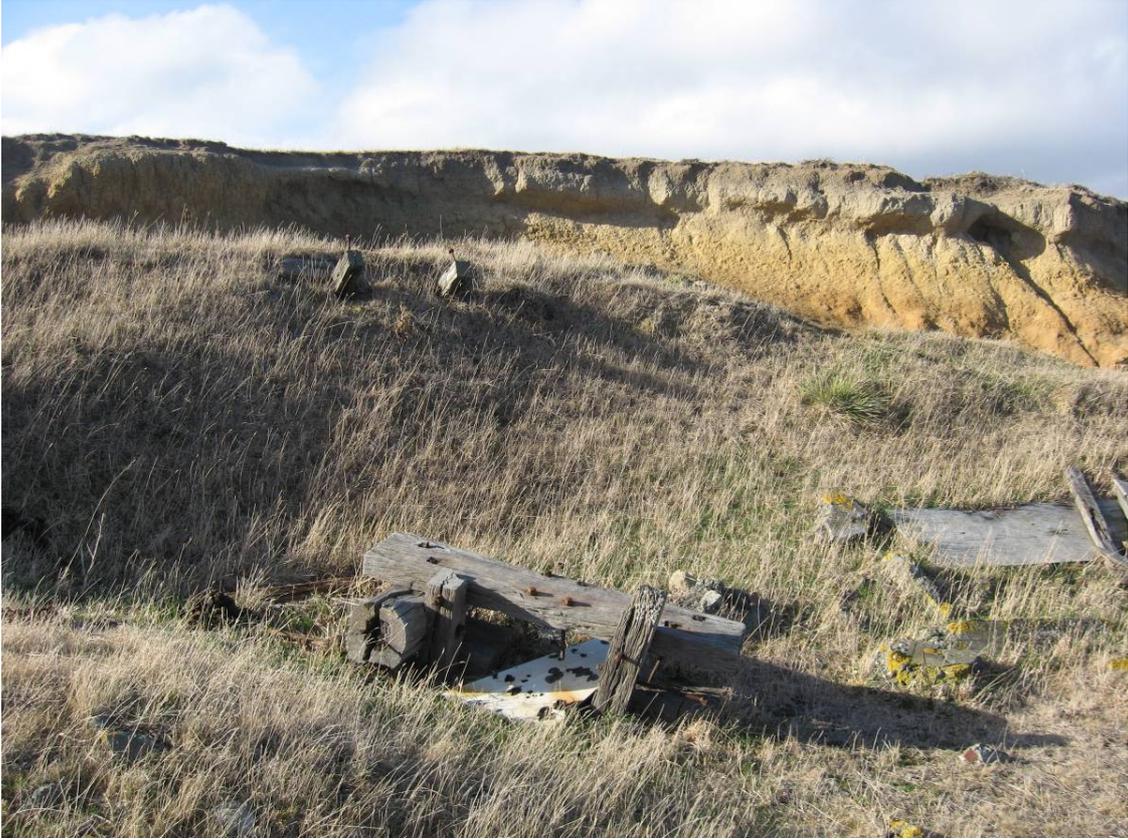
Fig. 15. The quarry area with wooden relics and bracing timbers.

There is an oval area about 12 x 6 m of excavation and levelling at the cliff edge 100 m east of the keepers' no. 1 house (Fig. 15). There are large sections of bolted hardwood including some bracing timbers on the surface. This area is at the head of an open gully with an even, steep slope to the beach below.

It is possible that this is the spot where the first foundations for the light were explored and abandoned for want of solid bedrock (see Beaglehole 2006: 142-143). In this position a 12 m-tall light might not fully command the coast and it seems unlikely that it would have been planned for that site.

Alternatively, the hardwood beams may be components of an aerial cable way station or gravel bin. Gravel for concrete and some goods may have been brought up here by an aerial cableway. However, nothing shows in the 1941 aerial photograph so this is unlikely.

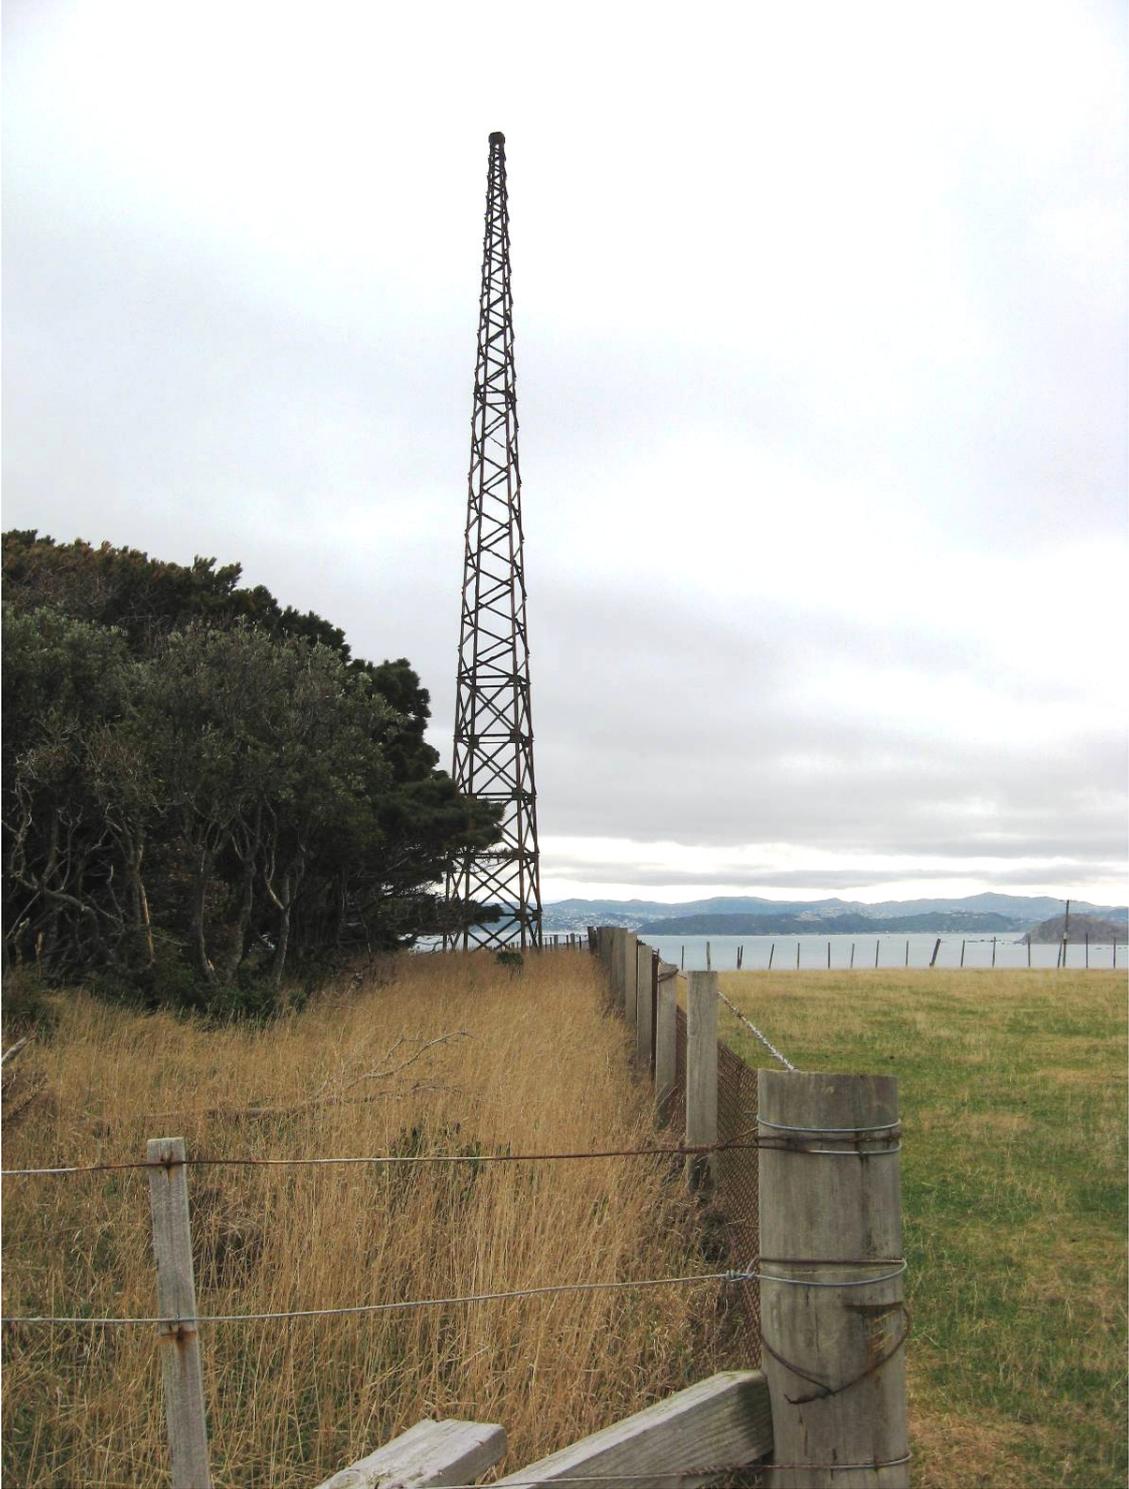
The south-western mast is maintained and painted. The north-eastern mast is visibly rusted at many of the bolted joints and also on the concrete base which needs to be kept dry and clear of soil, grass and encroaching vegetation. The stability of this mast needs to be reviewed. It is unclear as to whether it is in the reserve area or in the adjacent land.

Fig. 16. The north-east aerial mast.

6. Detailed safety check and maintenance schedule for the north-eastern radio mast which appears to be badly rusted; it also needs to be determined whether it is in the reserve area.

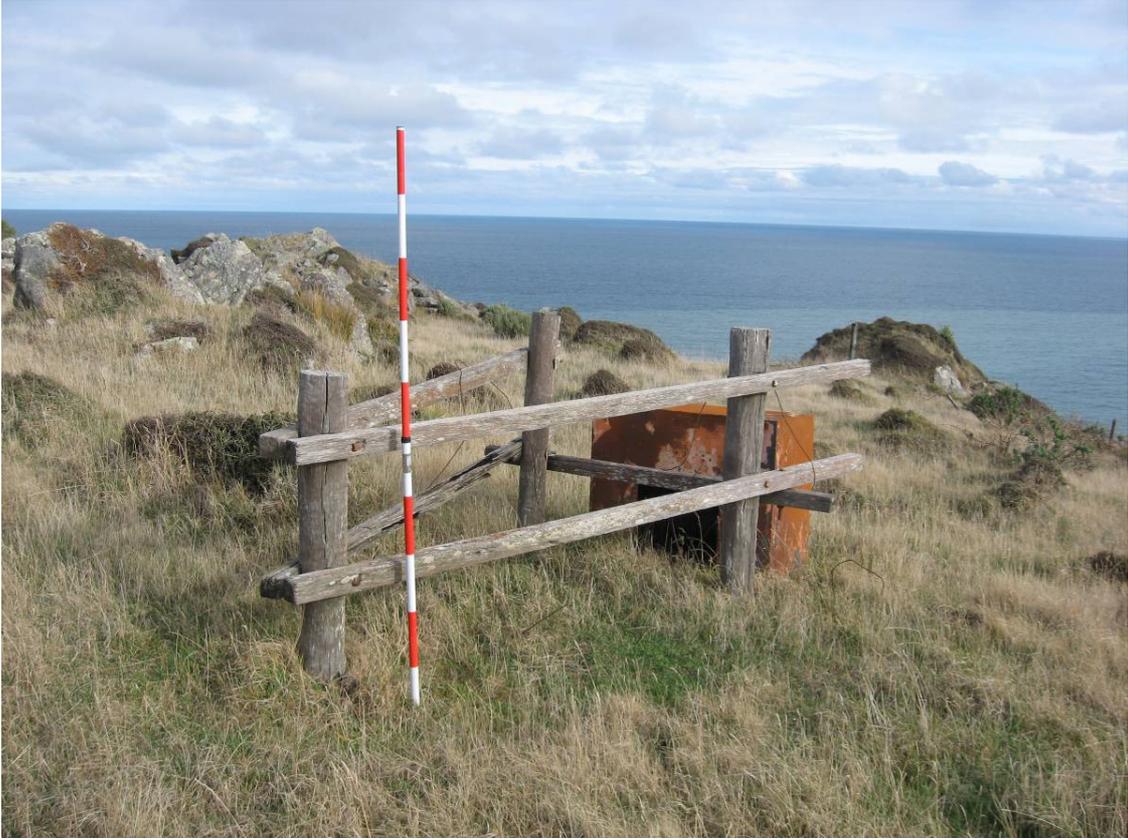
Fig. 17. The winch with the wing fence to keep stock away from the tensioning cable running across the top of the south-west mast to the Marconi T-antenna positioned between the masts.

Overall, this arrangement may be interpreted as: (1) a semi-static stay with counter-weight holding the cable over the north-eastern mast and (2) a live tensioning cable over a pulley or pulleys (the pulley shafts are still visible) atop the south-western mast to raise and lower the aerial.

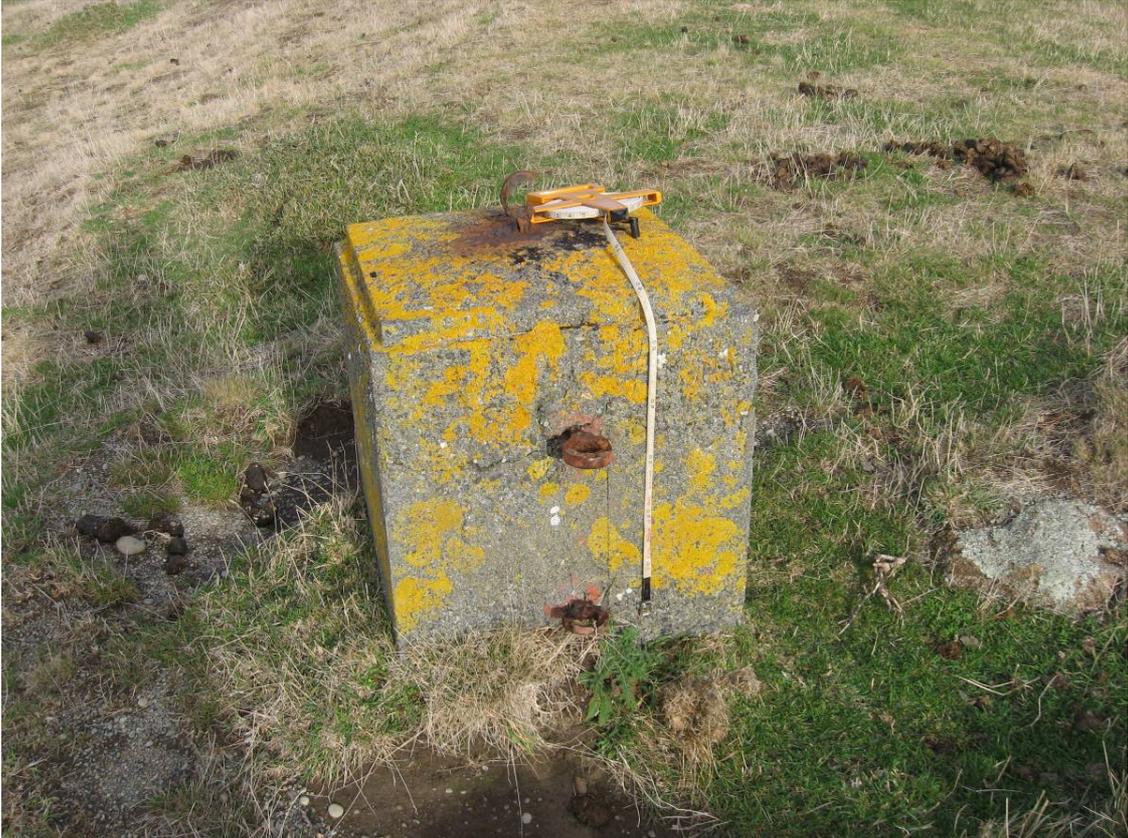
North-east of the north-eastern mast and about 25 m from the fence is a concrete block counter-weight (weighing about 500 Kg) and two *galvanised anchor stays* (Fig. 18). The cable from the aerial came down to a steel bracket (held by the stays) from which the counter-weight was suspended. South-west of the south-western mast is a *winch* with galvanised wire cable and a distinctive acute-angled wing of post and rail fence (presumably to keep stock from rubbing against the tensioning wire). There seems to have been no lateral stays to the towers.

Fig. 18. Concrete counter-weight for the static tensioning stay to the north-eastern mast. It was originally suspended in a steel frame (see Fig. 19).

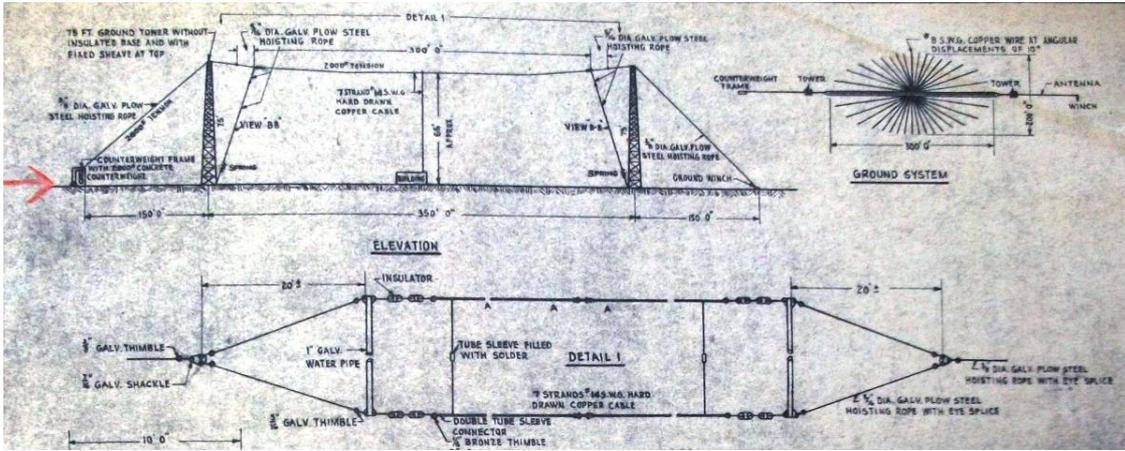
Fig. 19. Masts and Marconi T-type antenna as designed (P. and T. Department W.6649 A, 19 August 1936).

The aerial is likely to have been a “Marconi T Antenna” with an effective antenna length of about 50 m (Leach pers. comm.). The central feeder wire would have been attached somewhere above the generator building. This building also functioned as the wireless

A radio beacon provides a continuous transmission of an identifying morse signal at a low frequency for direction-finding by ships. The radio beacon's proposed specifications were for two AM transmitters consisting of CW (morse) with the letters ZLOA or ZLOG at 670 KHz. It is not exactly clear from the records what ultimately was installed. The gazette notice suggests one beacon putting out ZLOA at 297.5 KHz (1008 metres wavelength) (NZ Gazette 67: 2290, 7 Oct 1937. However, the antenna wire was designed to resonate at 680 KHz (Leach pers. comm.).

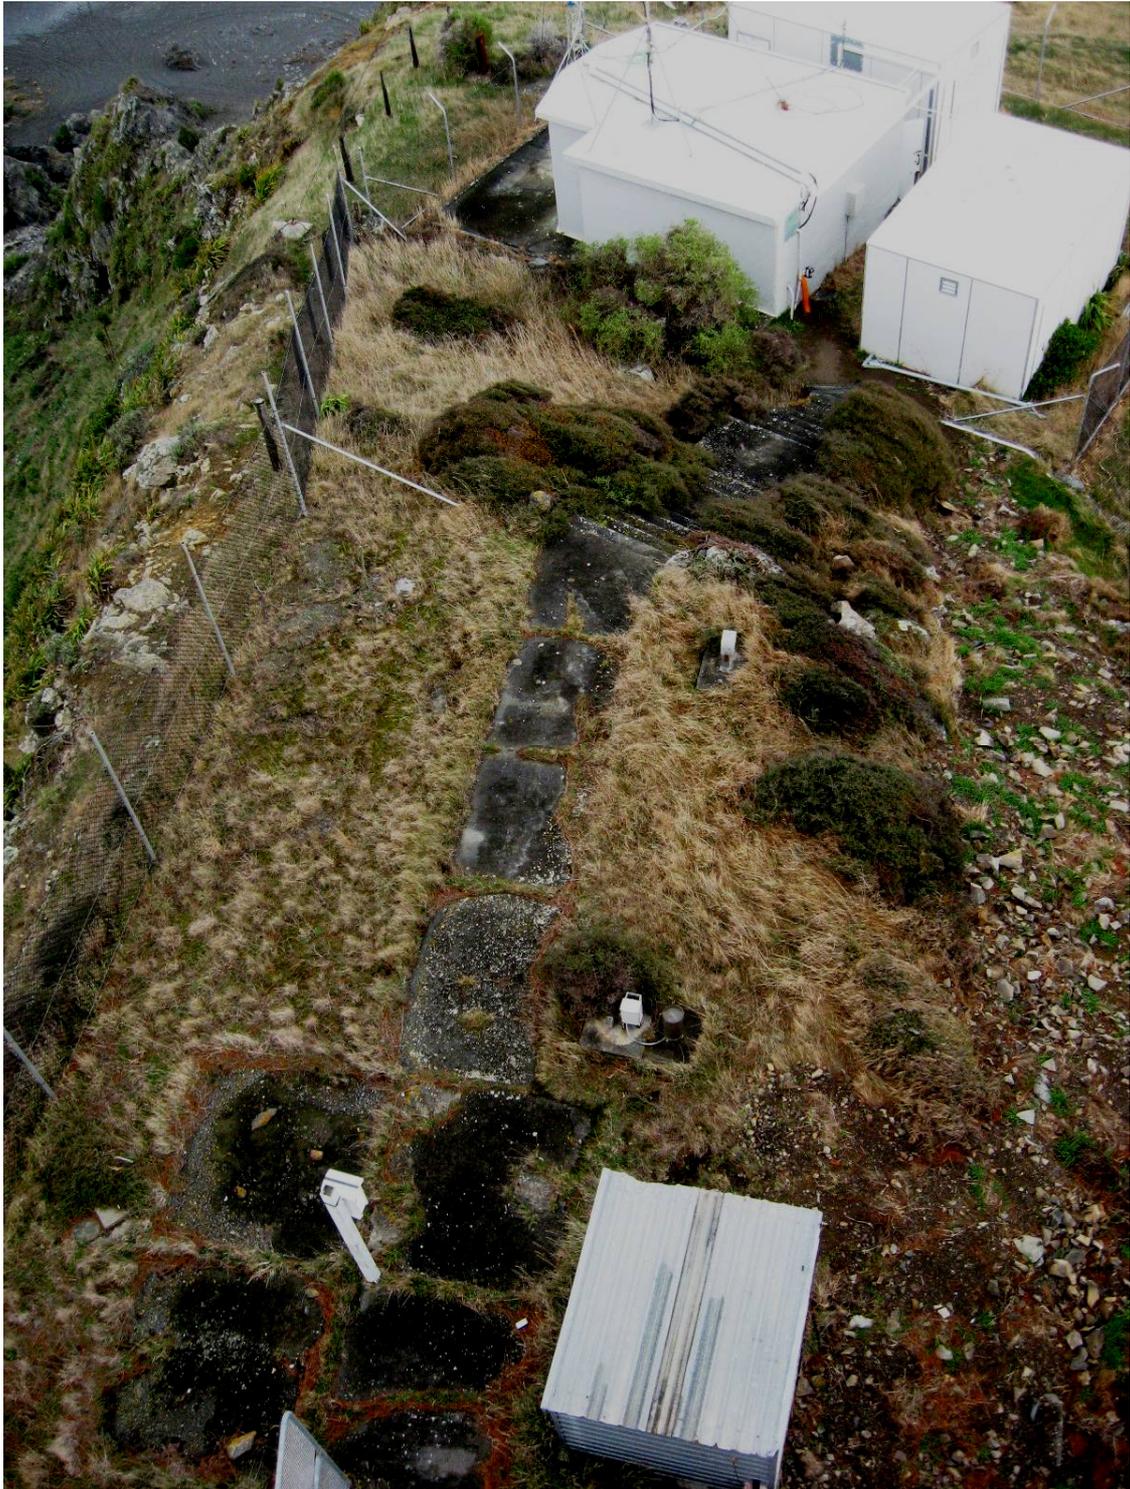
Fig. 20. The signal platform (at bottom), path and steps dated 1939 and the concrete radar building centre top. The WW II barracks would have extended out to the right where the near NIWA hut stands.

North of the lighthouse and within the fenced NIWA compound are a number of concrete structures. The 1941 photograph shows steps rising to a natural mound, a path and a square platform in a bright colour (new concrete) to the south-south-east of the lighthouse. This feature is still extant with two flights of 1.2 m wide steps and a path ('1939' marked in the concrete) which leads to a concrete platform overall 4 m square made up of four 2 m-square pads (Figs 20, 21).
