## **Baring Head, Ōrua Pouanui**

### **Archaeological Survey for Wellington Regional Council**

Kevin L. Jones  
Kevin L. Jones Archaeologist Ltd

25 June 2010

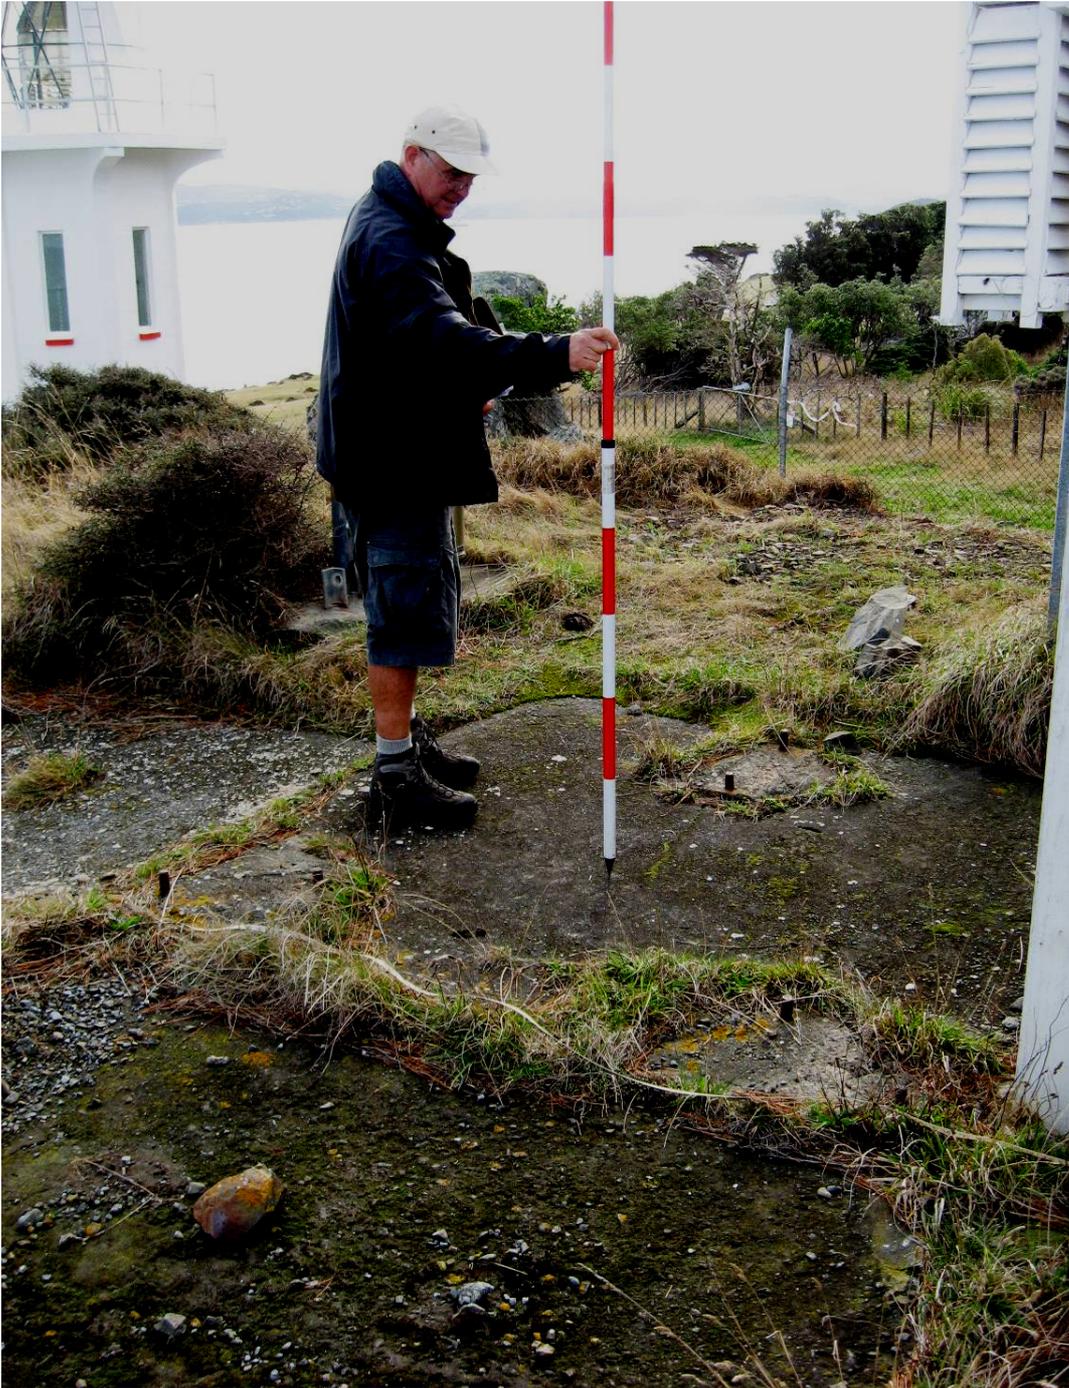
Fig. 21. The radial arrangement of bolts for the brackets holding the signal mast.

On the north-eastern pad are three sets of two 7/8-inch bolts set in a radial triangular pattern with an impression on the concrete surface of a short length of steel RSJ held down by the bolts. This is probably the ground bracket for the white-painted steel or wood *signal mast* about 12 m tall with crosstrees which can be seen in Figure 3.

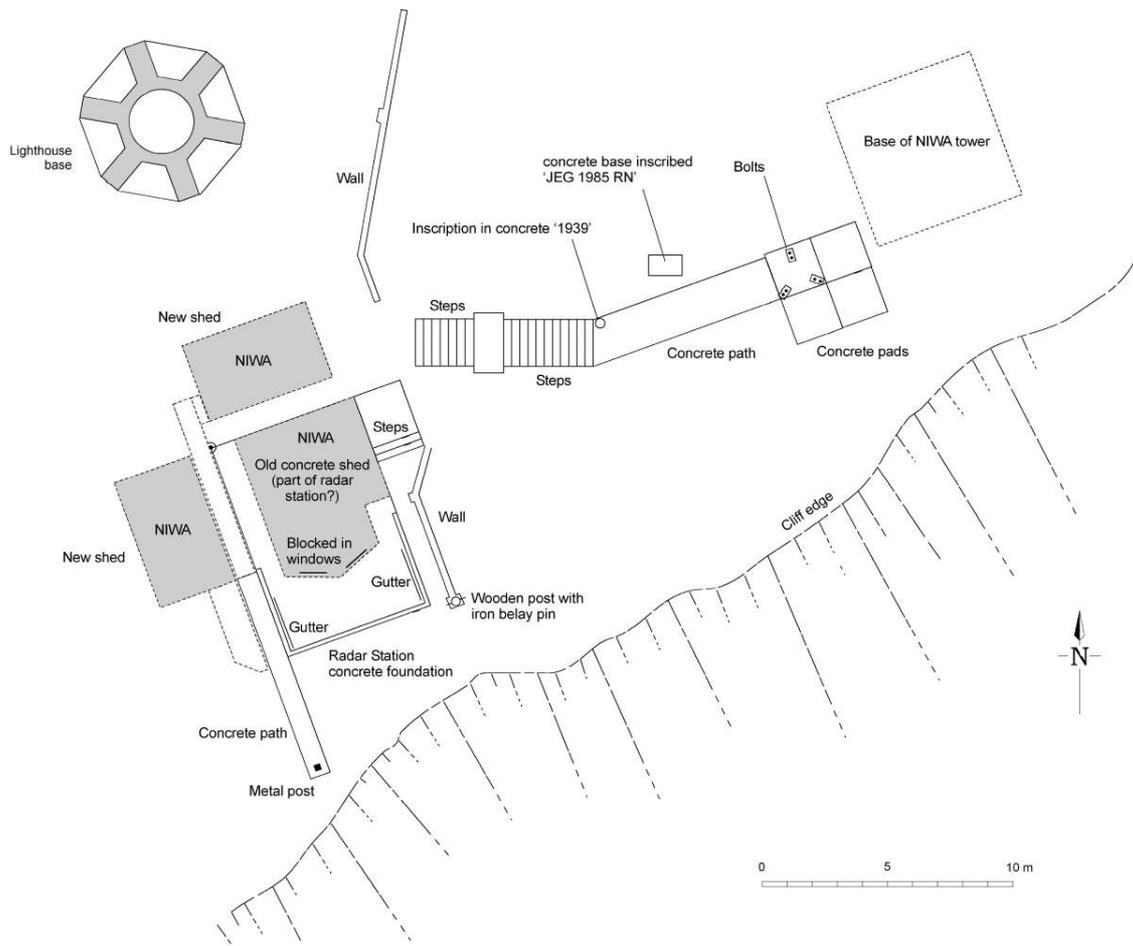
Fig. 22. The radar station and signal platform area. Tape and compass plan. Kevin L. Jones and Chris Edkins May 2010.

The radar building showing in 1941 and the 1950s is the surviving concrete building (now a NIWA lab) with the surrounding pad (see Figs 2, 3, 22, 23).

The porch-like extensions survive as: 1) a foyer/storage area on the east of the NIWA lab and 2) a section of truncated wall base on the west side. The north end of the concrete building has been infilled with sheet cladding and may have connected to the wooden barracks to the north.

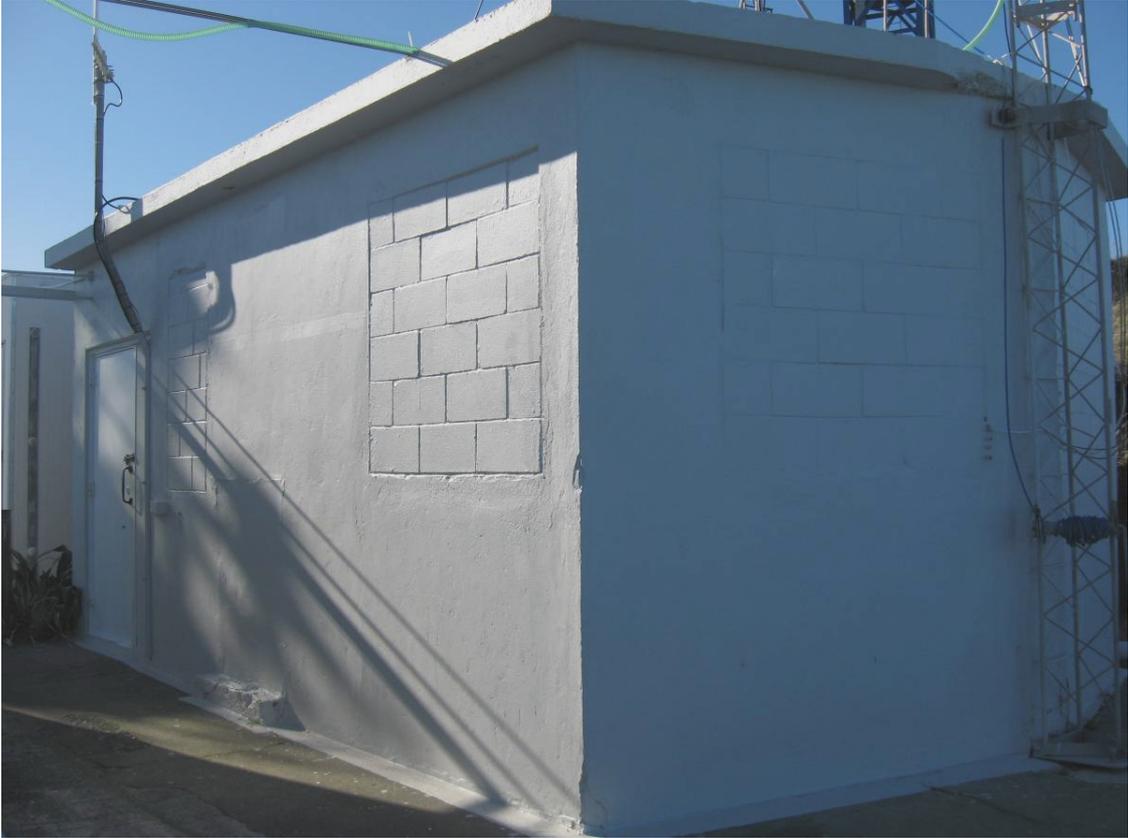
Fig. 23. The WWII radar building from the south-west with the blocked-in bow window and other window apertures.

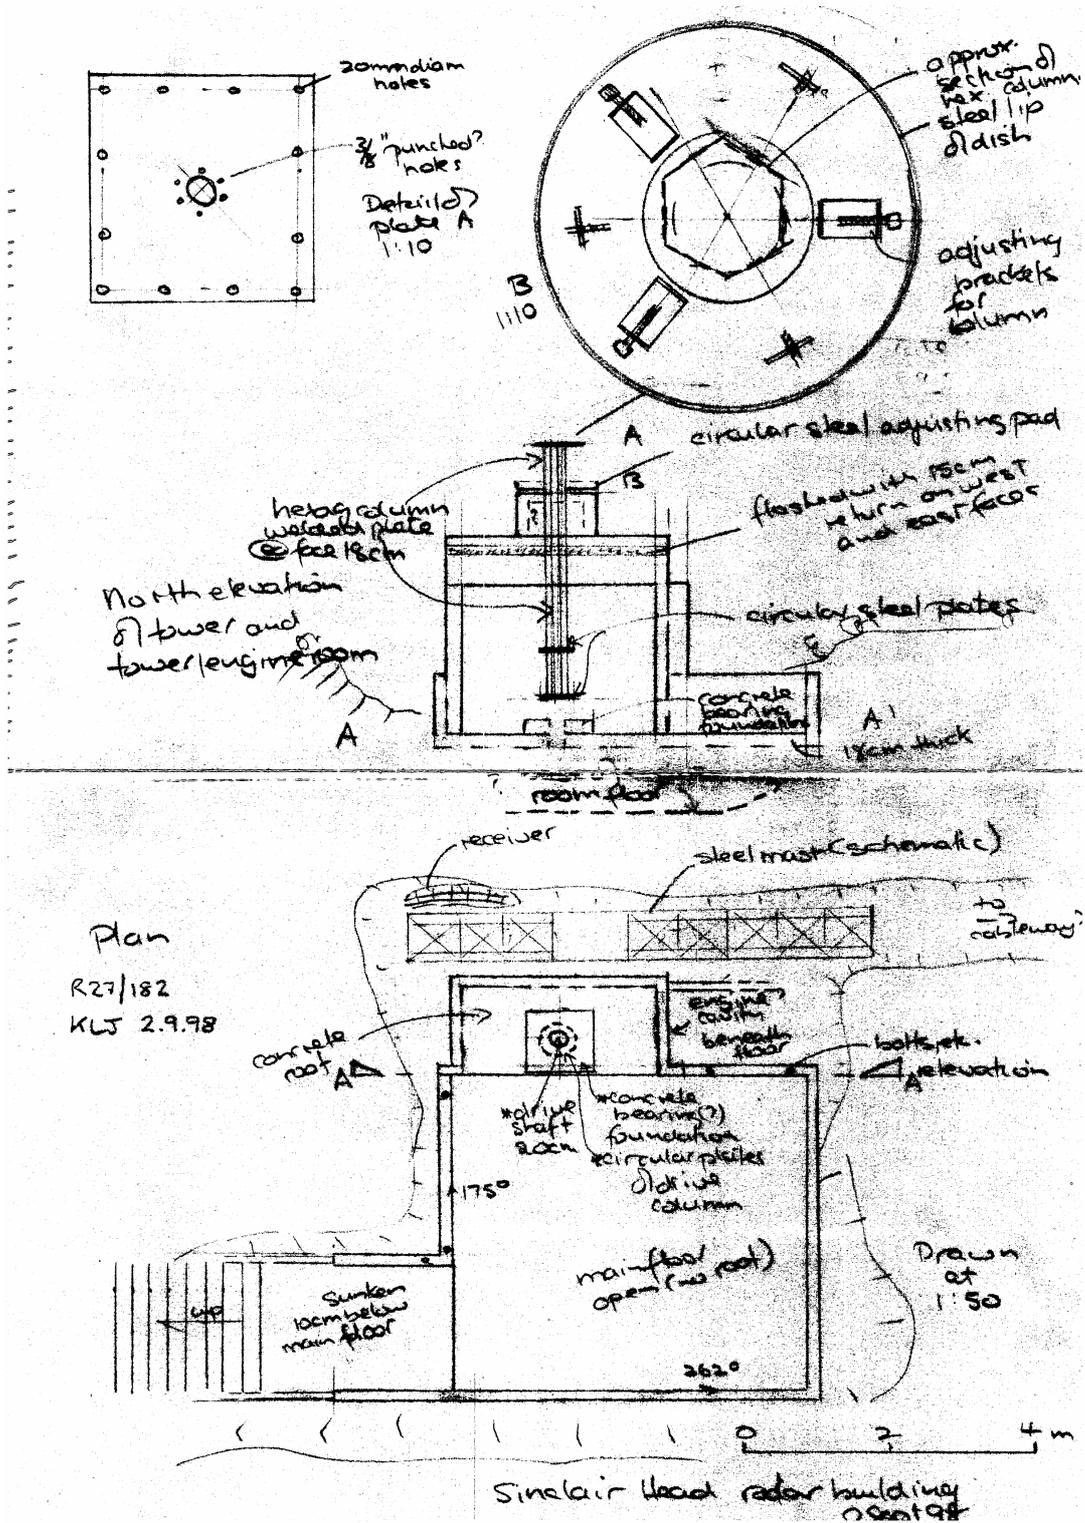
Fig. 24. Ruins of army radar station at Sinclair Head 1942-1943(?), probably similar in concept to that built at Baring Head.

There is a more or less complete radar station at Sinclair Head (R27/182 observation post). This will have been similar to the Baring Head installation of 1943-1944 except that the former had its own power supply.

The Sinclair Head radar facility is next to and landward from a conventional observation post. The radar station there is a concrete-floored building about 5 m square in plan with an adjoining low (3 m high) rectangular tower (Fig. 24). The tower held a vertical hexagonal drive shaft made of steel plate for the rotating transmitter/receiver array. The shaft had a circular plate and adjusting brackets for the aerial at the top and, at the bottom, a petrol engine below ground level. (Baring Head had an independent supply of power from the generator.) The rotating mast for the array was about 7 m long and consisted of a lattice of bolted angle iron.

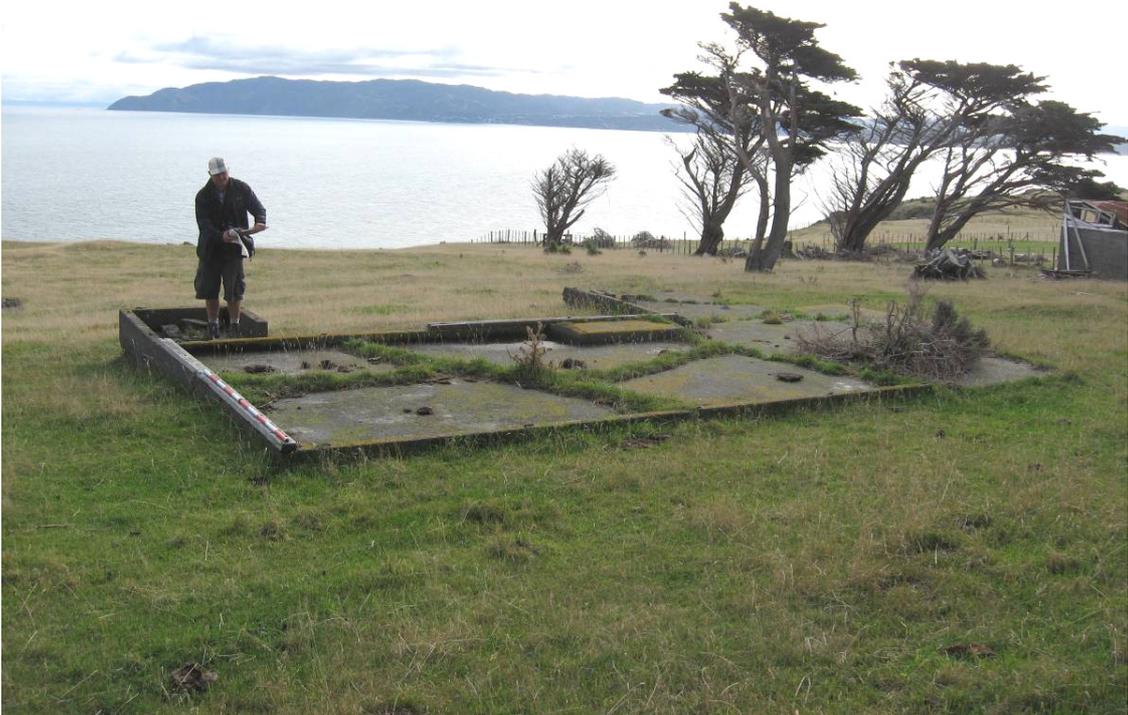
Fig. 25. Foundations of the WAAC barracks, western extension of shelter belt beyond Sinclair Head and western Cook Strait in the distance.

There were probably *barracks incorporated with the radar room* at the radar station (there is a septic tank to the downhill to the west) and a second barracks built after 1941 near the entrance to the lighthouse reserve and west of the army road (see Fig. 4). The latter does not show in the 1941 aerial photograph. It does show as a foundation in Figure 3. It survives today as a concrete slab with a rim with bolts for the wooden frame (Fig. 25) similar to those by the radar station. It was probably a *Women's Auxiliary Army Corps (WAAC) barracks* for the women running signalling and the radar station in 1942-1945.
