New Zealand Historic Places Trust Pouhere Taonga

Research Report on Heritage Features

Baring Head, Wellington

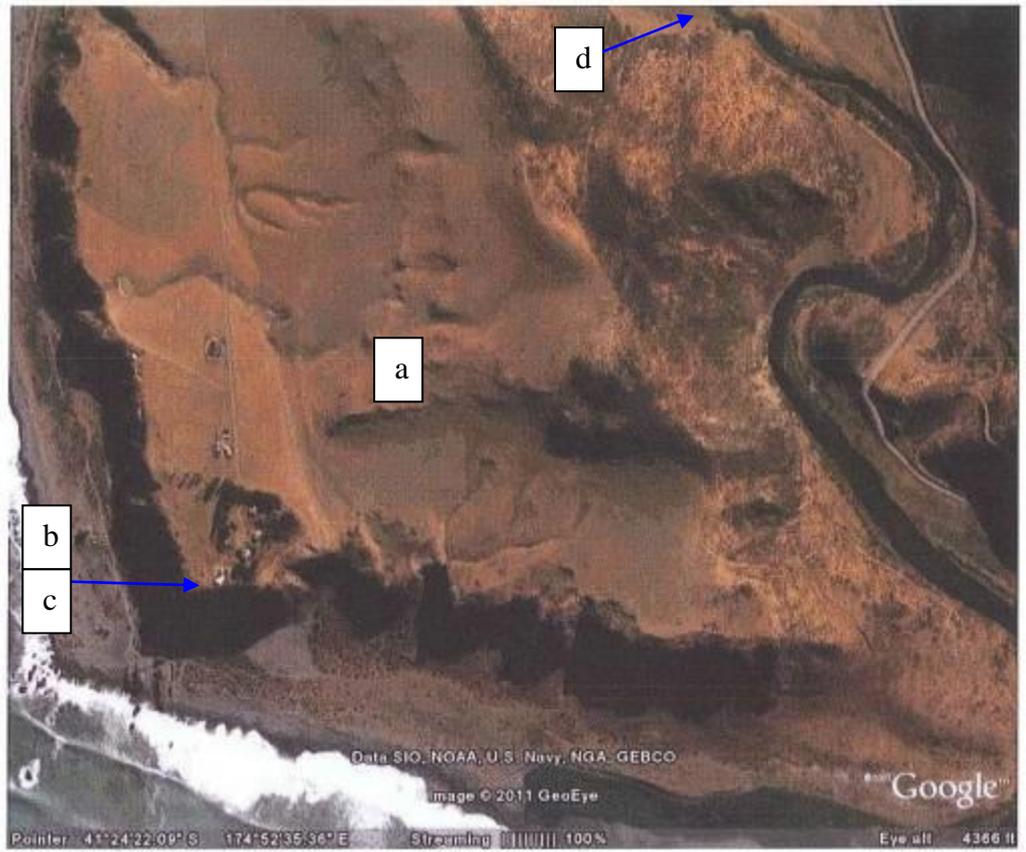
Figure 1: Showing the position of a) the Fortress Observation Post, b) Lighthouse station, c) the lighthouse, NIWA station and World War II signal station remains, d) pumphouse.

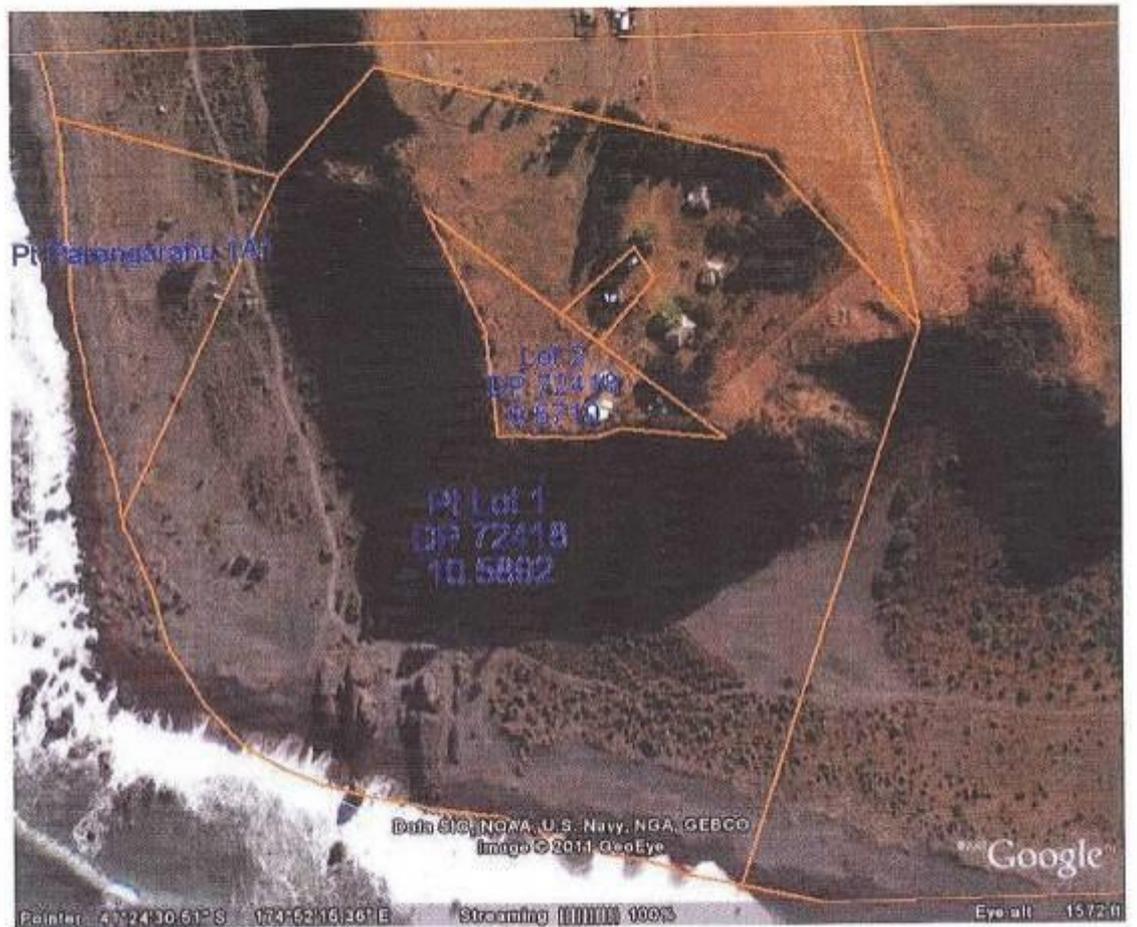
Figure 2: Showing the land boundaries in and around the lighthouse station at Baring Head.

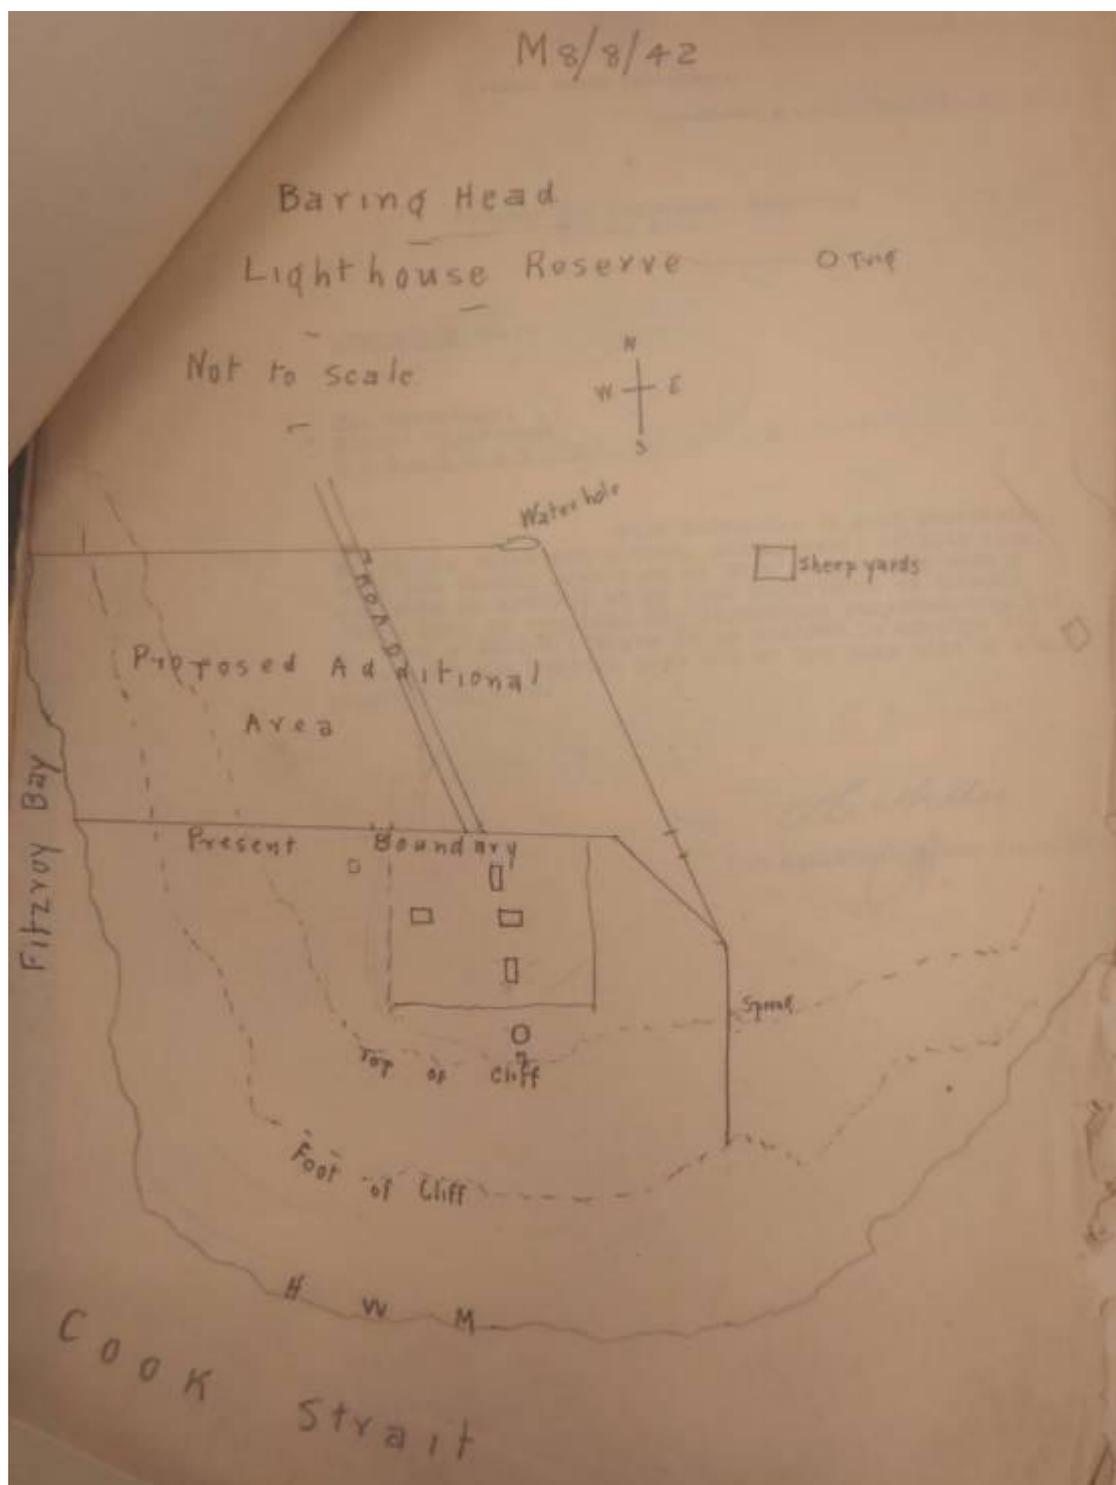
Figure 1: Survey plan of the proposed additional area to be added to the lighthouse keepers' accommodation complex in 1948, showing position of buildings on the site at that time (Baring Head 1928-52, M1 687 8/8/42, New Zealand Archives)

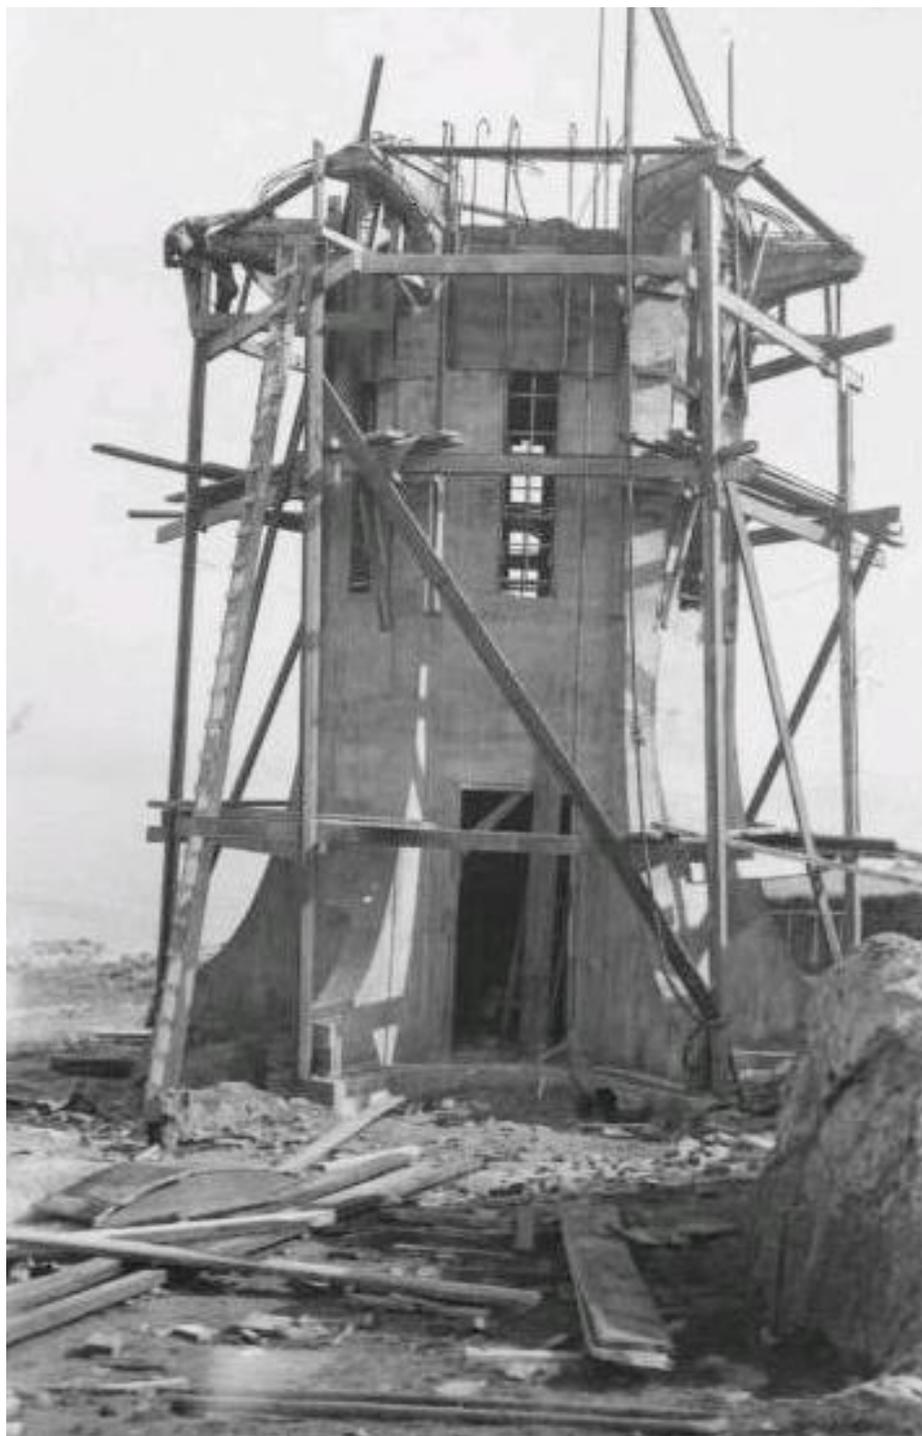
Figure 4: Baring Head Lighthouse tower under construction in March 1934. (EP-Transport-Shipping-Lighthouses-02, Alexander Turnbull Library)

The site for the tower was moved once, east, after solid foundations could not be found 2.5 metres down.³⁹ Work came to a halt during winter, with Jackson complaining that the wind was sometimes so strong that his men could not stand up.⁴⁰

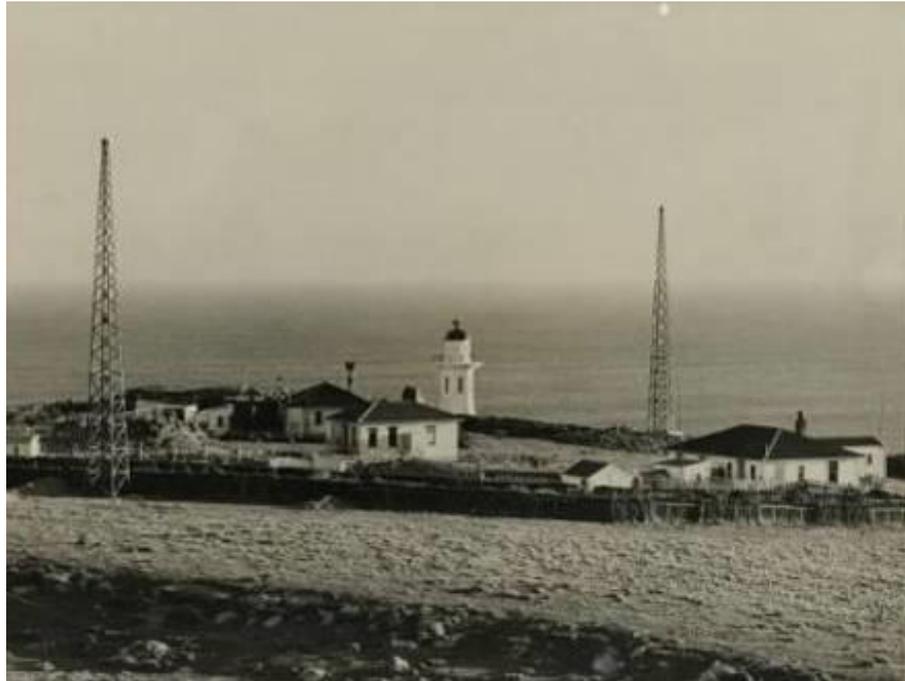
Figure 5: Baring Head Lighthouse Complex. Photographed 17 August 1937 by an unidentified Evening Post staff photographer, (EP-Transport-Shipping-Lighthouses-01, Alexander Turnbull Library).

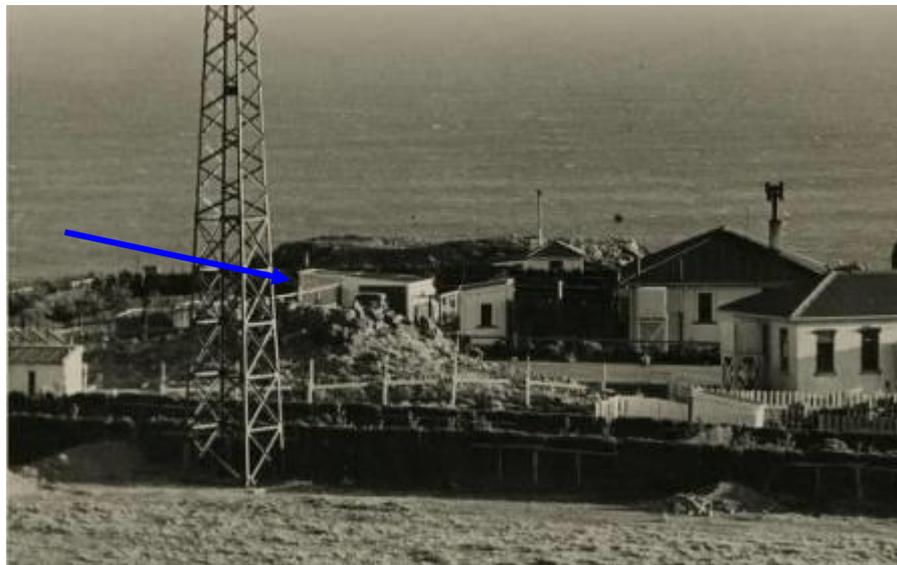
Figure 6: A detail of the above photograph showing second garage (signified with an arrow) and another building no longer extant at extreme left of photograph. Towards the top of the photograph another building has not been identified. Photographed 17 August 1937 by an unidentified Evening Post staff photographer. (EP-Transport-Shipping-Lighthouses-01, Alexander Turnbull Library.)

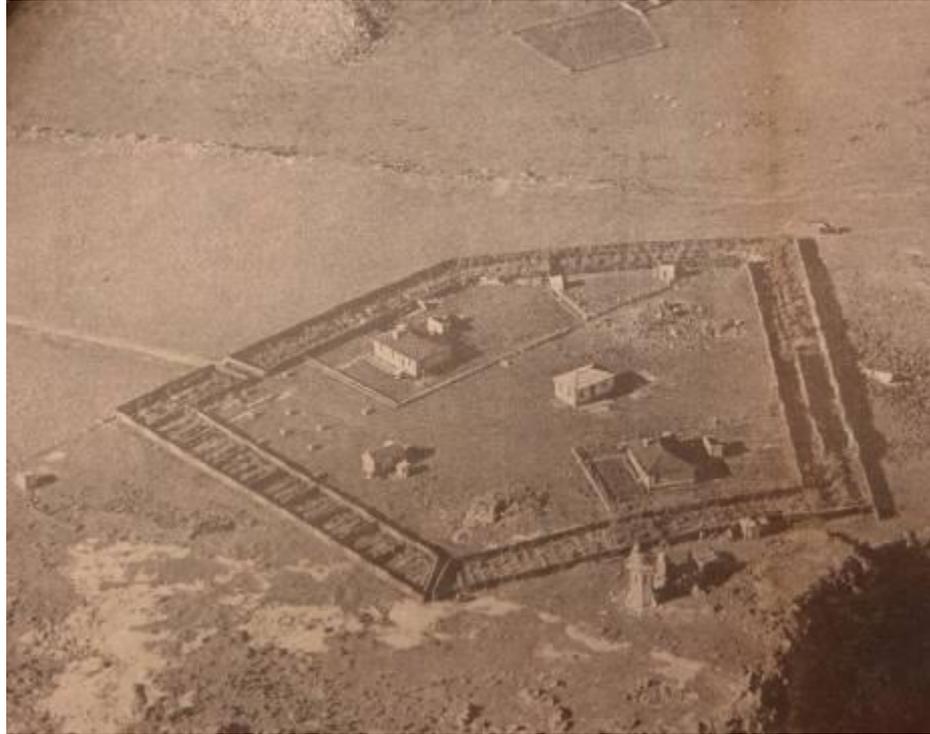
Figure 7: Aerial photograph showing the lighthouse complex in 1935. Photographed 1935 by an unidentified photographer, from the *Evening Post* April 9 1935. (Baring Head - origin - general, M1 769 8/62/1, Archives New Zealand).

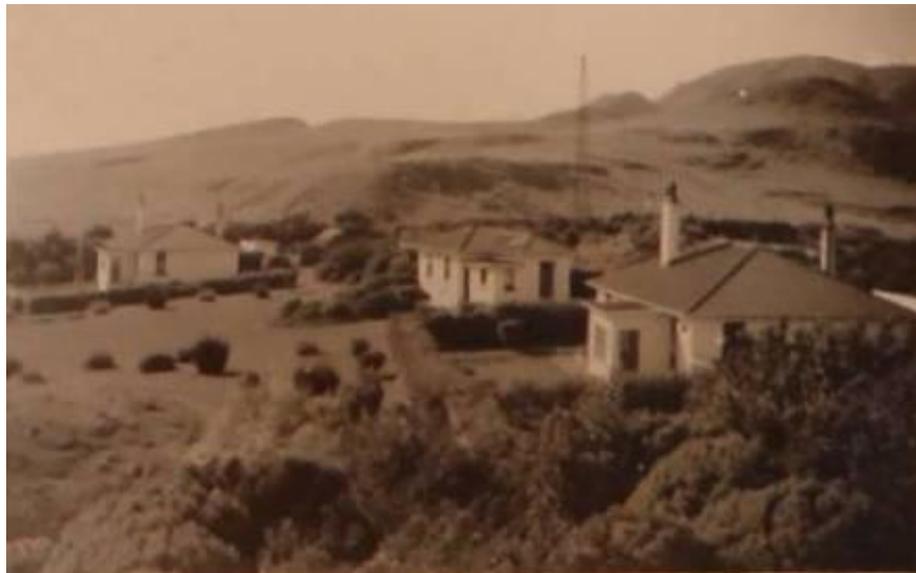
Figure 8: The lighthouse keeper's houses showing additions to the front of the houses. Date unknown (Album, ABPL W5221 8848 22E, Archives New Zealand).

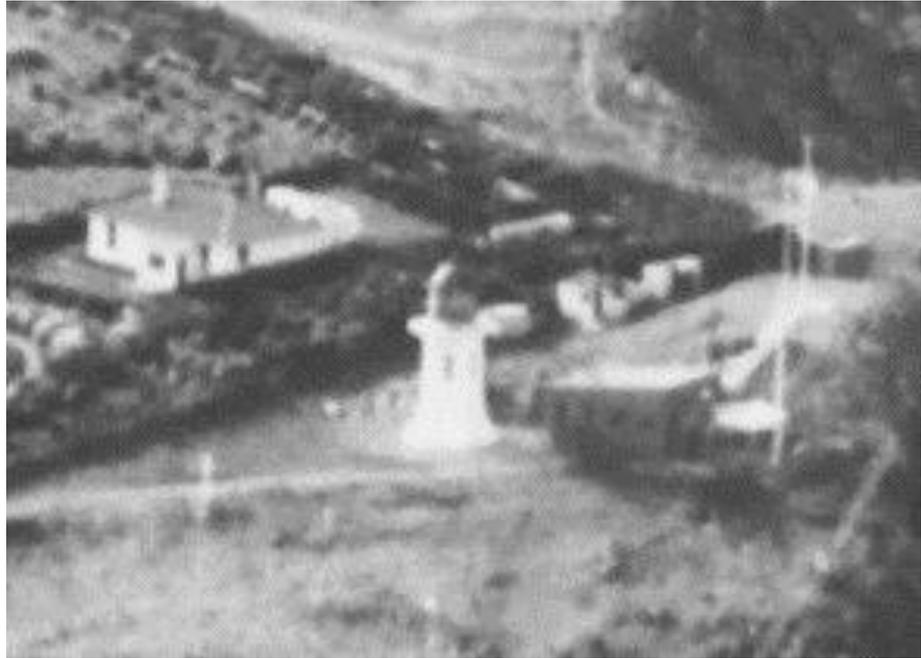
Figure 9: This indistinct image shows the lighthouse with the naval signal station close by. A flagstaff and what appears to be radar apparatus are alongside. There are numerous sheds up against the fence. Date unknown. (Album, ABPL W5221 8848 22E, Archives New Zealand).

Baring Head was also the site of a naval signal station (also known as a Port War Signal Station [PWSS]) and the concrete foundations of that structure are located in front of, and under, the current NIWA station, very close to the lighthouse itself and the edge of the cliff. The building consisted of a rectangular structure with a lookout in front. A photograph from the period suggests that the radar apparatus associated with this station was on the eastern side of the building. The complex operated until 7 September 1945, and was staffed, at

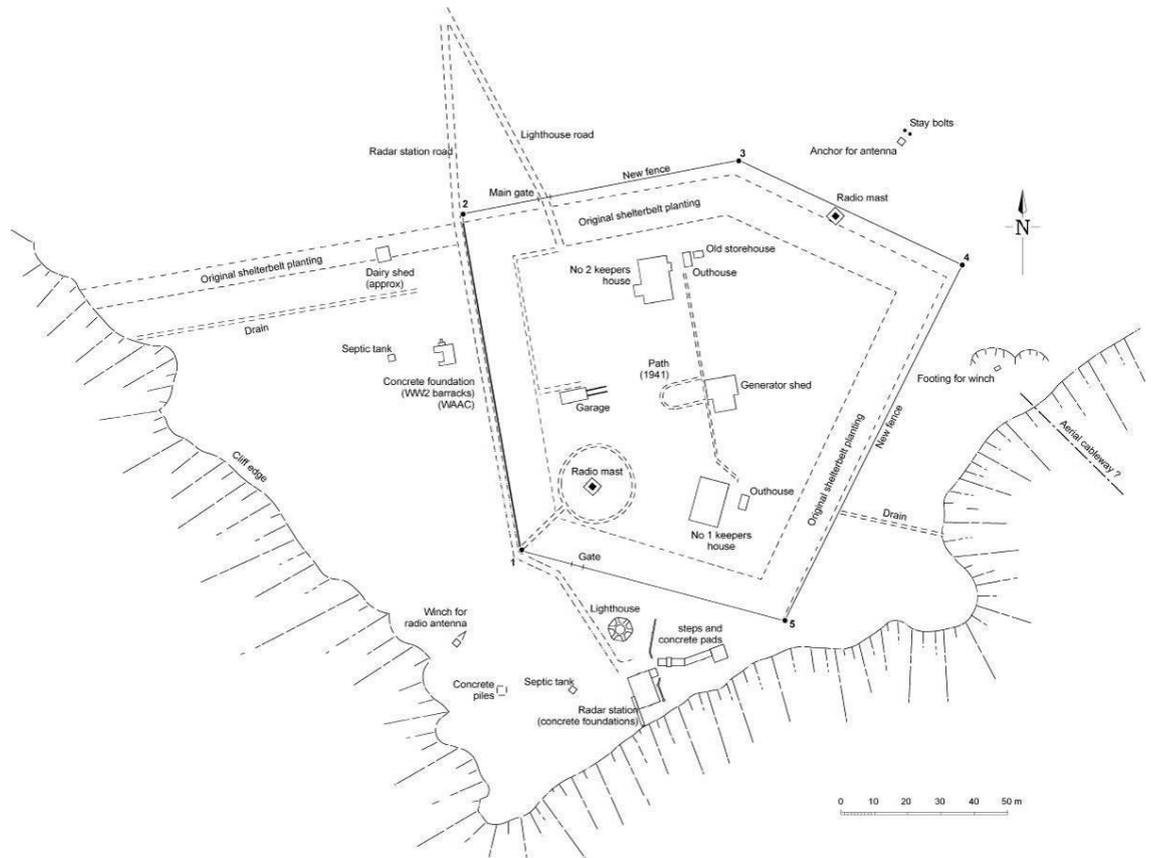
Figure 10: Baring Head Lighthouse Settlement area. Tape and compass plan, Kevin L. Jones and Chris Edkins, Courtesy Kevin L. Jones and Wellington Regional Council.¹⁰³

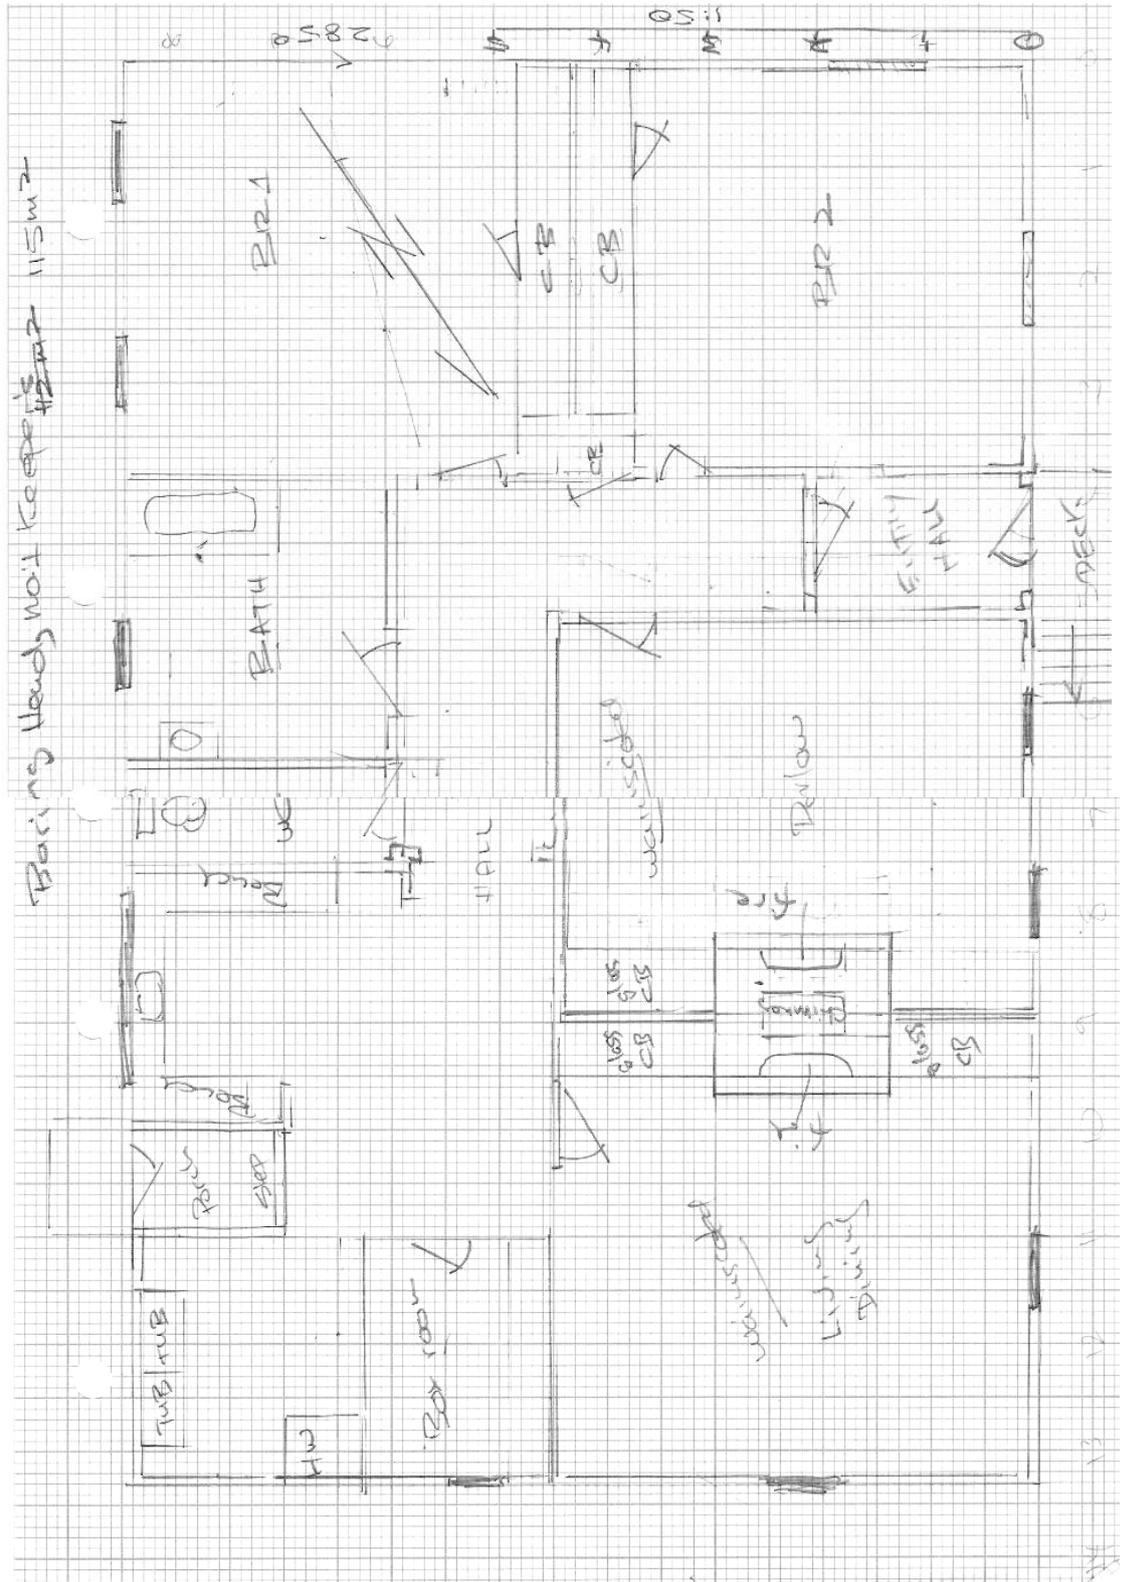
Figure 11: Interior plan of the Number One Lighthouse Keepers' House. Courtesy Kevin L. Jones and Wellington Regional Council.¹⁰⁴

The front entrance to the house is through a door in the west elevation, which is reached by a short set of stairs and deck outside the door. There are two rooms off the front corridor. A small vestibule is created by a second door, with six panes of frosted glass in the upper panels. The first room, to the left of the corridor and past the second set of doors, was a sitting or dining room. There are two sets of windows lighting this room - double hung sashes with two lights below and six above - and this style of window is used throughout the house unless otherwise noted. There is a fireplace in this room which is backed by another fireplace in the other sitting room. Both these rooms have original varnished wooden joinery in them. The fireplace is flanked to the right by a cupboard which is again mirrored in the other parlour. There are four panelled doors.

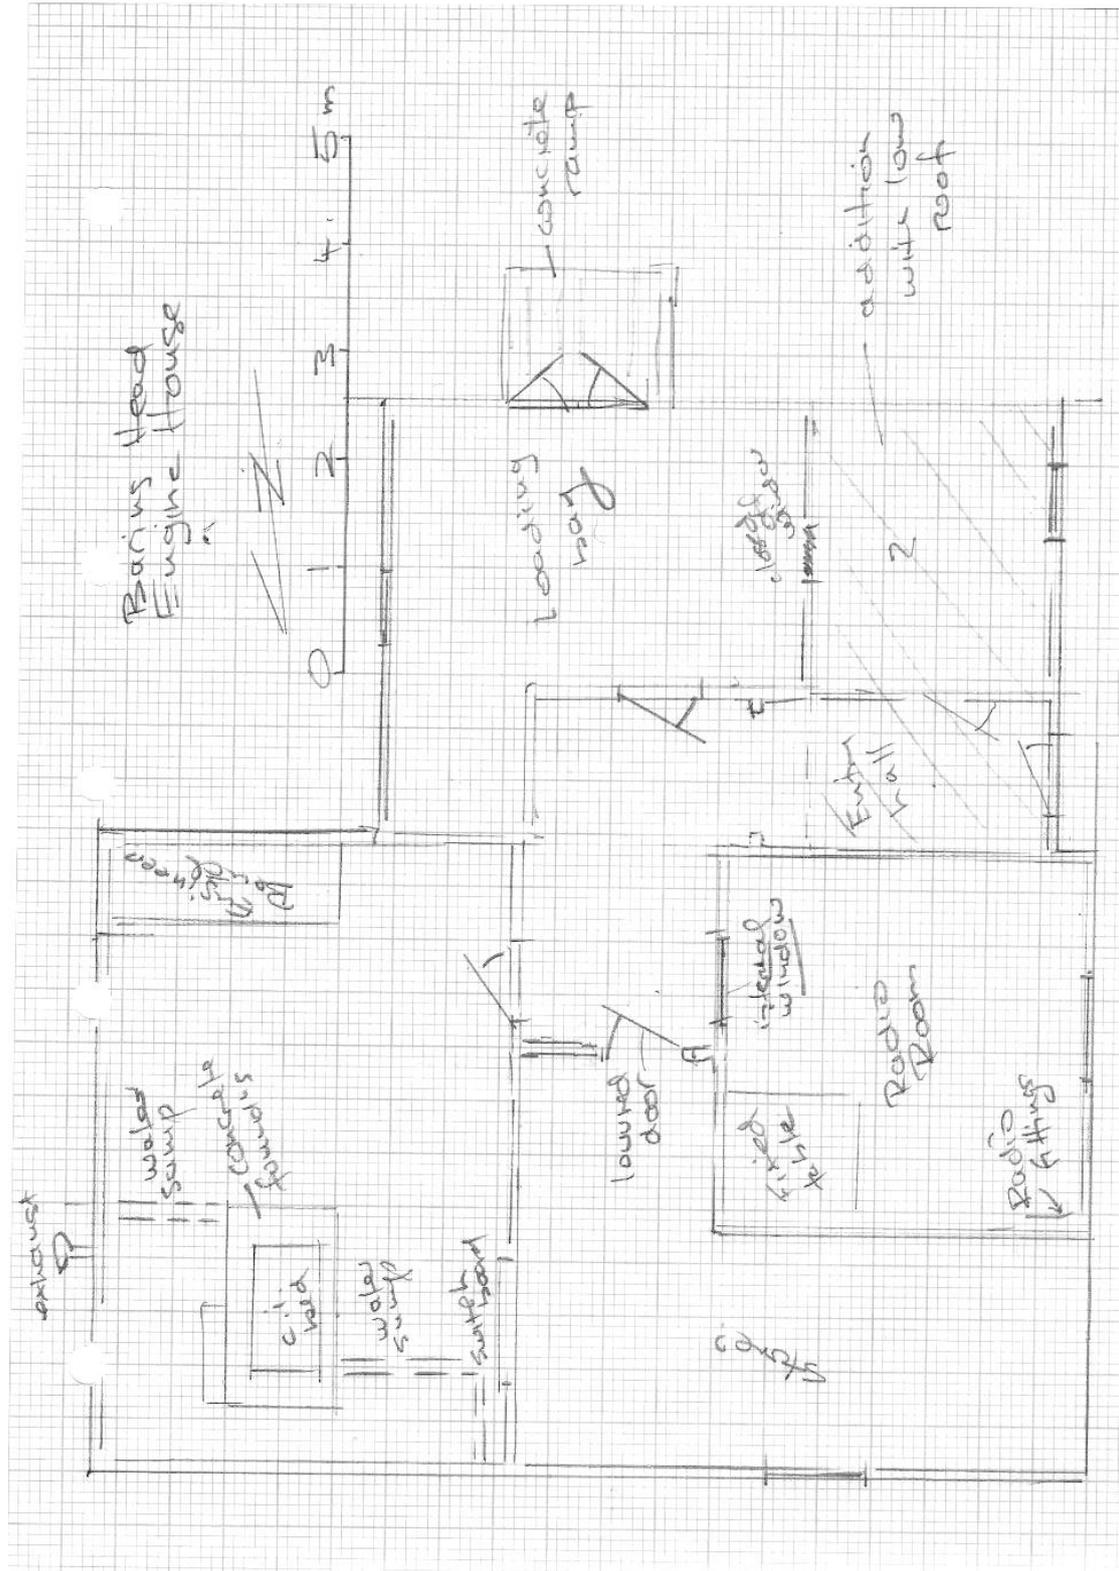
Figure 12: Interior plan of the generator or power house incorporating the radio room. Courtesy Kevin L. Jones and Wellington Regional Council.¹⁰⁵

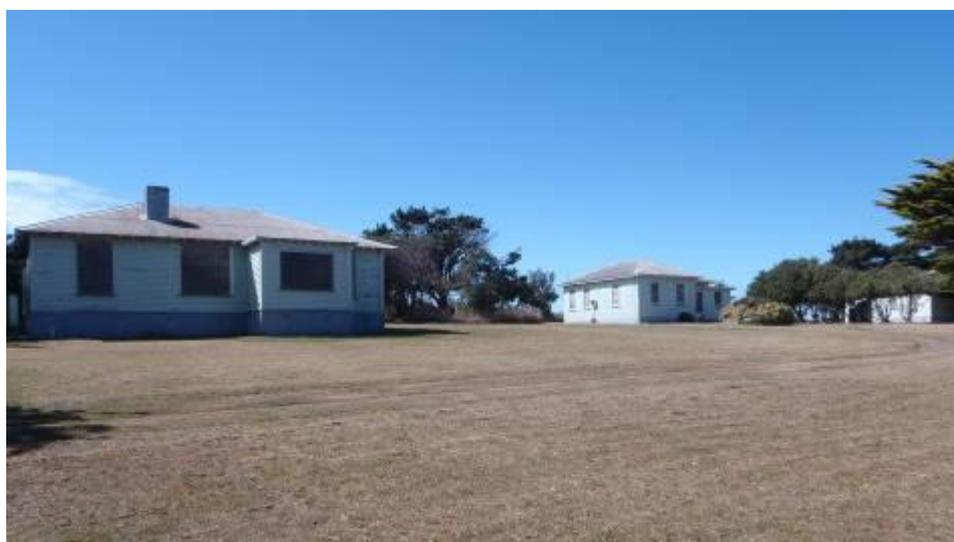
Figure 14: Relationship between the three main structures in the accommodation complex, with from left to right Number Two Lighthouse Keepers' House, the diesel generator building and Number One Lighthouse Keeper's House.

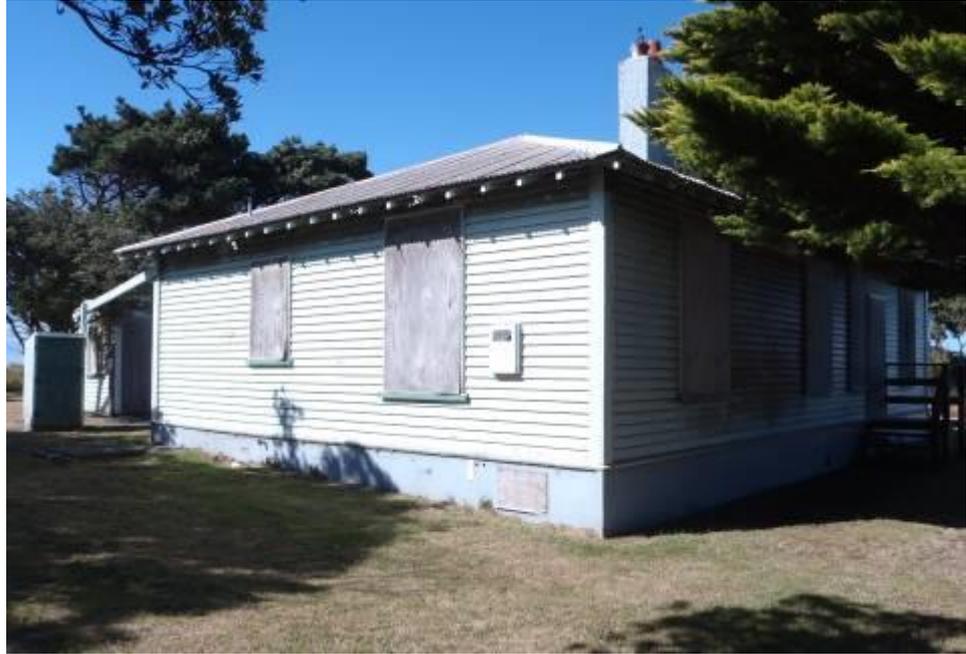
Figure 15: Number One Lighthouse Keepers' House from the southeast, with outhouse and pump house visible at the rear.

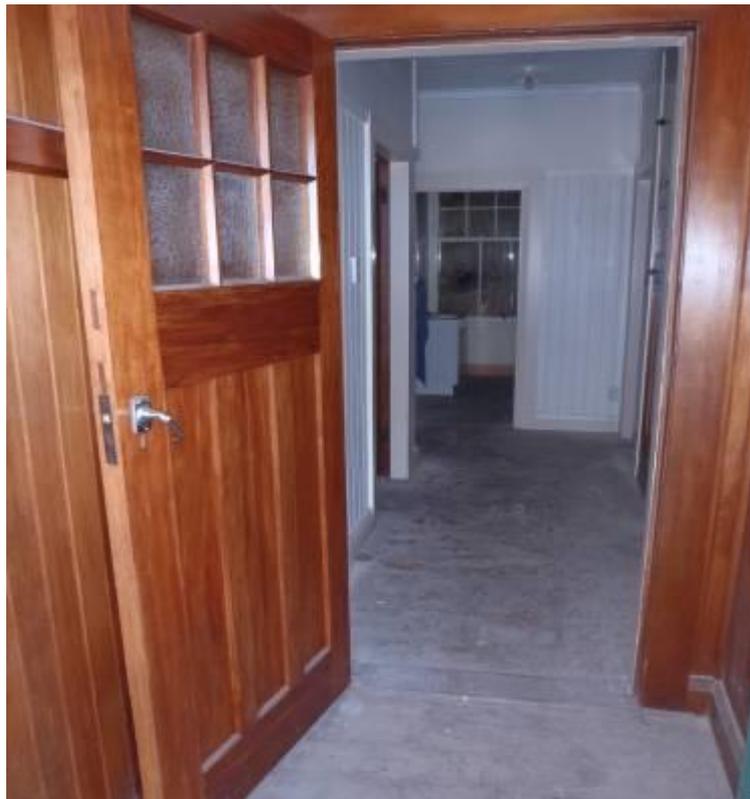
Figure 16: Interior of Number One Lighthouse Keepers' House showing vestibule, hall and tongue and groove wood panelling.

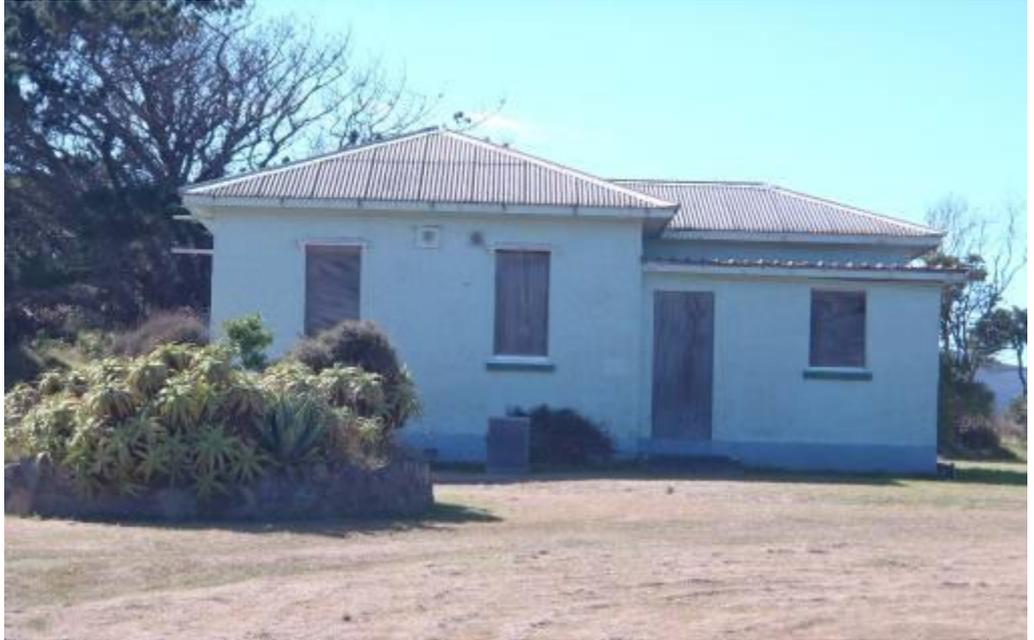
Figure 17: Diesel generator building with circular garden in the foreground.

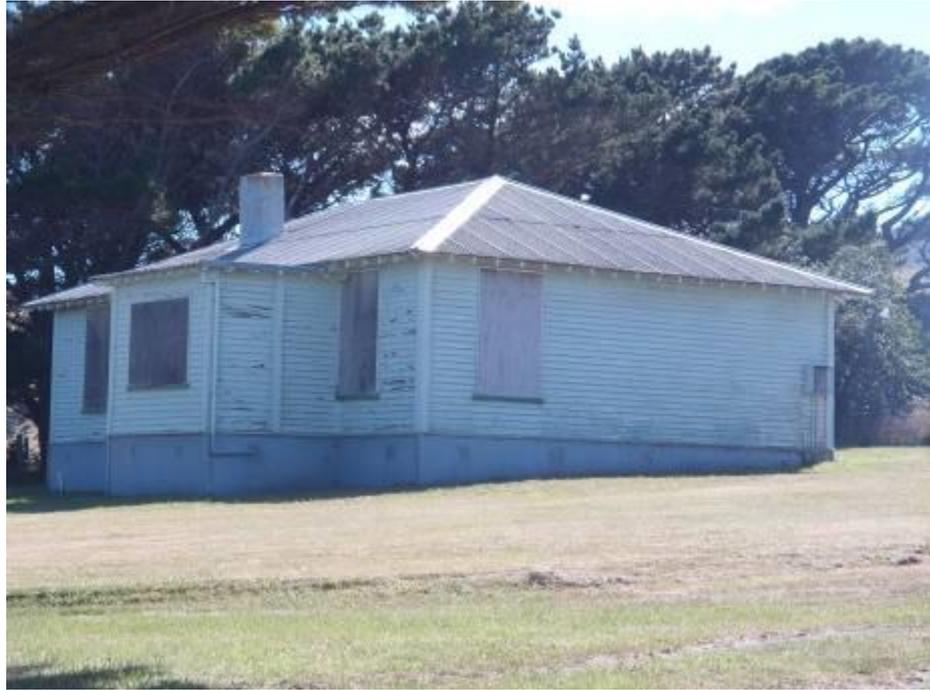
Figure 19: Number Two Lighthouse Keepers' House showing the additional bedroom on the front elevation of the house.

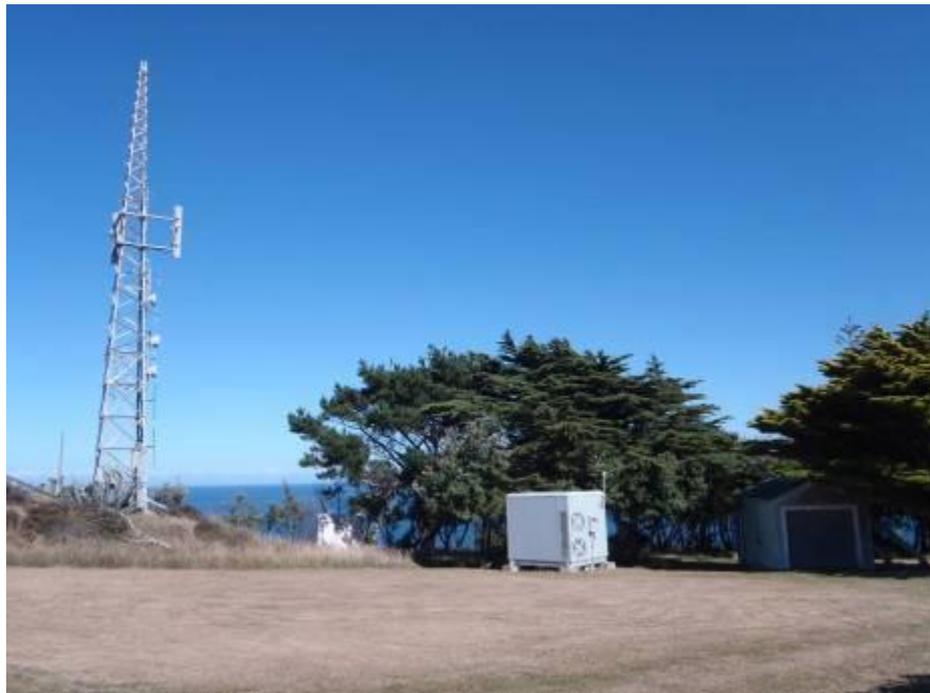
Figure 20: View from the generator building with the garage on the right, modern NIWA structure in the centre and the maintained telecommunications tower to the left.

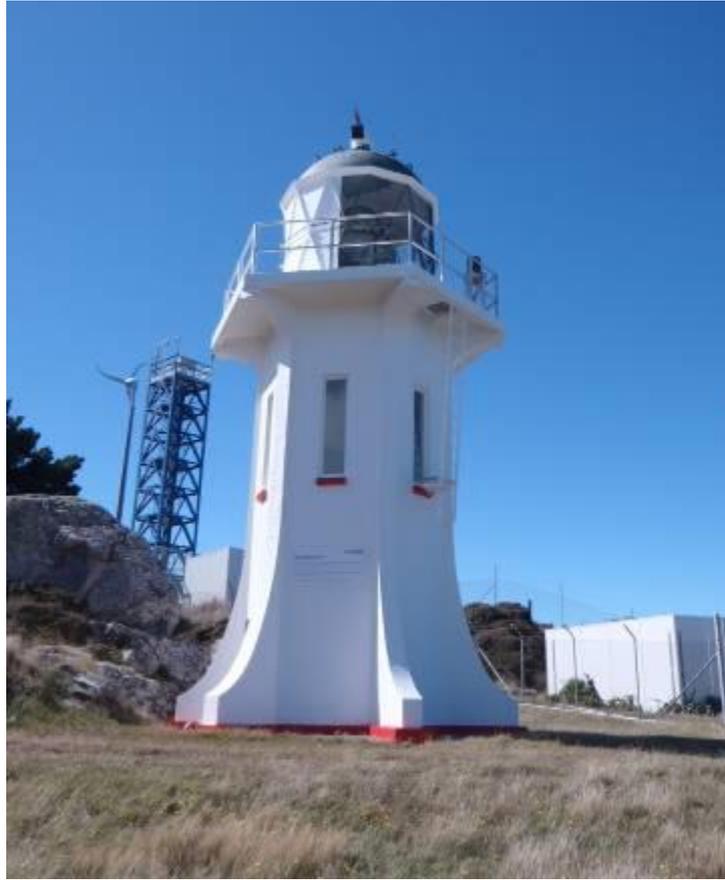
Figure 22: The Lighthouse viewed from the southwest, showing its relationship with the NIWA station behind.

Outside the shelterbelt area, and to the south of the complex of lighthouse keepers' houses is the lighthouse itself, enclosed within a fenced area. The lighthouse is a 1930s reinforced concrete structure. It has flared buttresses, which give the structure additional stiffening and a copper roof on a dome. The unlined interior gives internal access to the lantern. The foundations of the lighthouse are 2.5m deep, and the lighthouse is 12 metres tall, rising 87 metres from the beach below. Described in a newspaper report of 1935, it was stated that the lighthouse was designed 'somewhat differently' from the standard lighthouse design, 'the architects having paid special attention to its appearance and having added several features to improve its profile.'⁹⁵ The balcony around the lighthouse was made as small as possible, with a small ladder leading to the balcony instead of having a door leading out of the lantern chamber, as was the usual practice.⁹⁶

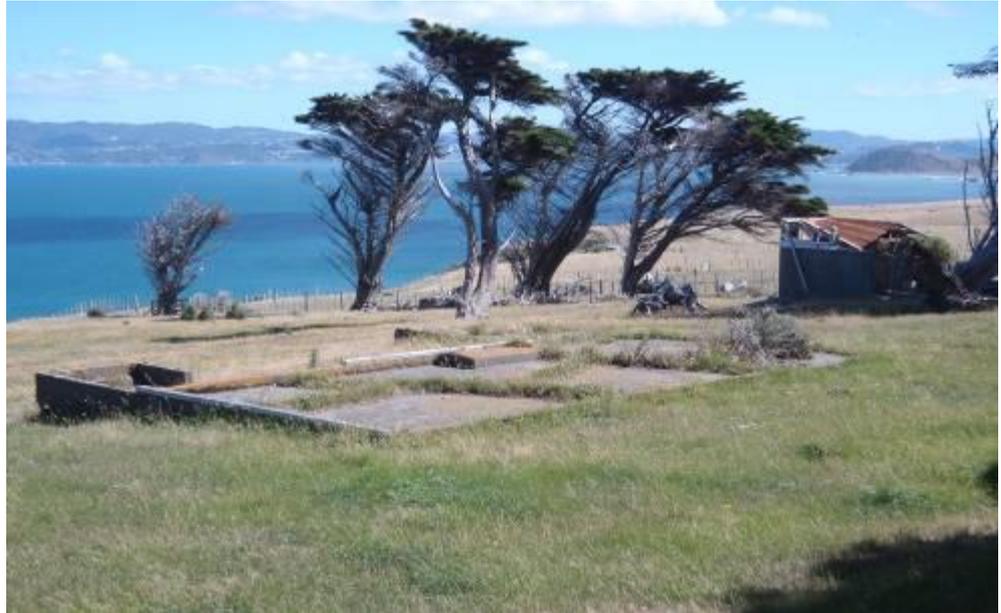
Figure 23: Foundations of the WAAC barracks.

To the west of the garage and outside the station complex is the WAAC barracks, built for women running the signal station and radar in 1942-45.⁹⁸ Probably built of timber, it was reduced to its concrete foundations by the time an aerial photograph was taken of it in the 1950s, suggesting that it was demolished or removed reasonably shortly after the war ended.⁹⁹

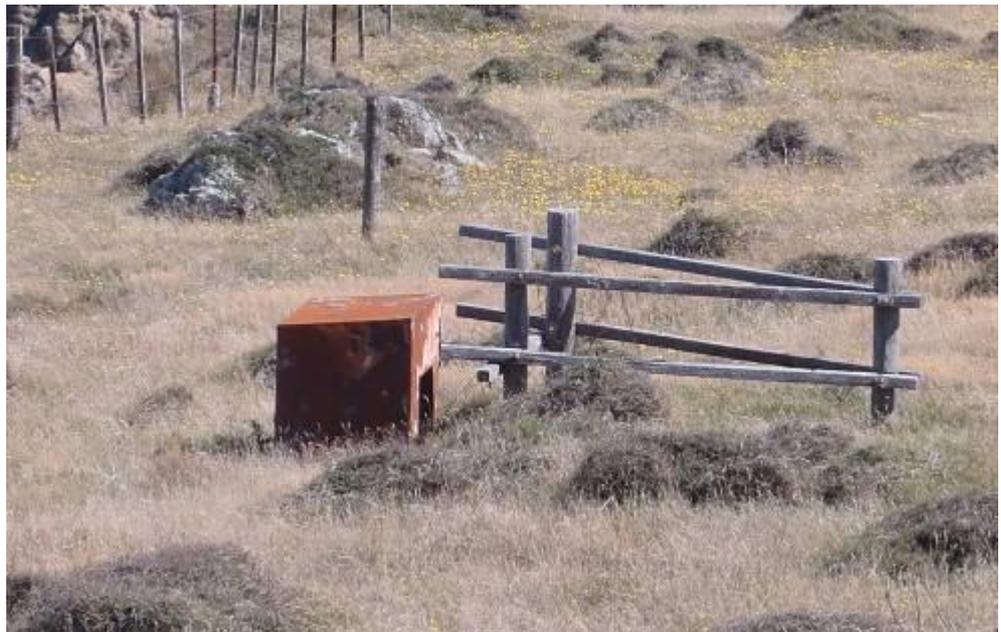
Figure 24: The winch. This has a wing fence surrounding it to protect it from stock.

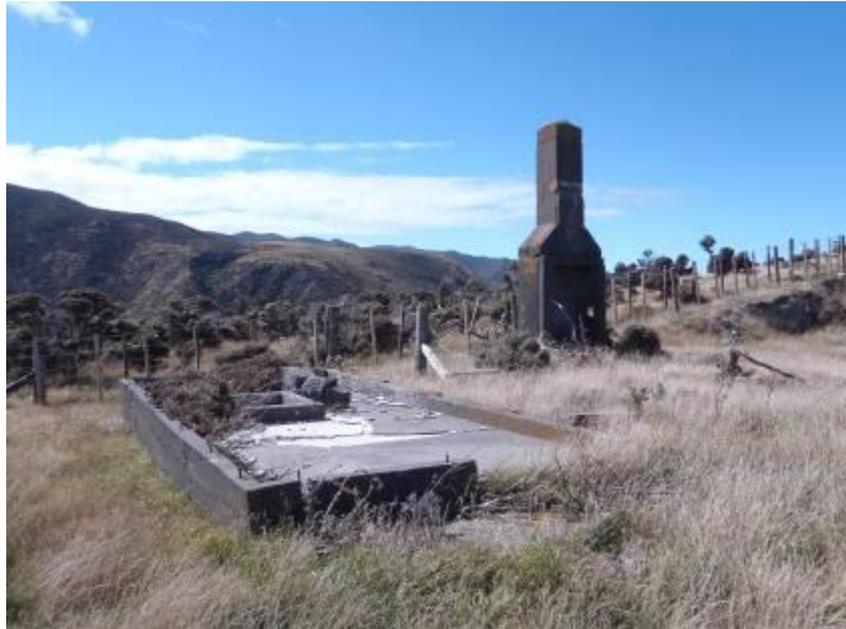
Figure 25: The site of what was the accommodation barracks and ablution block for the men who staffed the observation post. The barracks is assumed to have been constructed of timber and is no longer evident bar the concrete chimney. The ablutions block retains its concrete foundations, floor and drains, but is likewise missing its timber structure.

A short distance north, and down the hill, is the site of what was the accommodation barracks and ablution block for the men who staffed the observation post. Built in 1940, the barracks is assumed to have been constructed of timber and is no longer evident bar a concrete chimney. The ablutions block retains its concrete foundations, floor and drains, but is likewise missing its timber structure. These buildings have all been inspected and described in a report to the Greater Wellington Regional Council by an engineer

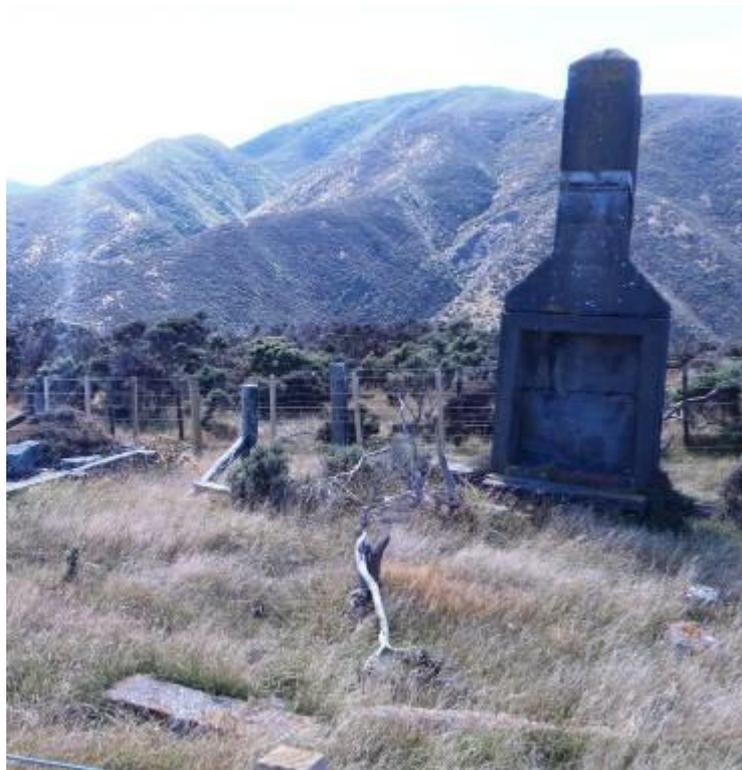
Figure 26: The site of what was the accommodation barracks, with concrete foundations visible at the left and lower half of the photograph.

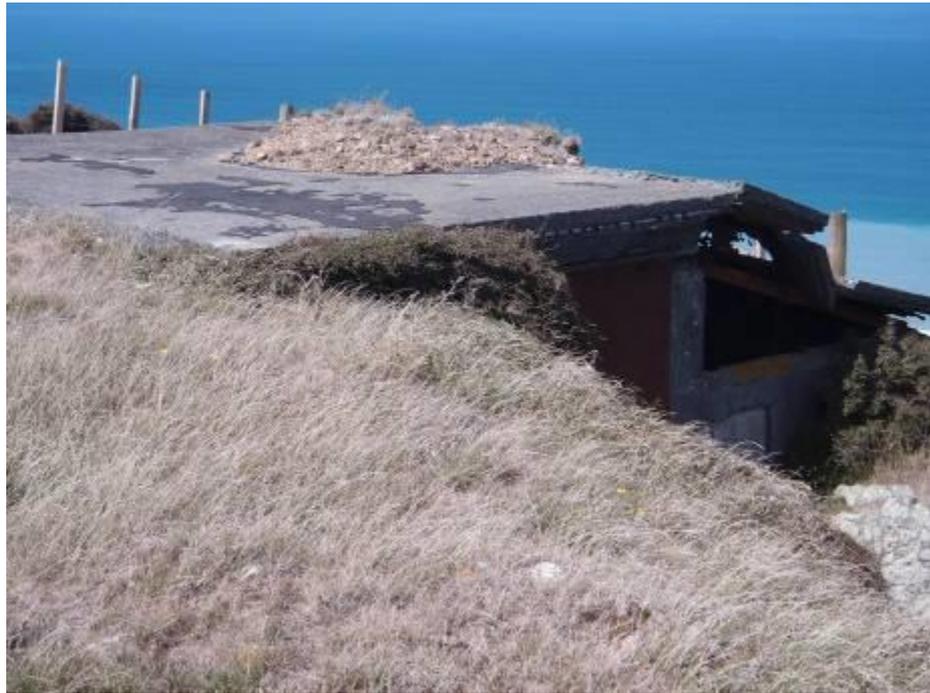
Figure 27: The observation post, built of reinforced concrete. Inside is the concrete foundation of what might have been a range finder or telescope. This building retains part of its camouflage (a layer of earth and vegetation visible on its roof) but the cantilevered roof over the viewing slit has collapsed. The path that has been constructed to allow entry to the building is shown to the right of the photograph

At the top of the hill is a trig and just to the south of this is the observation post (c.1935), built into the slope and constructed of reinforced concrete. Inside is the concrete foundation for the DRF. This building retains part of its camouflage (a layer of earth and vegetation directly on its roof) but the cantilevered roof over the viewing slit has collapsed.

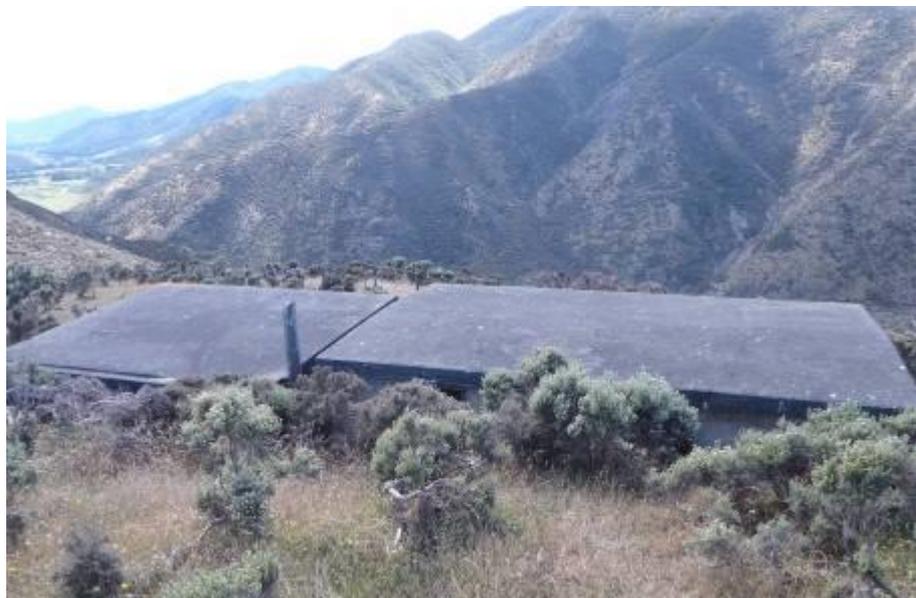
Figure 28: View from above showing the observation post's wireless room to the left and the (likely) mess room to the right. Wainuiomata Valley is in the background.
