New Zealand Historic Places Trust Pouhere Taonga

Research Report on Heritage Features

Baring Head, Wellington

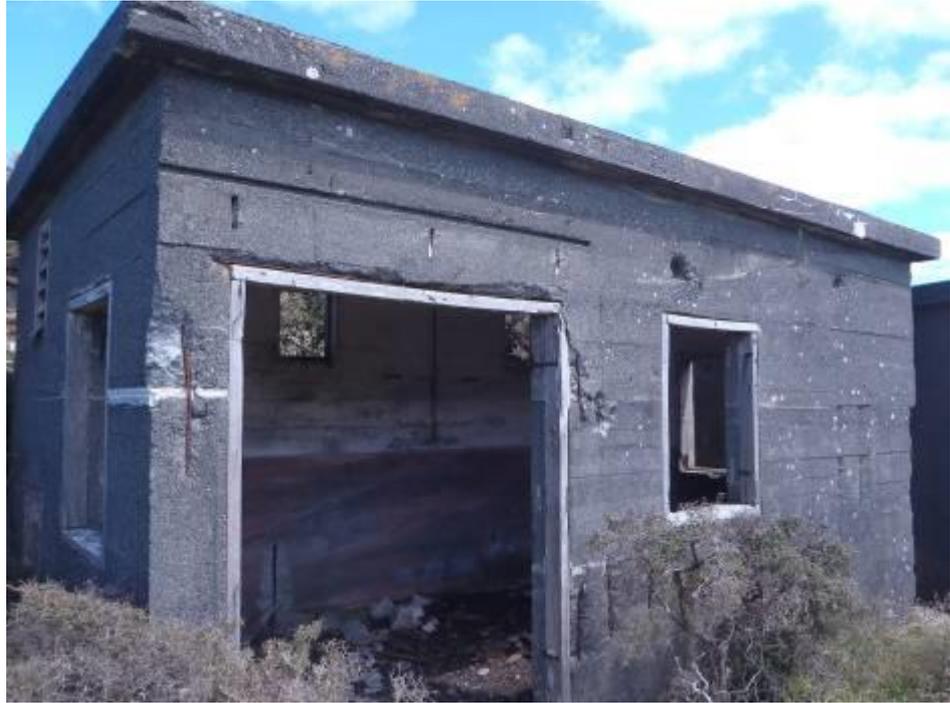
Figure 29: The possible mess room with reinforced concrete walls.

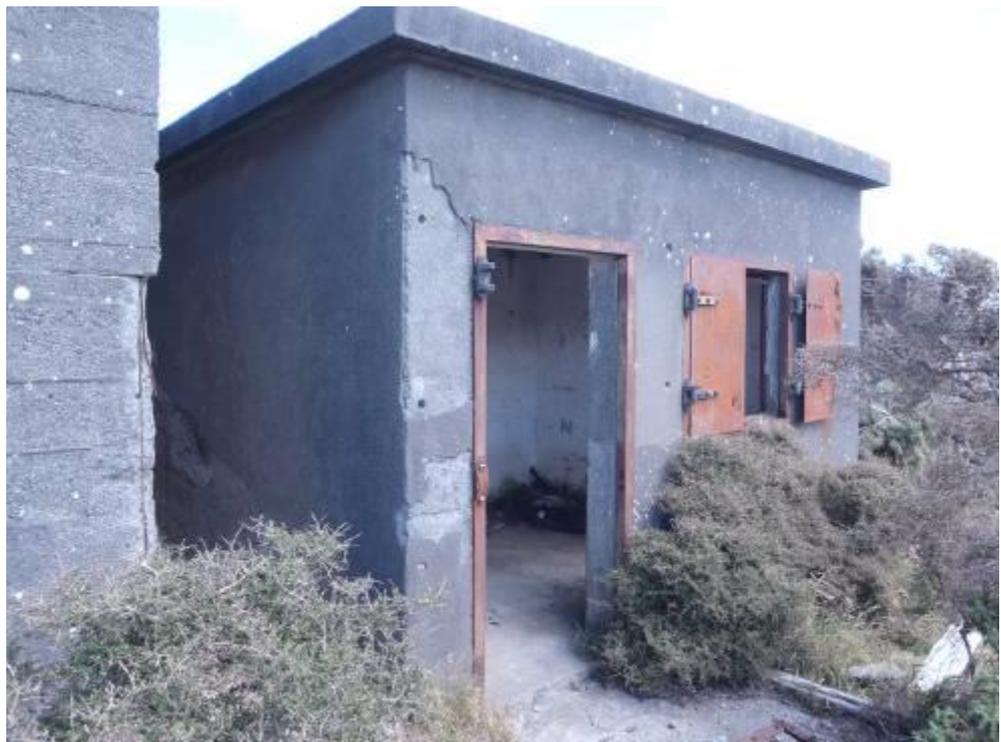
Figure 30: The wireless room. The reinforced concrete walls were rendered on the outside. The shutters are still in place and at the bottom of this photograph there is visible a small portion of the door which currently rests on the ground in front of the building.

The wireless room is a rectangular (c.4 x 3m) reinforced concrete structure with rendered (plastered) walls. It has a mono pitched roof that slopes slightly to the rear. There is one door and window. The remains of the steel door are on the ground near the building, while the steel shutters for the windows remain in place. Both the doors and shutters are actively corroding. The slightly bigger possible mess room (c 5 x 3 m), has five windows and space for a double door, but none of these remain *in situ*. There are vents near the roof in the southern wall of the structure. Both buildings are fenced off from the public.

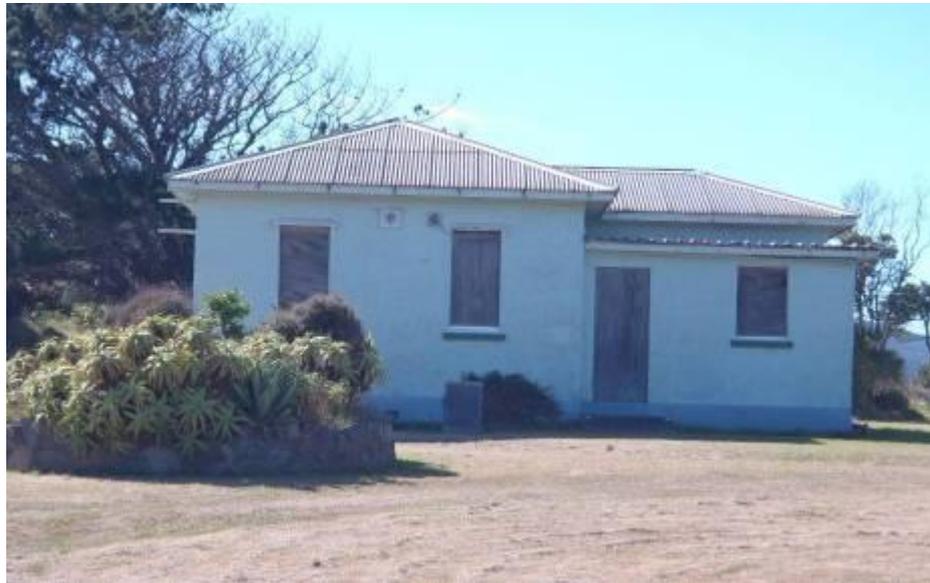
As part of the powering of the lighthouse (and the rest of the station) a building to house the diesel generators was required. The PWD opted to design the building in a domestic style to fit in with the two keepers' houses. Unlike the latter, this building was constructed in concrete, most likely to guard against fire. It is not known who built the structure. In 1948 work began on the construction of a power line to Baring Head. It was completed in 1950 and the diesel generators were no longer required, except perhaps as a back up. When they were removed is not known.

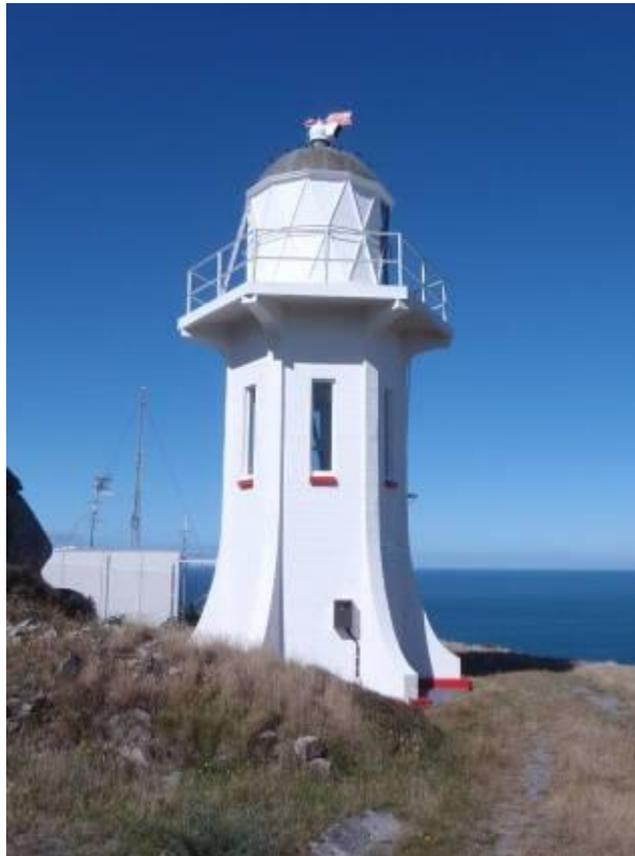
A tender was advertised for the erection of the reinforced concrete tower in November 1933.¹¹² Nearly identical to the later Cape Reinga Lighthouse, Baring Head demonstrated a new design aesthetic, using Moderne elements in the curved solid buttresses. The designs were probably the work of the Public Works Department. The successful contractor was Messrs Joseph Jackson

Outside the shelterbelt area, and to the south of the complex of lighthouse keepers' houses is the lighthouse itself, enclosed within a fenced area. The lighthouse is a 1930s reinforced concrete structure. It has flared buttresses, which give the structure additional stiffening and a copper roof on a dome. The unlined interior gives internal access to the lantern. The foundations of the lighthouse are 2.5m deep, and the lighthouse is 12 metres tall, rising 87 metres from the beach below. Described in a newspaper report of 1935, it was stated that the lighthouse was designed 'somewhat differently' from the standard lighthouse design, 'the architects having paid special attention to its appearance and having added several features to improve its profile.'⁹⁵ The balcony around the lighthouse was made as small as possible, with a small ladder leading to the balcony instead of having a door leading out of the lantern chamber, as was the usual practice.⁹⁶

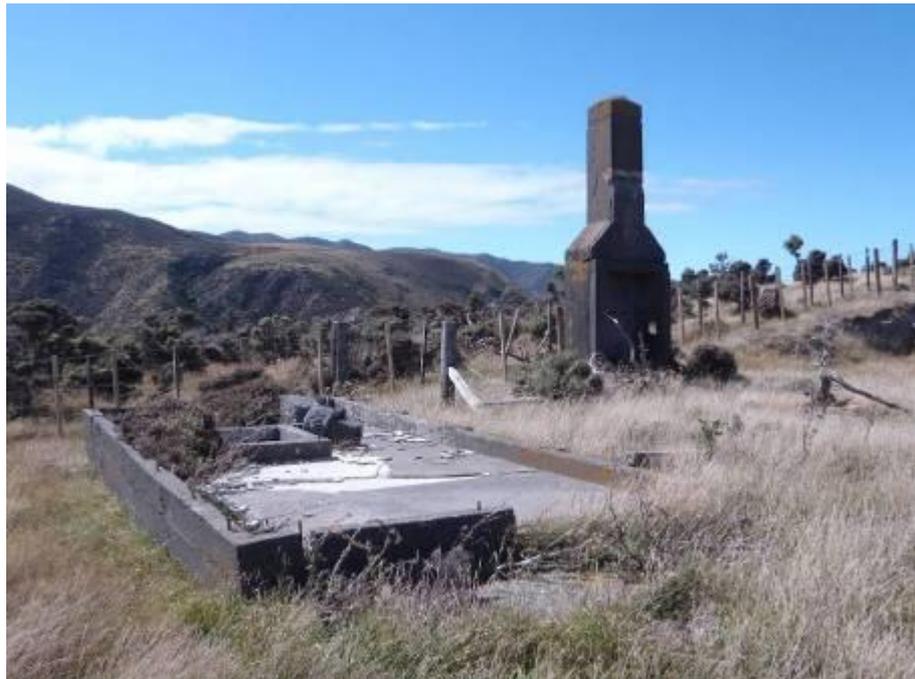
Remains of the ablutions block (foreground) and the site of the barracks to the right (with chimney extant)

A short distance north, and down the hill, is the site of what was the accommodation barracks and ablution block for the men who staffed the observation post. Built in 1940, the barracks is assumed to have been constructed of timber and is no longer evident bar a concrete chimney. The ablutions block retains its concrete foundations, floor and drains, but is likewise missing its timber structure. These buildings have all been inspected and described in a report to the Greater Wellington Regional Council by an engineer

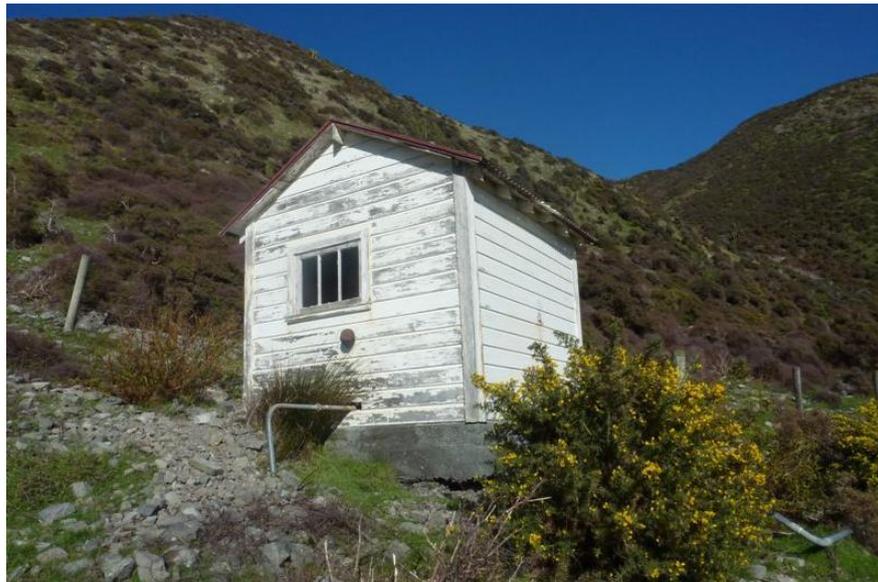
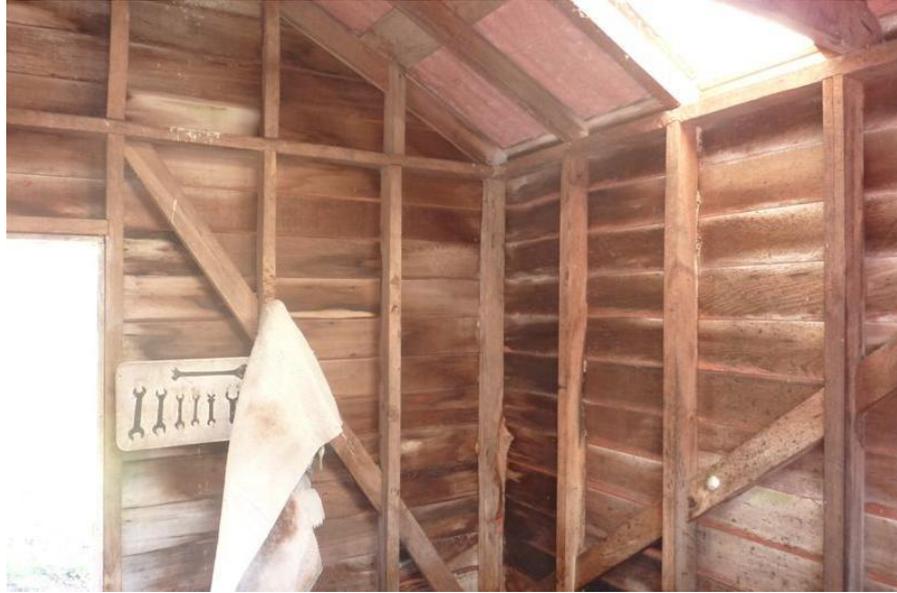
The pumphouse was built about 1940 to extract water from the Wainuiomata River for use at Baring Head. From the river the water was pumped to the top of the Para trig where it was stored in a tank. From there it was distributed to the observation post buildings and down to the lighthouse station complex and naval signal station. Following the end of the war, water continued to be pumped to Baring Head from the stream. When it was ceased to function is not known but the pumphouse remains in situ as do many of the galvanised pipes that carried the water and the water tank (see Fortress Observation Post).
