PROJECT REPORTS

1903-1990

A summary and archive reference for each of the major engineering works, and unique minor works, which in total form the Hutt River Flood Control Scheme.

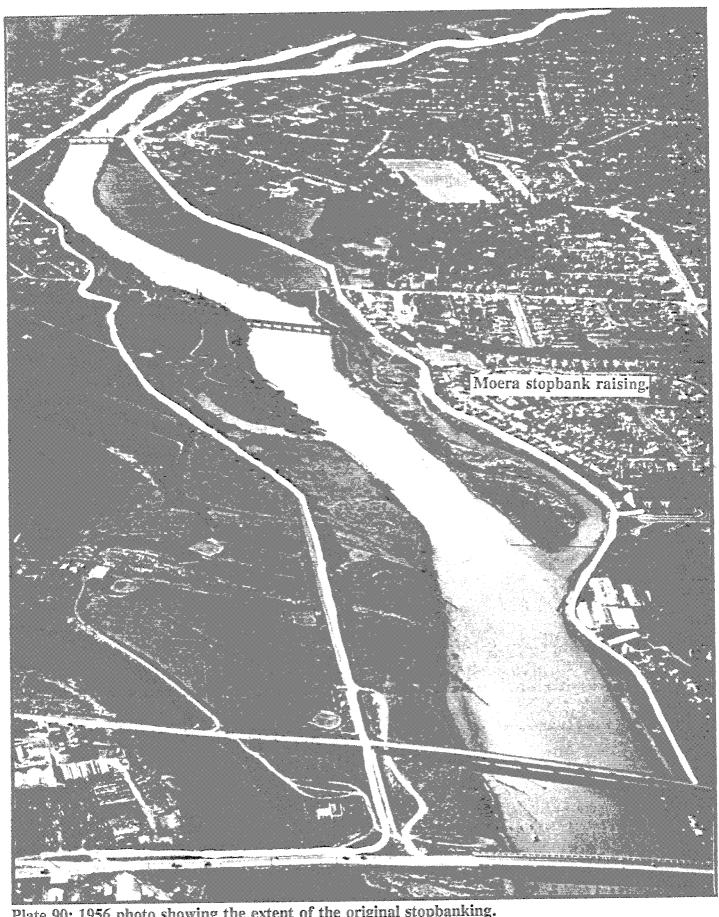
Plate 90: 1956 photo showing the extent of the original stopbanking.

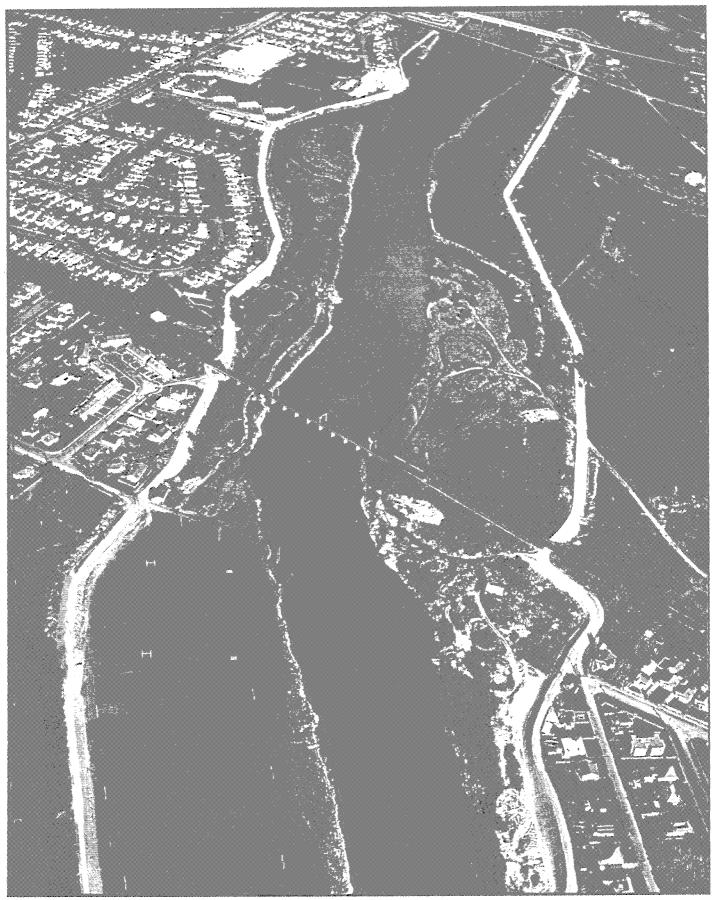
Plate 91: 1956 stopbank works in progress.

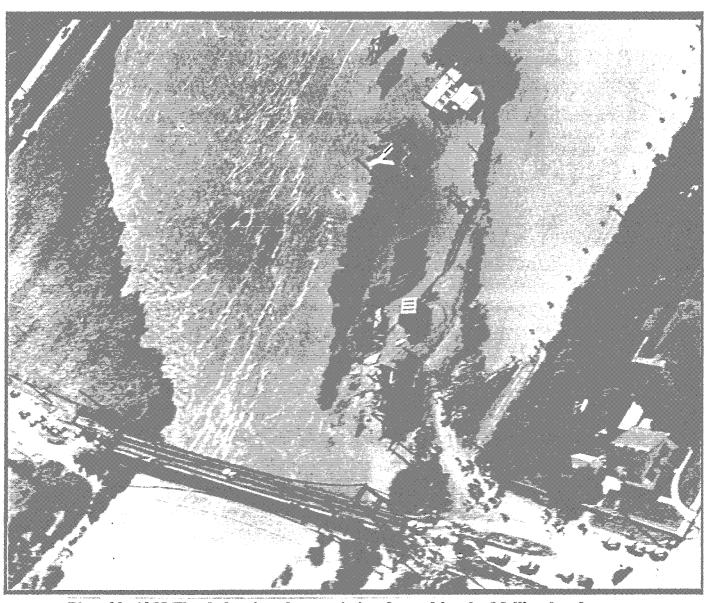
Plate 92: 1955 Flood showing the restriction formed by the Melling bend.

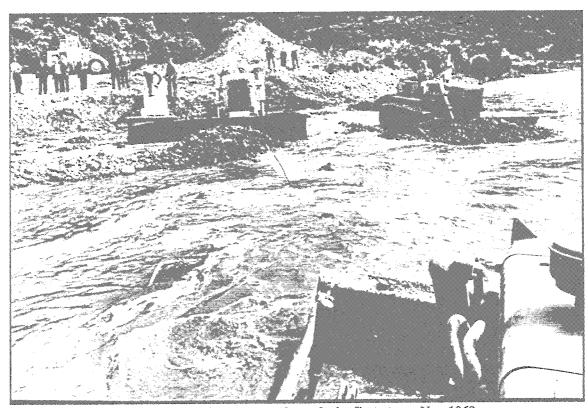
Plate 93: Closing the channel to direct water through the first stage, Nov 1969.

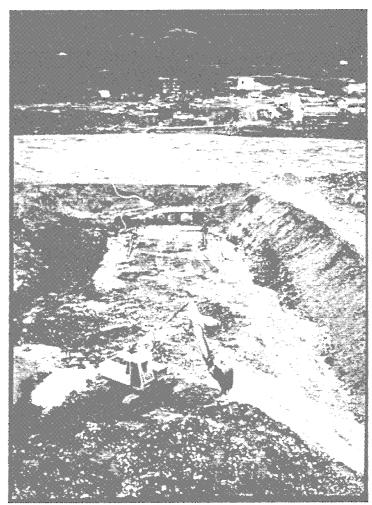
Plate 96: Construction of the sewer crossing 1976. Note the bed depth above the structure.

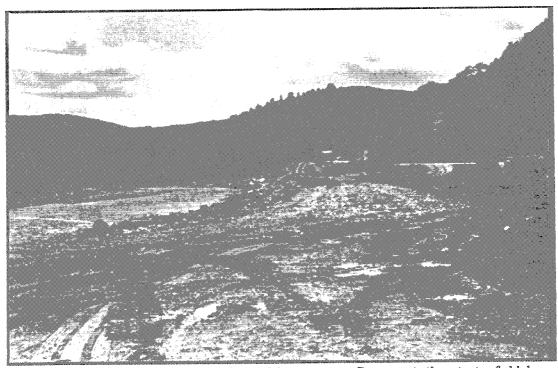
Plate 97: Hutt River bed south of the Mangaroa confluence at the start of highway construction. The river flowed against the highway before the diversion.

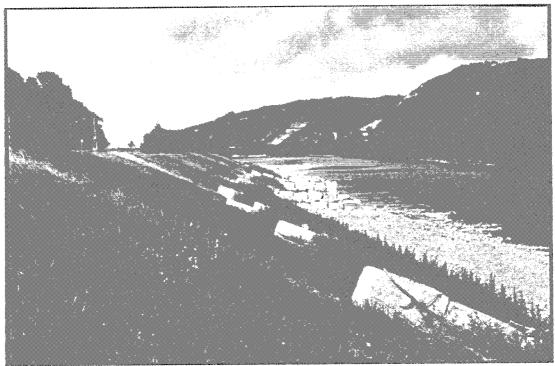
Plate 98: Stokes Valley Stream dividing stopbank 1982.

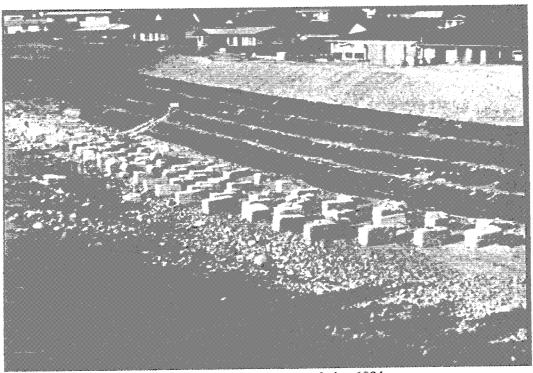
Plate 100: Stopbank and stabilisation works on completion 1984.

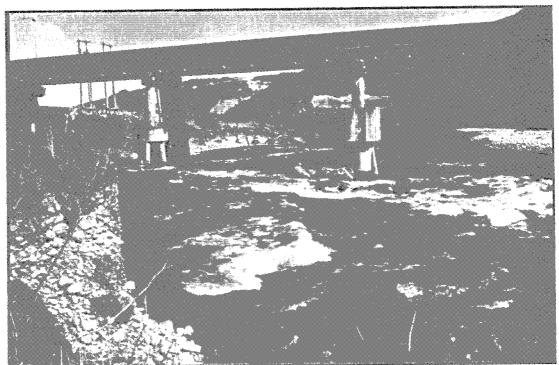
Plate 102: Pomare bank erosion. The eastern stopbank at the head of the Taita housing estate can be seen in the background.

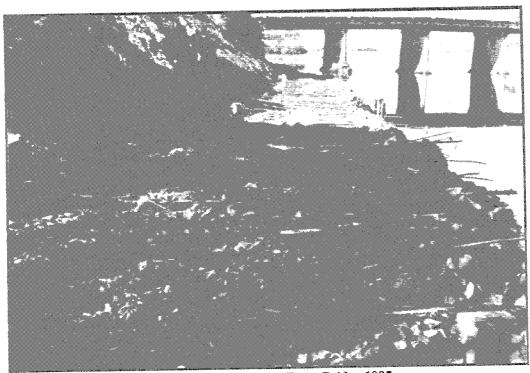
Plate 103: Reinstatement of the eastern bank, Ewen Bridge 1985.

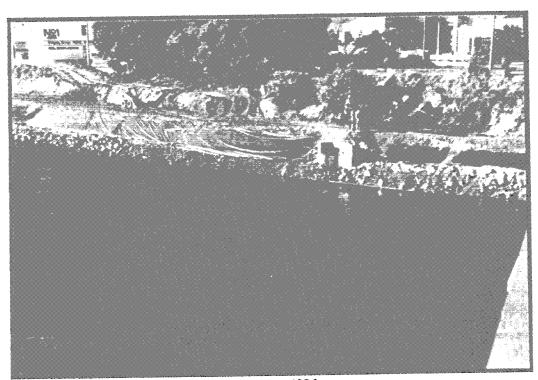
Plate 104: Ewen Bridge left bank stabilisation 1986.

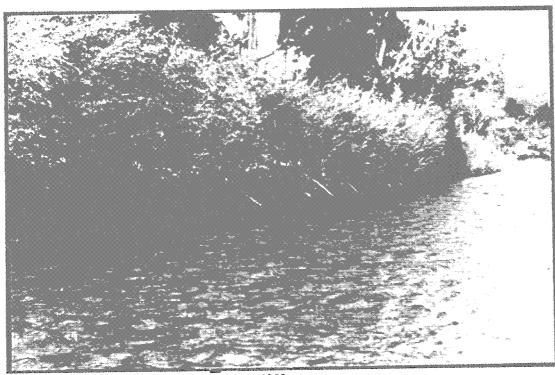
Plate 106: Harcourt Park toe stabilisation 1989.

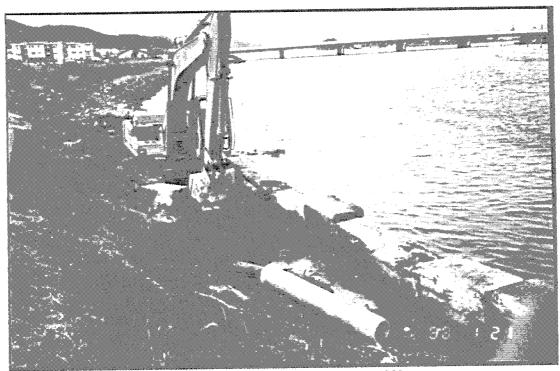
Plate 107: Croft Grove excavation of unsuitable stopbank toe 1988.

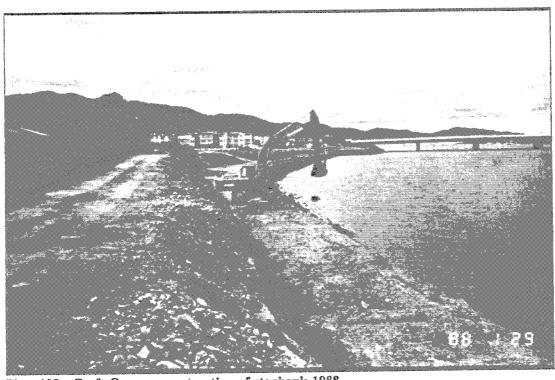
Plate 108: Croft Grove reconstruction of stopbank 1988.

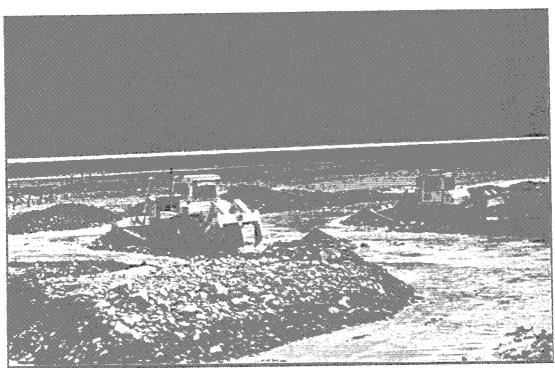
Plate 109: Upper Hutt Bypass River Works - establishment of meander pattern.

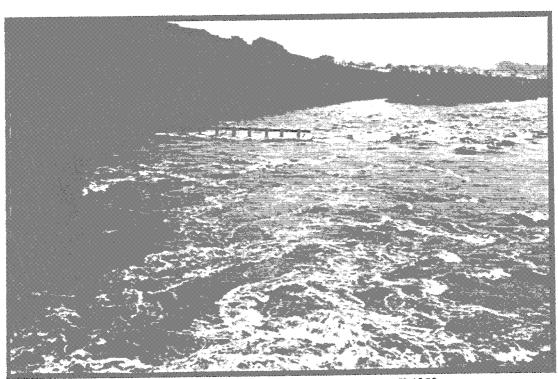
Plate 110: Upper Hutt Bypass - Maoribank deflector and river wall 1989.

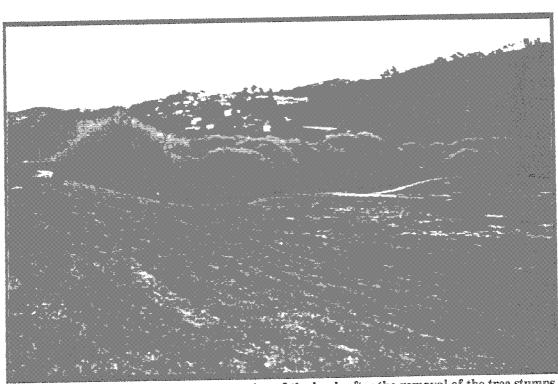
Plate 112: Melling Stopbank. Reconstruction of the bank after the removal of the tree stumps.
