Title: Hydrology and water allocation in Te Awarua-o-Porirua Whaitua

- **Purpose:** To provide an overview of the hydrological systems and current water allocation within Te Awarua-o-Porirua Whaitua.
- Author: Environmental Science Department, GWRC
- Date: September 2015

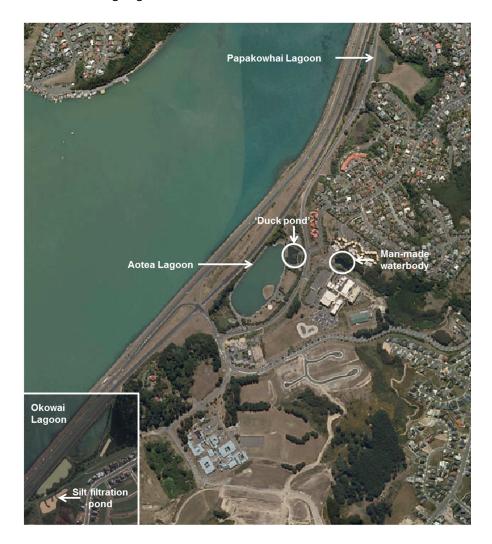
Figure 2: Map showing all three lagoons (Papakowhai, Aotea [including the 'duck pond'] and Okowai), the man-made waterbody in the NZ Police College grounds, the freshwater wetland and the silt filtration pond (built as mitigation for sediment loss as part of the development of Aotea) at the southern end of Okowai Lagoon.

There are several lagoons (shallow waterbody separated from the Harbour by a barrier but with a water interconnection), freshwater lakes and a swamp in the Whaitua (Fig. 2):

- Papakowhai, Aotea and Okowai lagoons are manmade and all tidal to varying degrees, controlled by the size of culverts connecting them to Onepoto Arm.
- Whitby Lakes and Cannons Creek Reserve Lakes are also manmade. Whitby is an 'ornamental' lake, while Cannons Creek Lakes were built primarily for flood detention.
- There are also two other small man-made waterbodies: one simply called the 'duck pond' adjacent Aotea Lagoon and one in the Royal New Zealand Police College grounds.

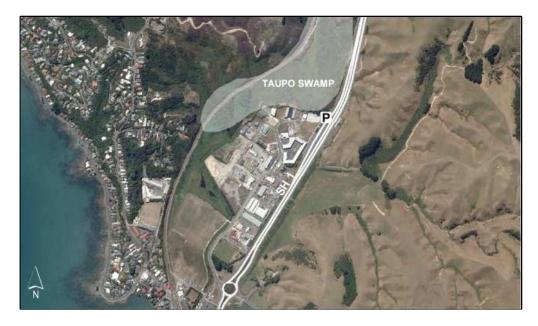
Figure 3: Map showing area of Taupo Swamp off SH1 in Te Awarua-o-Porirua Whaitua.

Taupo Swamp (Ara Harekeke; Fig. 3) is the largest (30 ha) and nationally significant harakeke (flax) wetland in the Wellington region. It plays a role in sediment trapping, maintenance of water quality and support of aquatic and terrestrial food chains. It is surrounded by the North Island Main Trunk Railway, SH 1, Airlie Road and private land. The catchment is predominately pasture with some forestry and scrub. The southern end of swamp has been reclaimed and developed for farming, playing fields and industrial use. The catchment and stream above the swamp has been highly modified – including ephemeral streams flowing from pasture and into a compacted channel stabilised and covered by healthy native vegetation. There are elevated flax swamp remnants to the west of the rail line. Historically, the stream and swamp were an area where mahinga kai (such as tuna) and harakeke were gathered. It is home to a number of threatened plants, birds such as the bittern and fish such as mudfish and longfin eel. In localised areas exotic weeds are rapidly displacing indigenous vegetation.

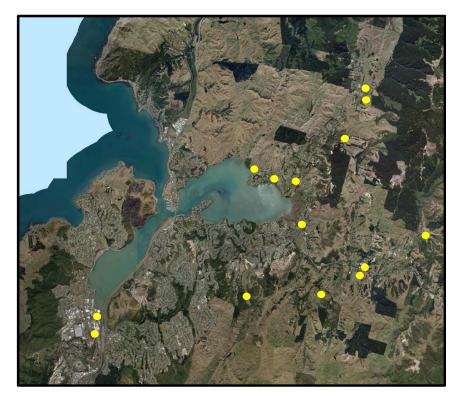
Figure 5: Map showing location of known bores and wells (yellow dots) in Te Awarua-o-Porirua Whaitua.

Groundwater (water found underground in the cracks and spaces in soil, sand and rock) is a limited resource in the Whaitua, and while there are no resource consents for groundwater take, there are a few bores and wells (Fig. 5). It is unknown a) whether any water is taken from these bores and wells, and b) if it is, how much. Some of the bores are quite shallow (less than 10 m deep) indicating they may have been used to see if there was any groundwater available or to estimate the depth for building.

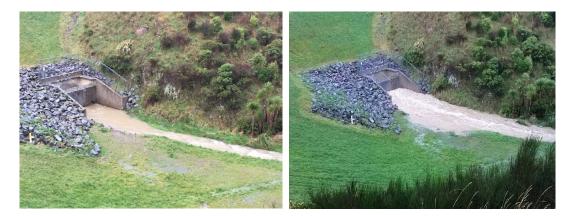
Figure 6: Stebbings Stream flood detention dam at Churton showing the energy dissipation structure at the outlet prior flooding (photos S. Miller) and after flooding in May 2015 (photos K. Neill).

Stebbings detention dam, completed in 1994, is situated in the lower reach of the Stebbings catchment and was built as part of the Porirua Stream flood control measure.

- Stebbings flood detention dam (Fig. 6) at Churton Park to control flooding along Porirua Stream
- Debris arrestor situated on the Porirua Stream along Glenside
- Seton Nossiter Park flood detention dam in Paparangi
- Cannons Creek Lakes Reserve (more detail in section 1.5.5) (current status uncertain)
- Stream bank protection undertaken such as that along the Belmont stream, one of the few remaining natural lowland streams left in Wellington, and the tidal reach of the lower Porirua Stream
- Takapu Stream flood detention upstream of SH1.
