Air, land and water in the Wellington region – state and trends

### Wairarapa Valley sub-region

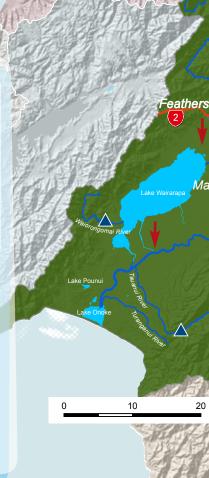
#### Water quality index

To get an overall picture of river and stream water quality we combine six key indicators into an index: water clarity, oxygen content, dissolved reactive phosphorus, nitrite-nitrate nitrogen, ammonia and *E. coli* bacteria.

- 🔺 Excellent
- 🔺 Good
  - Fair
- 🔺 Poor

It's a mixed bag. Six of the 20 river sites we routinely monitor have excellent water quality but eight sites are graded just 'fair' or 'poor' because at least two key indicators don't meet recommended guidelines. These sites are generally on the lower reaches of rivers and streams in largely agricultural catchments – like the Ruamahanga River at Pukio, Parkvale Stream and the Taueru River at Gladstone. Urban sewage discharges also affect some waterways, particularly the Mangatarere Stream in Carterton.

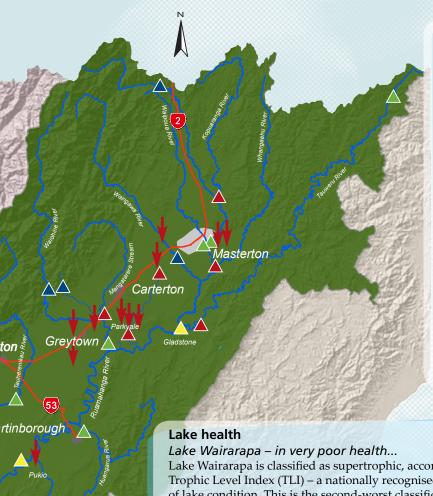
The arrows on the map show sites where groundwater levels significantly declined (1994 to 2011)

Groundwater resources in the Wairarapa Valley are also under more pressure. Groundwater allocation quadrupled between 1990 and 2010, and analysis of a selection of 29 groundwater monitoring wells found water levels in almost half had significantly declined between 1994 and 2011 (see red arrows on map). In several wells the water levels did not fully recover over winter, indicating there is a high risk that the amount of water taken from the underlying aquifer is not sustainable. The highest risk aquifers are the deep confined (artesian) aquifers of the middle and lower valley, such as the Parkvale artesian aquifer.
