# Wairarapa Coastal Habitats: Ecological Vulnerability Assessment

Prepared for  
Greater Wellington Regional Council  
April 2023

Salt Ecology  
Report 108

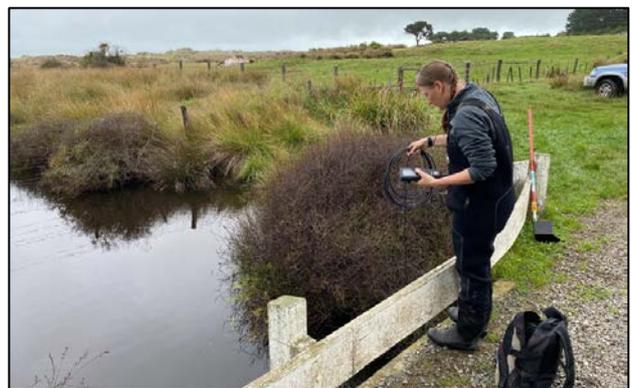
Measuring water quality from the upstream bridge at Wairou Estuary

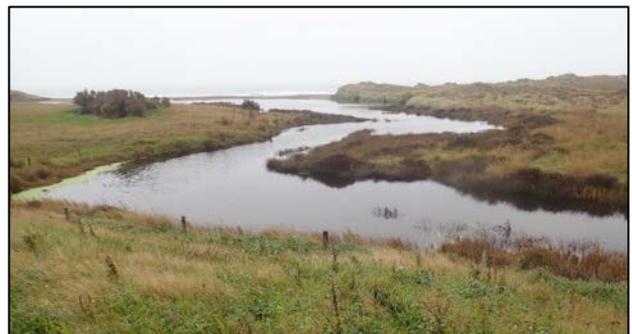
Waironu Estuary with extensive salt marsh along the margins

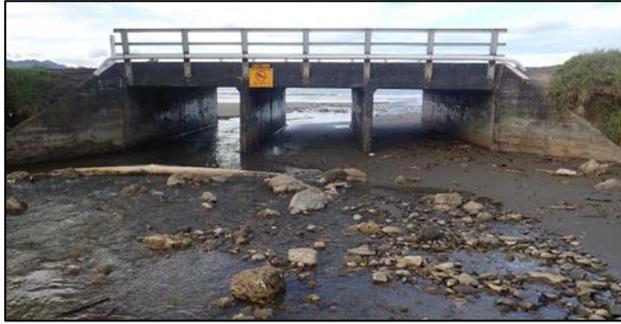
Other estuaries in relatively poor condition included Okau, Castlepoint, Otahome, Riversdale North and Riversdale Central. Okau, Castlepoint, Riversdale North and Riversdale Central (see Appendix 1) are all small estuaries that have been highly modified, with partly hardened margins, and the latter three are located within residential areas. Otahome is similar to Ngākauau in that it has a pastoral margin, poor water clarity, muddy sediments and a high proportion of salt marsh under pressure.

Castlepoint drains onto the beach through box culverts, an orange sign warns against recreational use due to pollutant levels

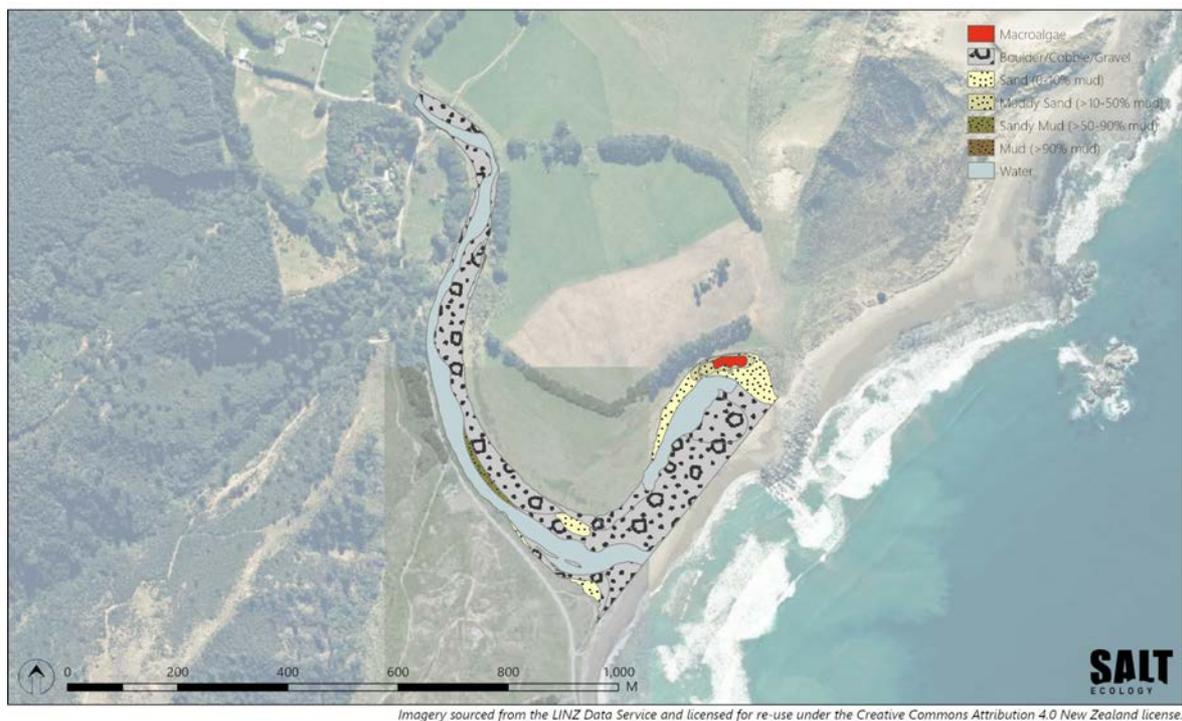
Fig. A1.2. Mātaikona Estuary dominant vegetation and substrate features. In this instance the red area represents thick beds of benthic algae.

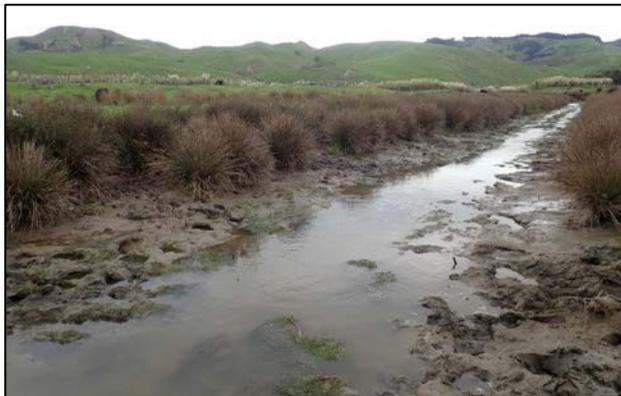
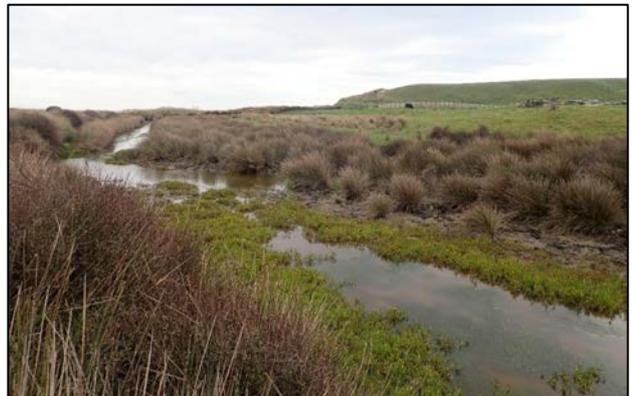
Soft sandy mud and *Ruppia* spp. within the straightened unnamed small stream. Note significant pugging damage in foreground

Salt marsh, rushland and herbfield, and *Ruppia* spp. growing in pooled areas

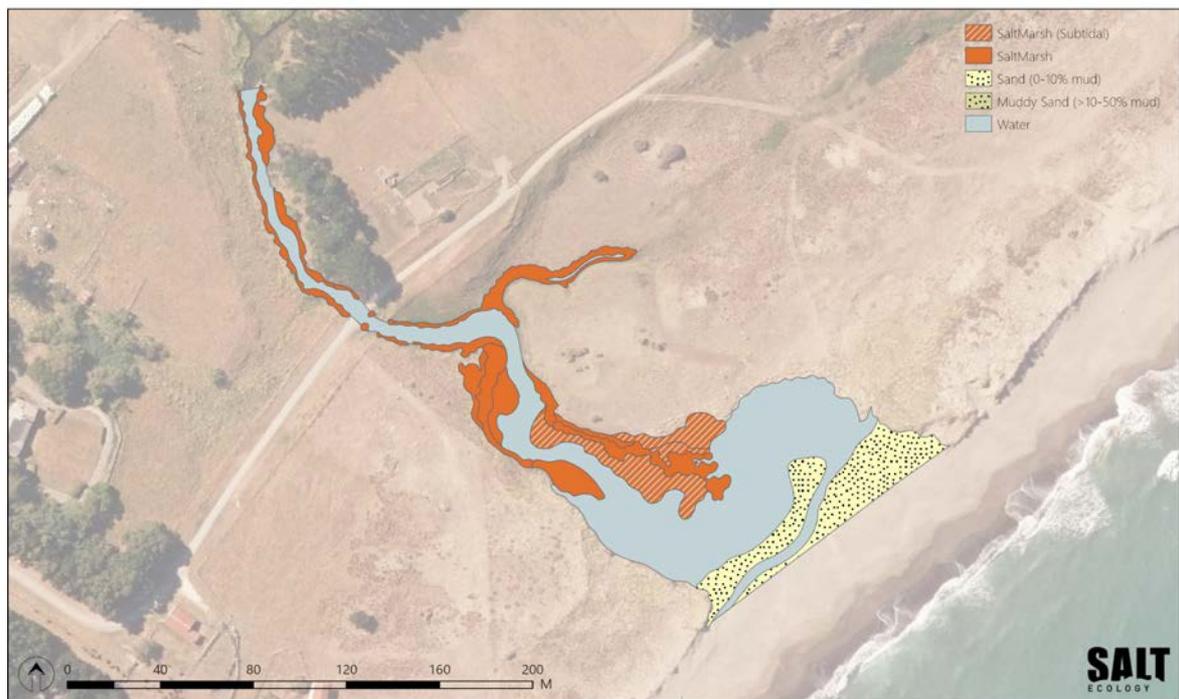
Fig. A14.2. Waioronu Stream Estuary dominant vegetation and substrate features. Note subtidal salt marsh would normally be intertidal under base flow conditions (the survey followed a high rainfall event).

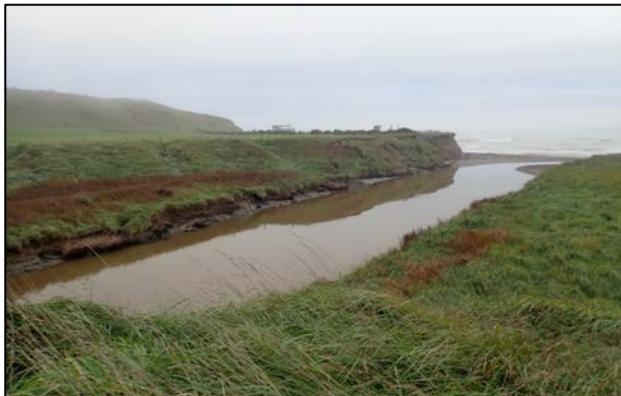
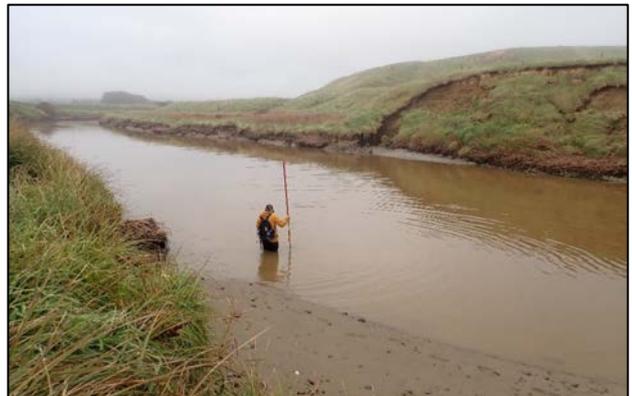
Erosion of dune and wetland vegetation (top) and wetland area between the lagoon and stream (bottom)

Looking downstream toward the estuary entrance

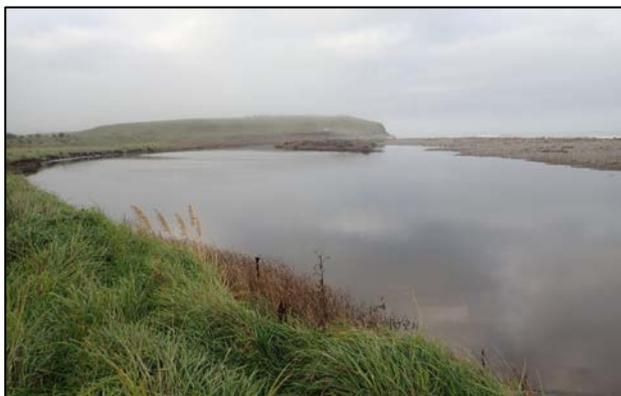
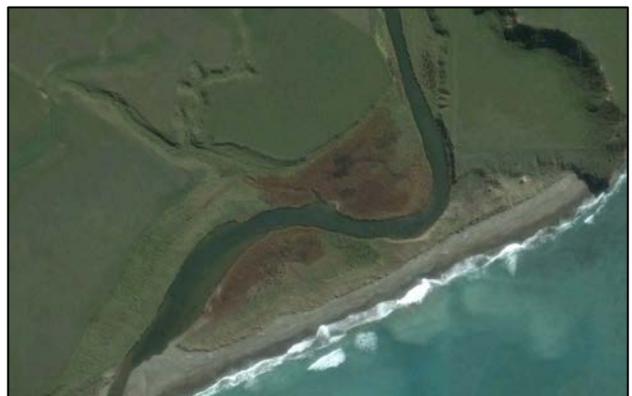
True left bank slumping, erosion observed on both banks

Patanui Lagoon, south of Patanui Stream. The estuary previously discharged to the coast via the lagoon (see photo opposite) but now drains directly to the sea with the lagoon now disconnected

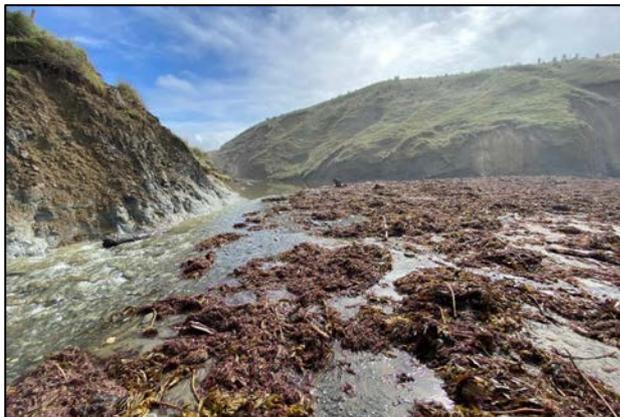
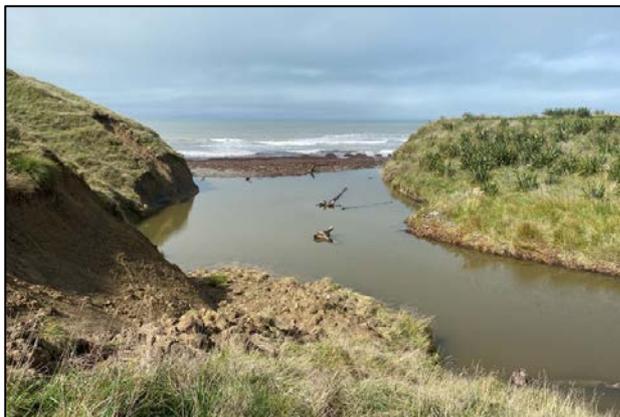
Available habitat for salt marsh was limited with only a small area of three-square present. While the margins were grass-dominated, there are riparian plantings of flax and other natives. A recent landslide into the lagoon on the north bank (see bottom photo) had deposited a large amount of fine sediment, and the water column was turbid from both this and a recent rain event.

Waiohuru Estuary discharges along the southern (true right) side, with debris (mainly seaweed) deposited at the entrance (top). A lagoon is present behind the entrance sand bar, with native plantings on the margin (bottom). Note recent slip in foreground.

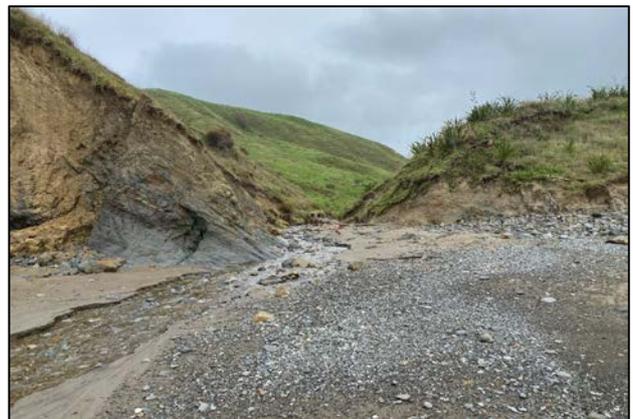
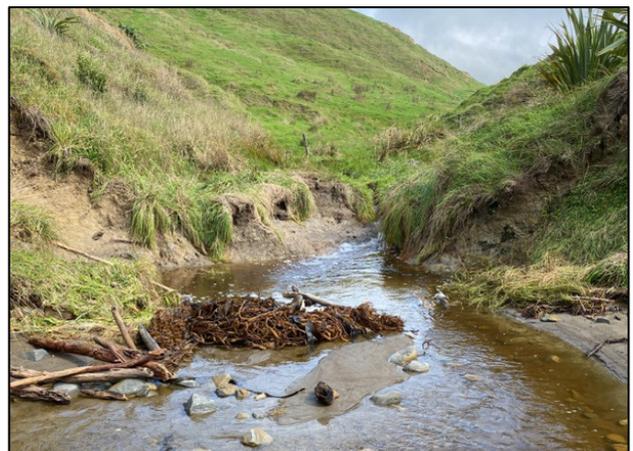
“Homewood South” Estuary ~2.5km south of Kamokopuna Stream (top), and looking upstream from the beach (bottom) with both bank erosion and slumping present

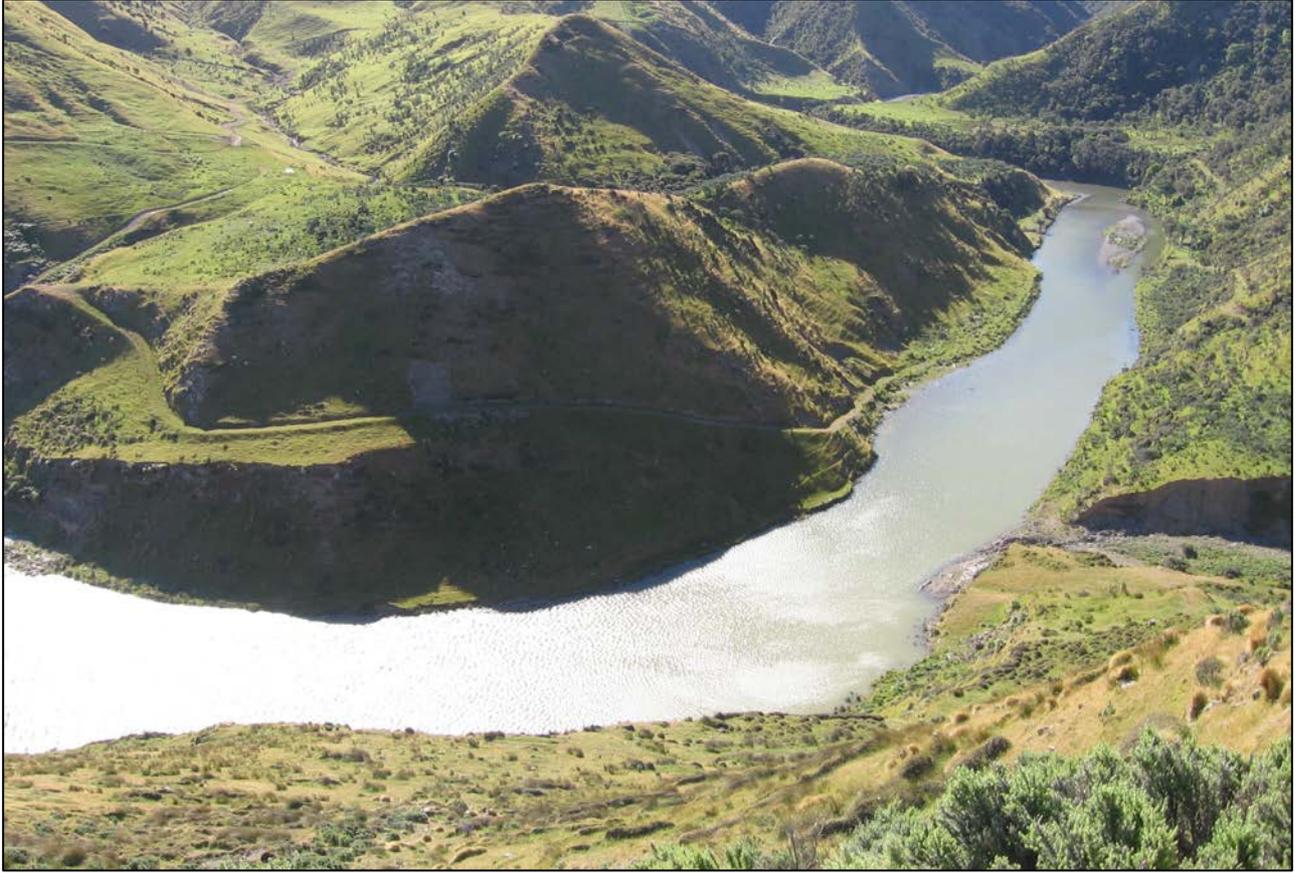
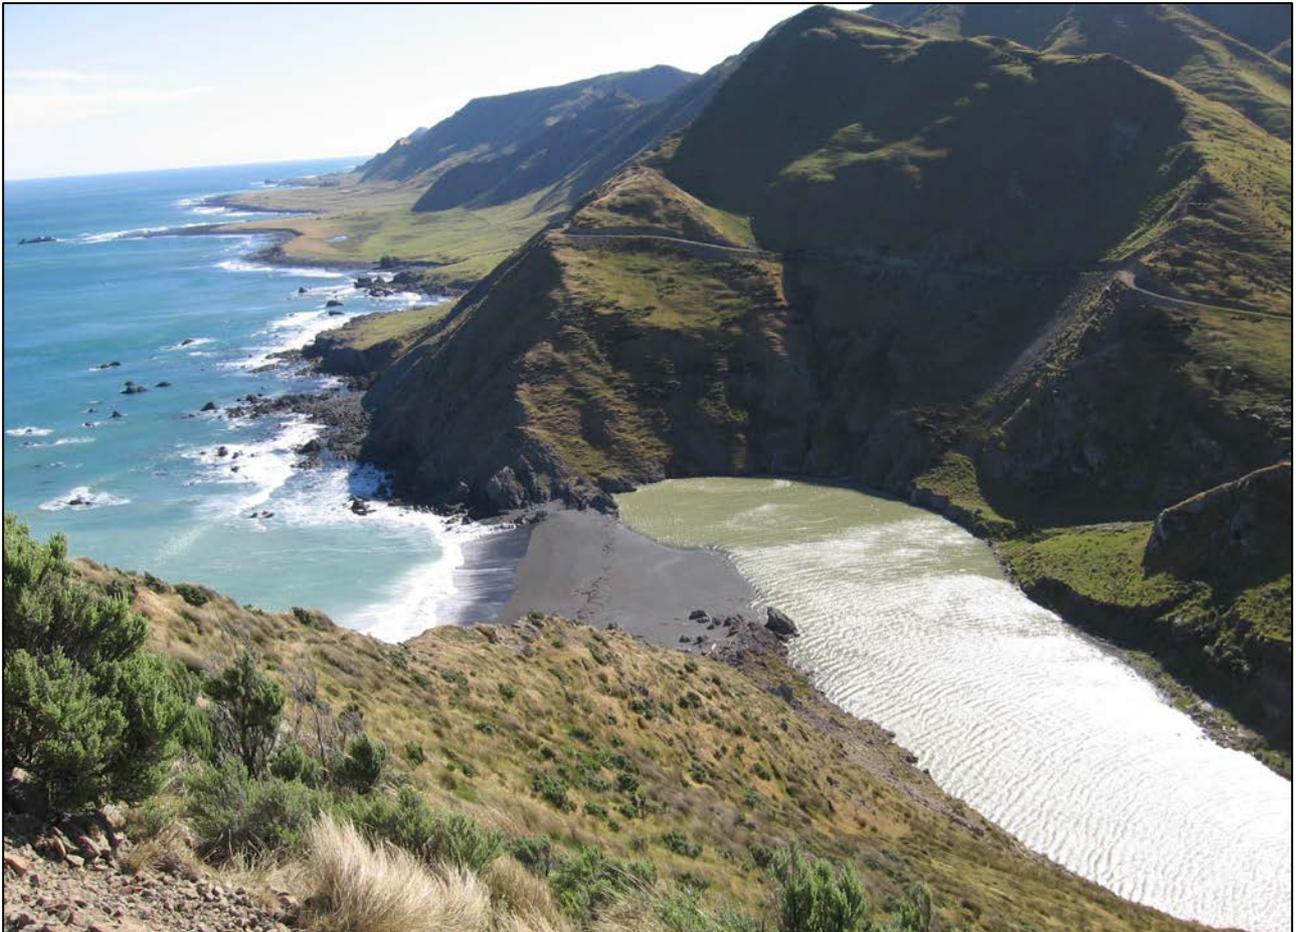
Rerewhakaaitu River looking upstream (top) and the estuary entrance (bottom) in December 2006, the entrance is closed and a lagoon has formed behind the sand/gravel bar that is flanked by very steep cliffs (photos sourced from Robertson & Stevens 2007)

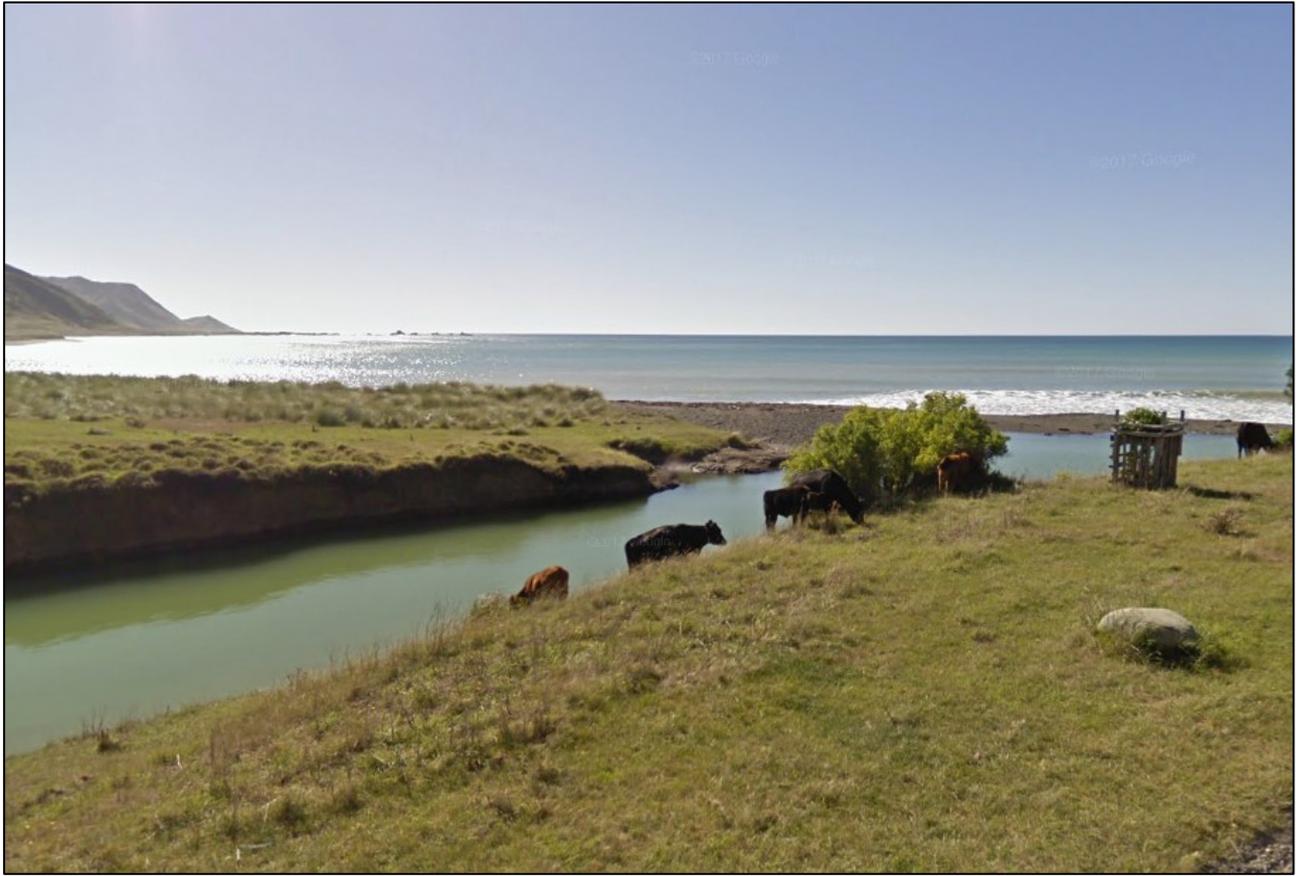
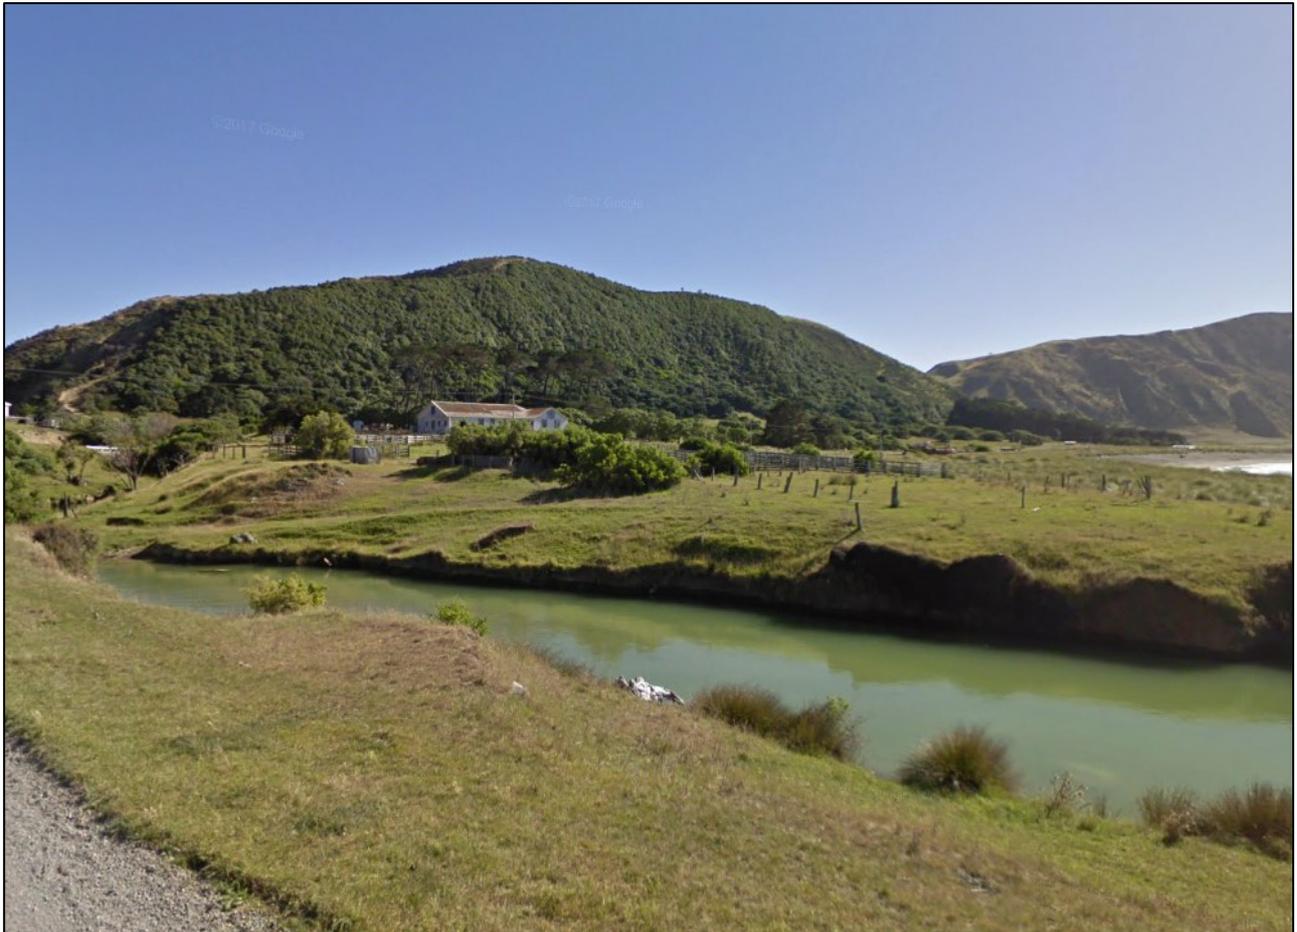
Awheaiti Stream Estuary looking toward the beach (top) with cattle grazing on the margin of the southern bank and looking upstream (bottom) at Tora Station. Both images show the banks eroding and high turbidity of the water column (photo: March 2010, Google Maps Street View)

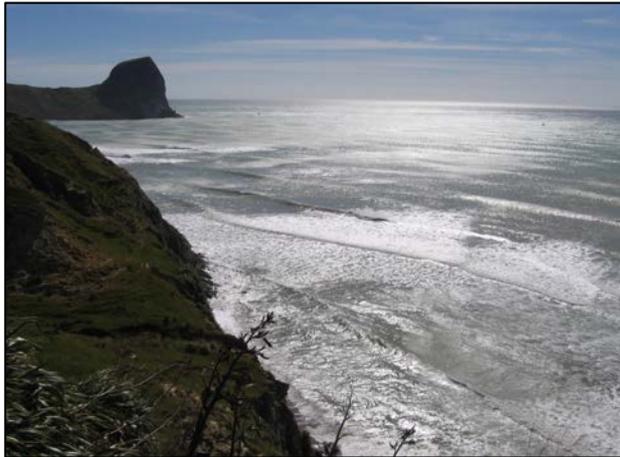
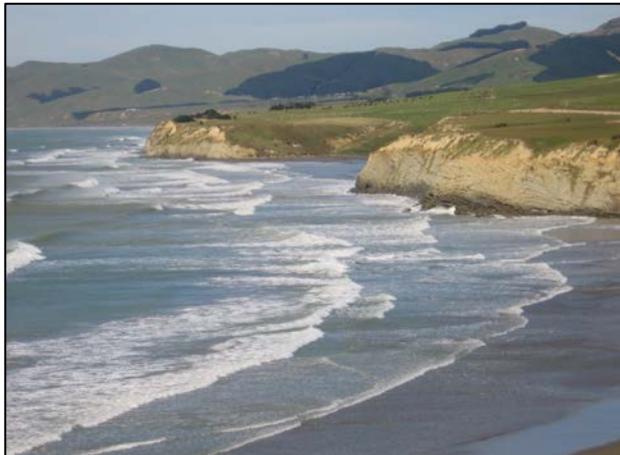
Steep eroding cliffs looking north to Castle Rock (top) and south of Ngākauau Stream (bottom; photo: December 2006, Wriggle Coastal Management)
