Request for information 2025-213

“What reports, investigations, decisions and action has GWRC done or planned since the start of 2018 in regard to reducing the flooding impact (eg image below) from upstream of Harrison Street to the downstream side of SH53 from the Donald Creek Detention Scheme?”

Flood Modelling of Donalds Creek and the Detention Dam

Donalds Creek Detention Dam Failure Modes & Effects Analysis

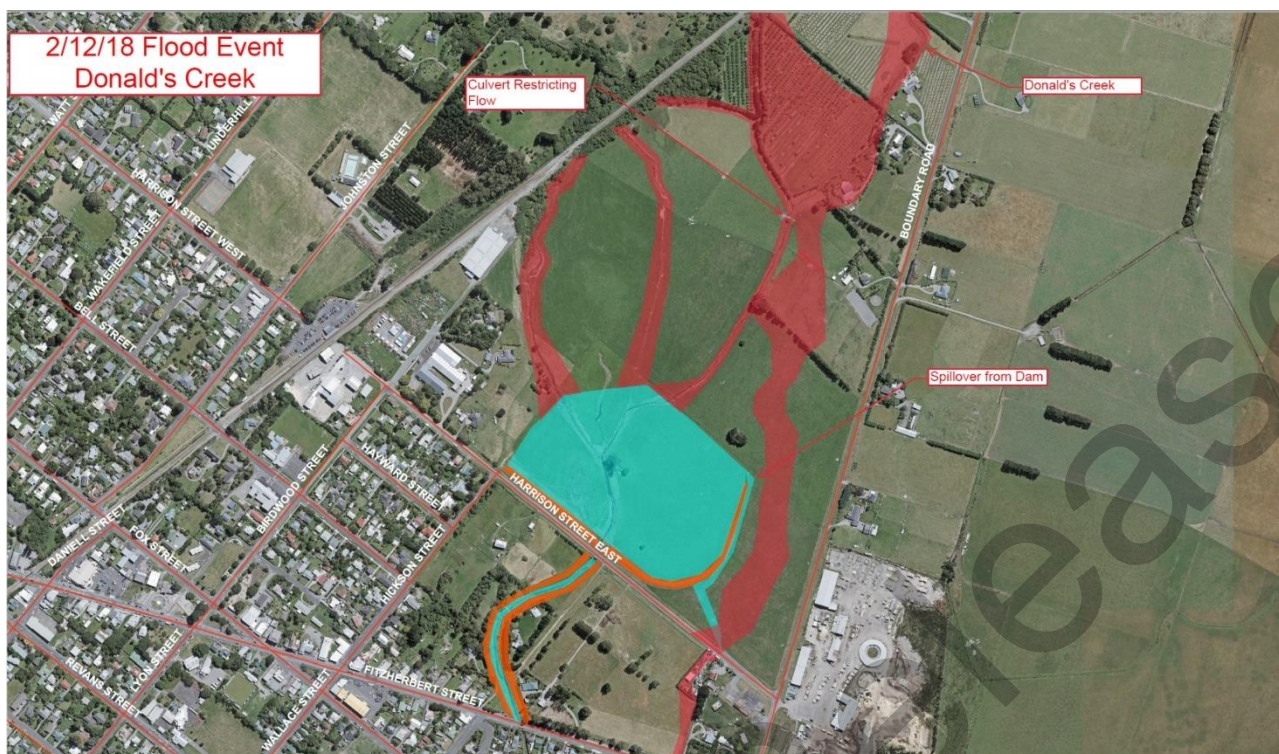
Figure 5.4 shows the estimated flood area observed during the 2018 flood event.

Figure 5.4: Estimated flood areas around Donalds Creek Detention Dam during the 2018 flood event

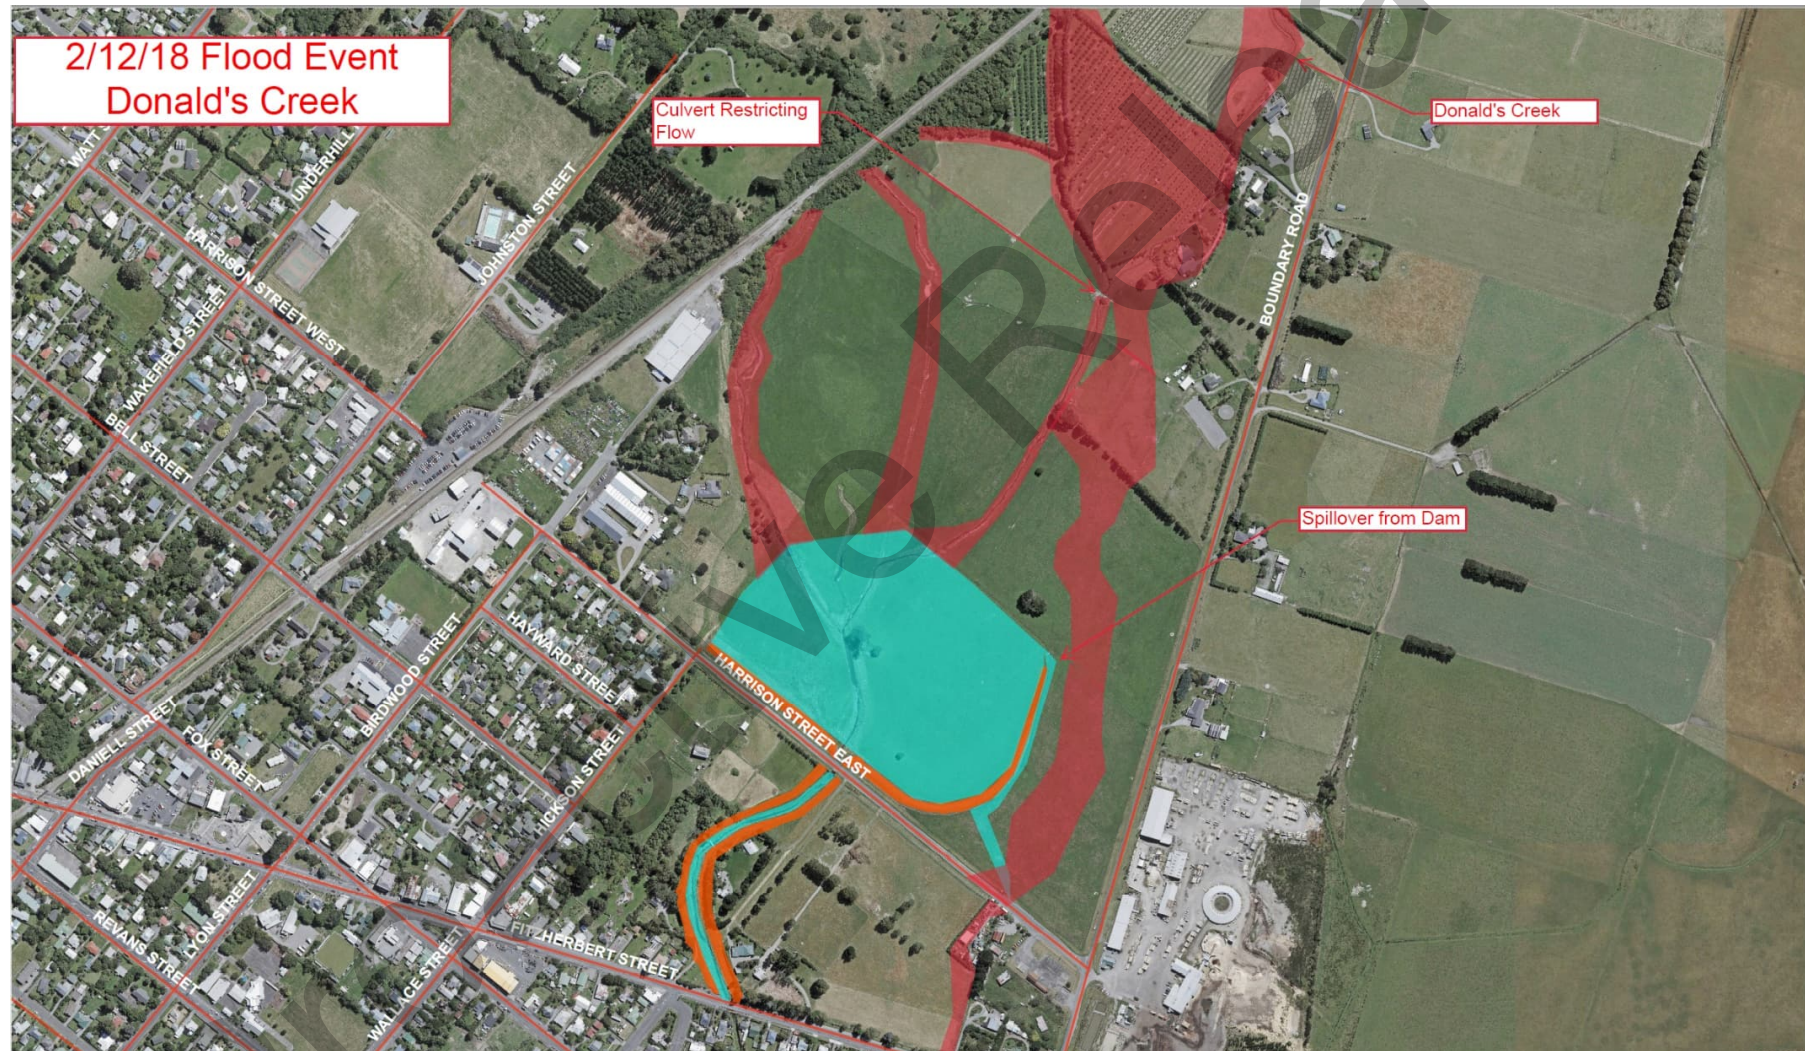
Flood Hazard – Dec 2018 Flood

- GW 2018 post-event appraisal:

- Floods in 2003 and 2005, estimated to have a 1:10 AEP.
- Most recent flood on 2 December 2018:
 - Spillway discharge estimated to be $\sim 2 \text{ m}^3/\text{s}$ at RL 38.37 m.
 - Estimated by GWRC to have been a 1:50 AEP event including effects of climate change based on WSP study. (How?)
 - A culvert upstream of the dam restricted flow and diverted the flow away from the reservoir.

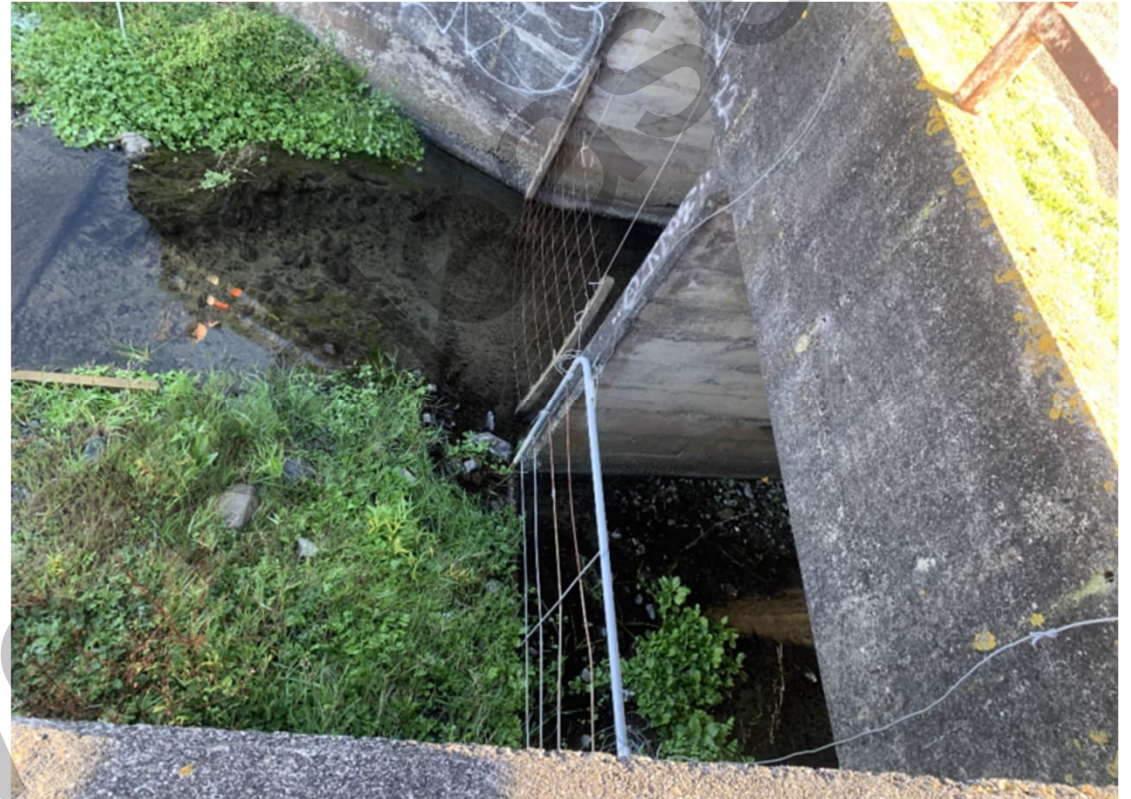
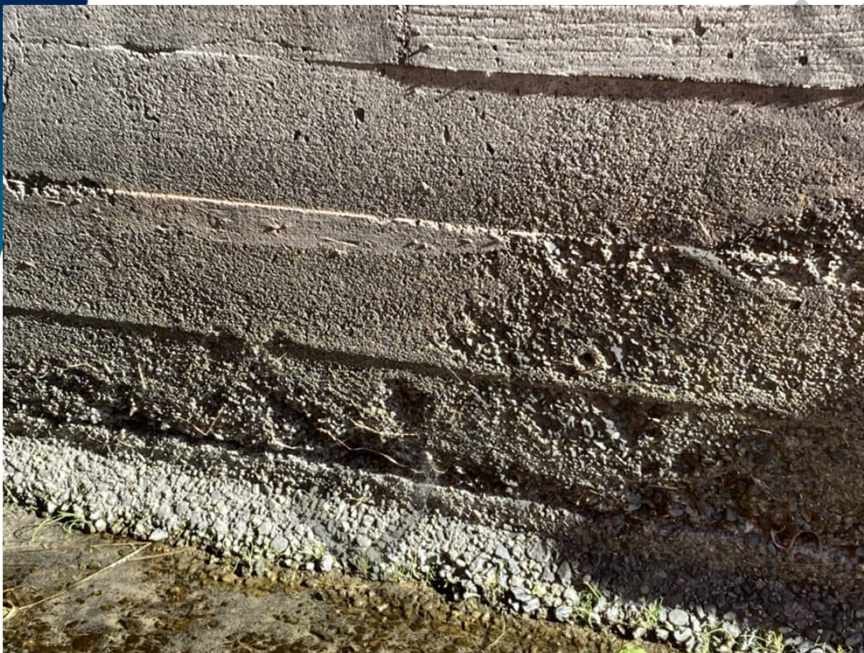
Hanging fences at downstream end of culvert

Signs of deterioration at base of right wall of left culvert
