LakeSPI surveys of waterbodies in Wellington Region: 2021/22

Prepared for Greater Wellington Regional Council

NIWA CLIENT REPORT No: 2022179HN
Report date: June 2022
NIWA Project: WRC21201

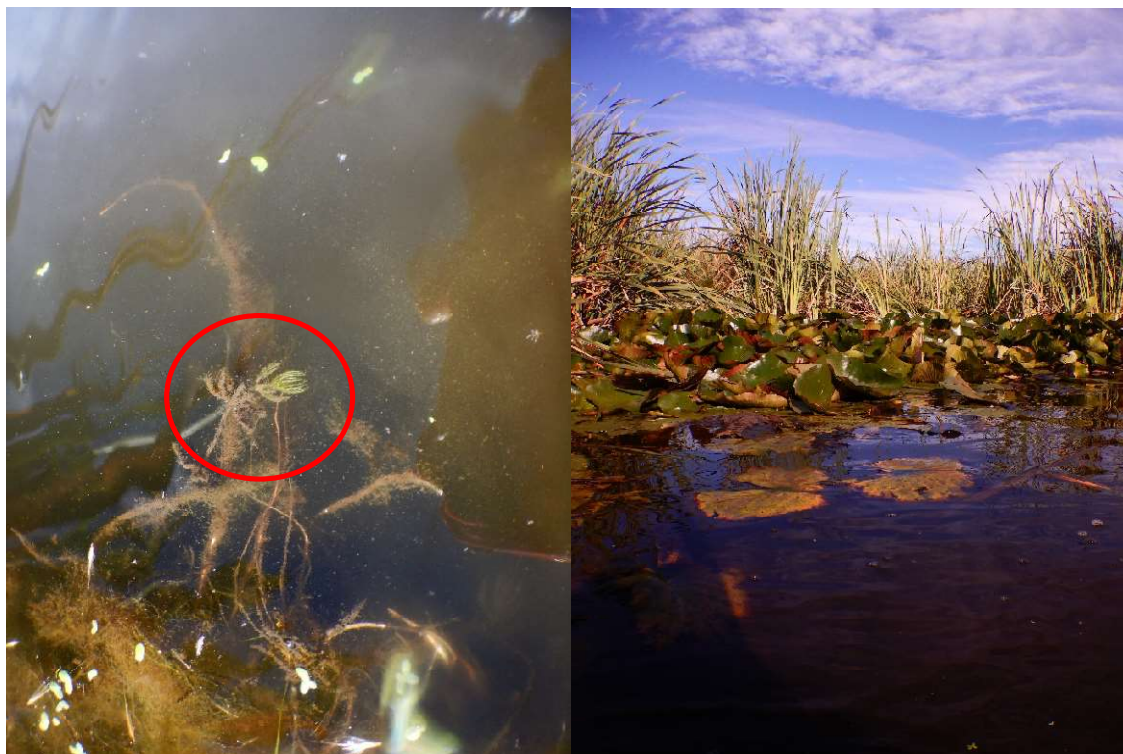
Figure 4: Aquatic vegetation at Lake Waiorongomai. A) hornwort (*Ceratophyllum demersum*) occurred as scattered plants or floating fragments (ringed), B) raupō (*Typha orientalis*) and *Nymphaea* hardy cultivar near the lake outlet.

At this time, native *Ruppia polycarpa* was the most common submerged plant, together with native pondweeds *Potamogeton ochreatus* and *Stuckenia pectinata*. Invasive exotic weeds included hornwort (*Ceratophyllum demersum*, Figure 4) and curled pondweed (*Potamogeton crispus*). The floating plant *Lemna disperma* was recorded at the lake margins and a waterlily (*Nymphaea hardy* cultivar) was observed in the vicinity of the lake outlet (Figure 4).

At the time of NIWA's 2022 survey, submerged plants did not exceed 10% cover and the lake was categorised as non-vegetated. Hornwort has been present at Lake Waiorongomai since at least February 2013 and has previously formed a complete cover, with surface reaching bands along parts of the lake margin and amongst emergent plants (Spinks 2018). However, large die-backs of hornwort have been observed at the lake in late summer (Spinks 2018) and it may be that our survey coincided with such an event. Alternatively, our survey may reflect a major vegetation decline indicating the that the state of the lake has deteriorated further, and it can no longer support extensive growths of hornwort

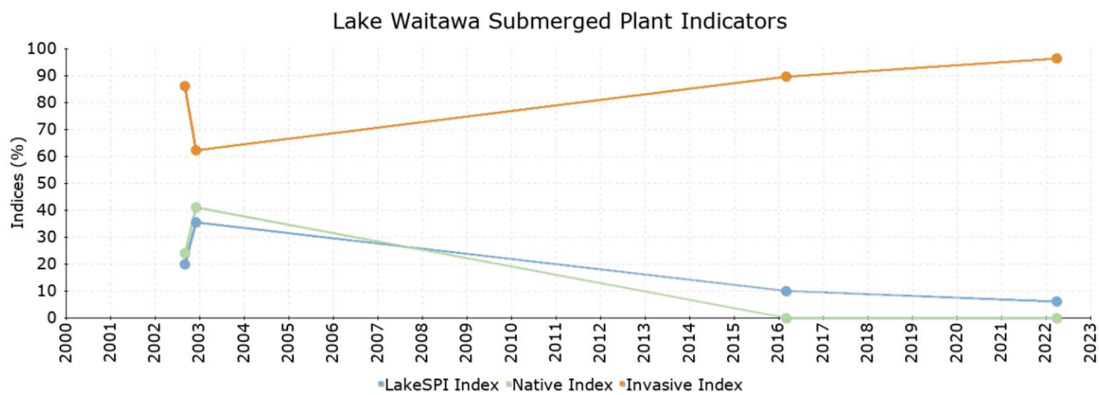
Figure 5: LakeSPI results for Lake Waitawa from the 2022 and earlier surveys.

In 2022, Lake Waitawa had a LakeSPI Index of 6%, indicating a poor lake ecological condition (Figure 5). The lake had a high Invasive Impact Index of 96% and a Native Condition Index of 0% (Figure 5).

Survey Date	Status	LakeSPI %	Native Condition %	Invasive Impact %
March 2022	Poor	6.0%	0.0%	96.3%
February 2016	Poor	10.0%	0.0%	89.6%
November 2002	Moderate	35.5%	41.0%	62.2%
August 2002	Poor	20.0%	24.0%	85.9%

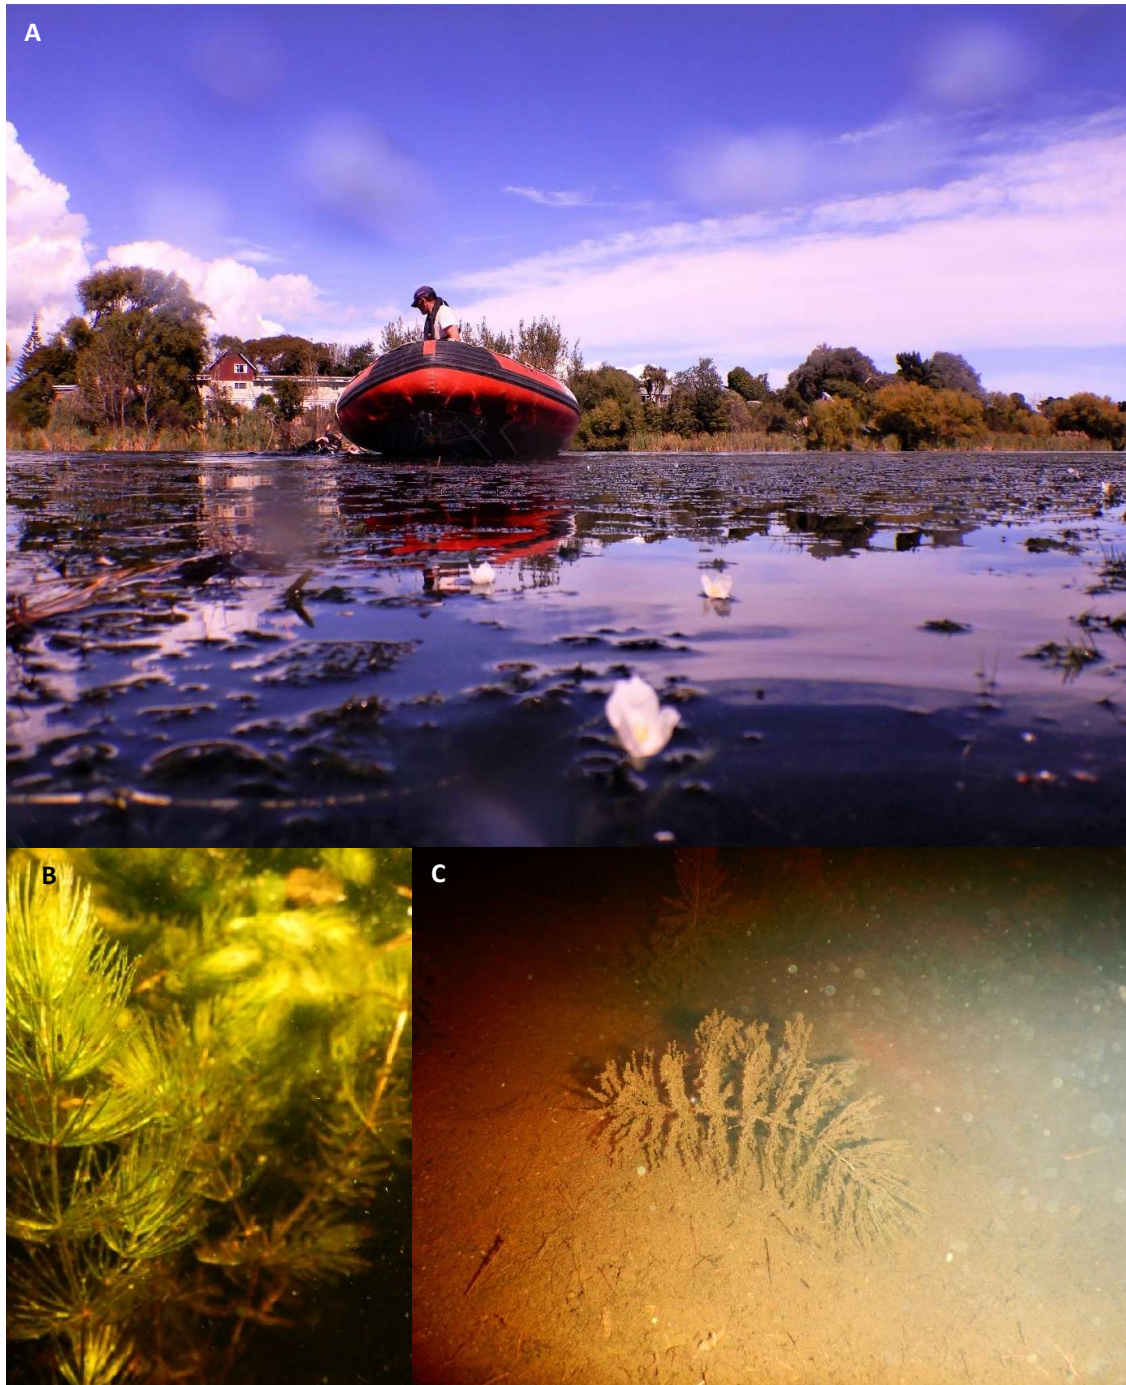
Figure 6: Lake Waitawa vegetation. A) a surface reaching band of hornwort (*Ceratophyllum demersum*) and white flowering egeria (*Egeria densa*), B) hornwort near the surface and C) fragments at c. 4 m depth.

In the 2022 survey, no native submerged plants were recorded in Lake Waitawa. Hornwort (*Ceratophyllum demersum*) formed a dense, surface-reaching band weed around the margin of the lake (Figure 6A and B) to an average of 2.7 m depth. Hornwort fragment fall-out was present down to 4 m depth but was probably not viable long-term (Figure 6C). *Egeria* (*Egeria densa*) was the only other submerged plant present (Figure 6A), where it mainly contributed to the weed bed in shallow water to 1.5 m depth.

Emergent bands of raupō (*Typha orientalis*) fringed the lake margin and waterlilies (*Nymphaea* hardy cultivar) occurred in shoreline patches. The floating plants, native *Azolla rubra* and non-native *Landoltia punctata*, were associated with the marginal lake vegetation.

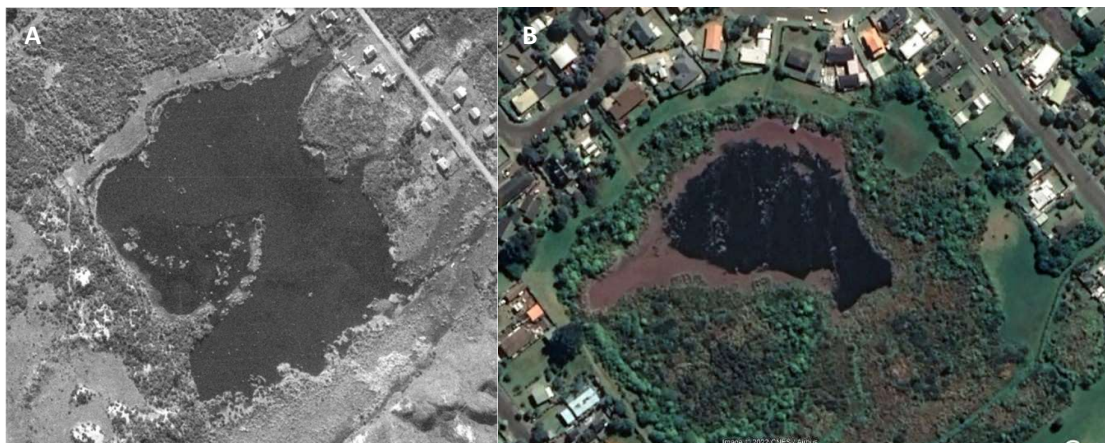
Figure 7: Waimeha Lagoon aerial photographs. A) the 1940's, B) 2020.

Based on historic aerial photos of Waimeha Lagoon from the 1940s (Kapiti Coast District Council⁶) this natural, shallow waterbody has substantially decreased in area of open water (Figure 7). The wetland pond-like character, including dominance of floating plants, mean it is not suitable to assess using LakeSPI.

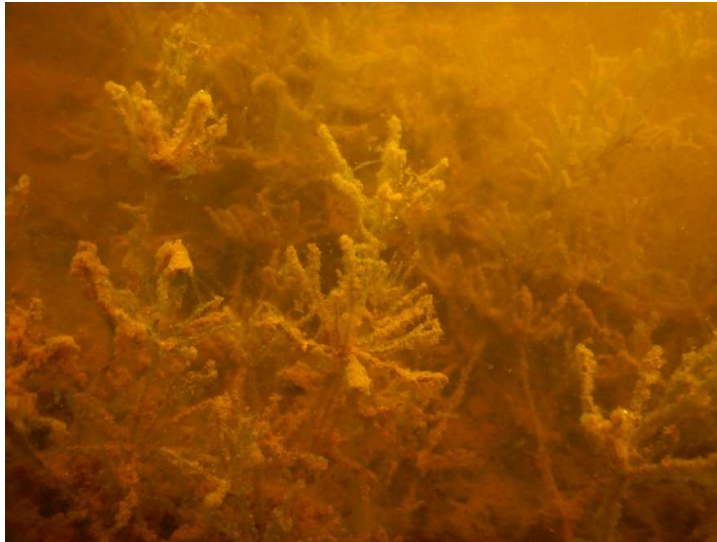
Figure 11: Submerged vegetation at Manly Street Lagoon comprised *Chara australis*, with plants encrusted with sediment.

The waterbody was fringed by dense beds of raupō (*Typha orientalis*) that extended into the open water area at lower covers. Abundant floating plants of native duckweed (*Lemna disperma*) had accumulated within the open margins of emergent beds.

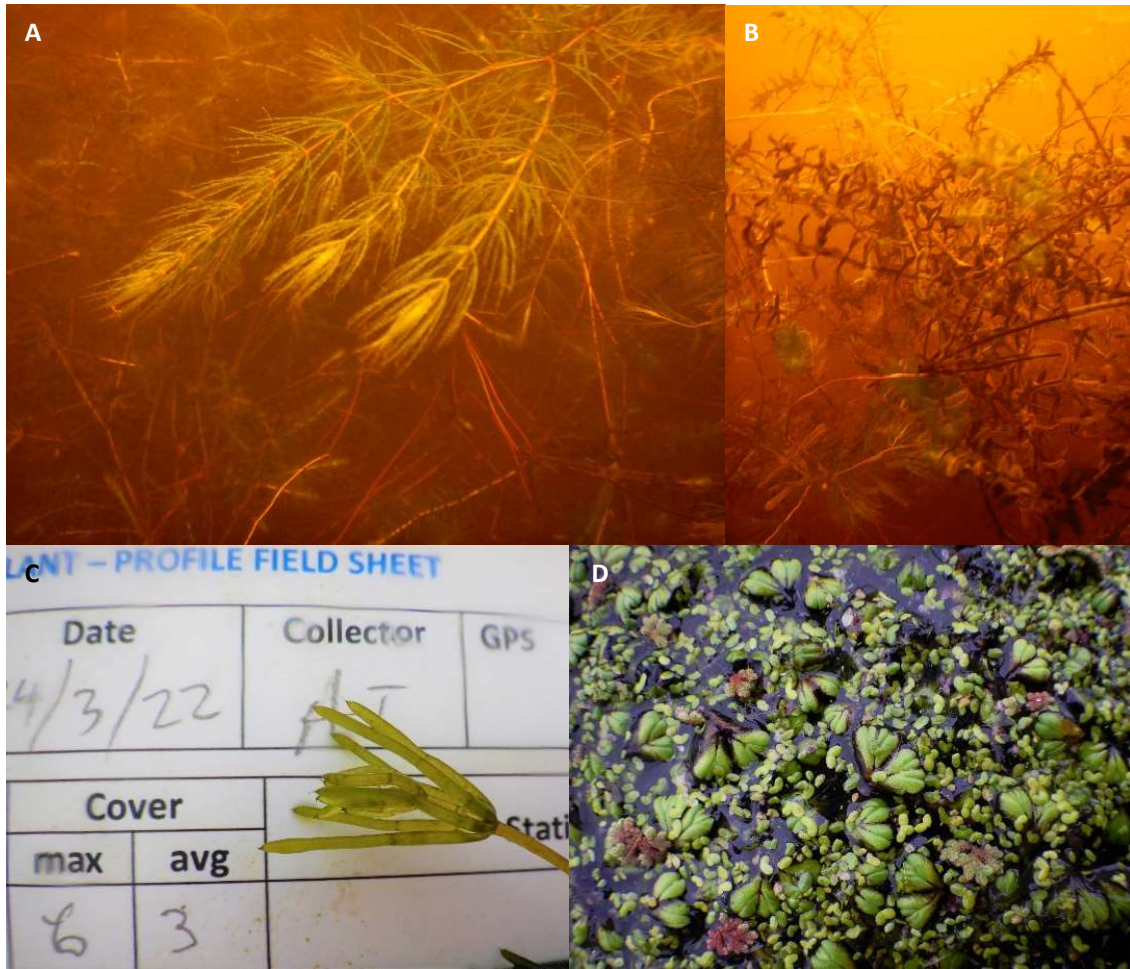
Figure 20: Matthew's lagoon vegetation. A) hornwort (*Ceratophyllum demersum*) and B) elodea (*Elodea canadensis*) plants occurred in patches, C) *Chara australis*, D) mixed assemblage of floating plants at the lagoon margin.

Hornwort was first recorded in drains entering the lagoon in 1998 and confirmed in the lagoon in 1999 (NIWA freshwater pest plant records). Although hornwort has been present for over 20 years it did not dominate the lagoon but did form patches of high cover. Exotic rudd (*Scardinius erythrophthalmus*) and goldfish (*Carassius auratus*) are reported for the Boggy Pond/Matthew's Lagoon complex (Reeves et al. 2013), but no obvious fish disturbance damage for plants was observed.

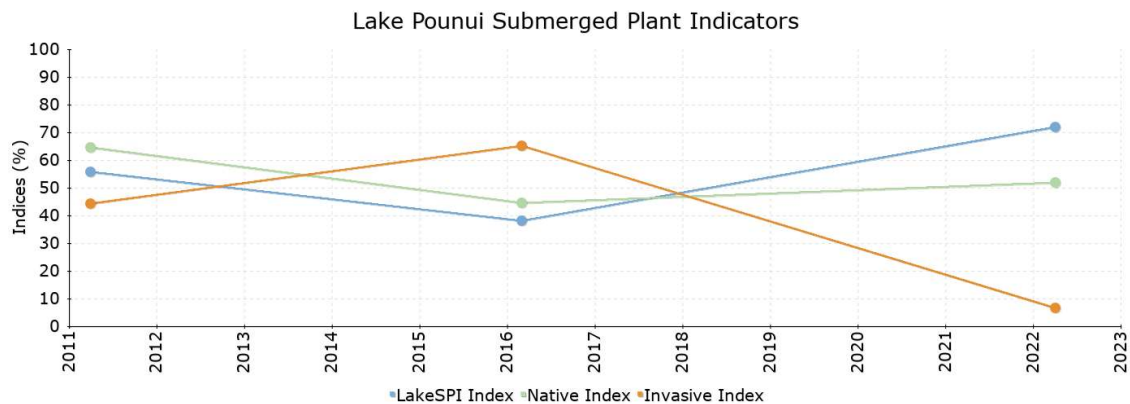
Figure 23: LakeSPI results for Lake Pounui from the 2022 and earlier surveys.

Survey Date	Status	LakeSPI %	Native Condition %	Invasive Impact %
March 2022	High	71.9%	51.8%	6.7%
February 2016	Moderate	38.1%	44.5%	65.2%
March 2011	High	55.7%	64.5%	44.4%

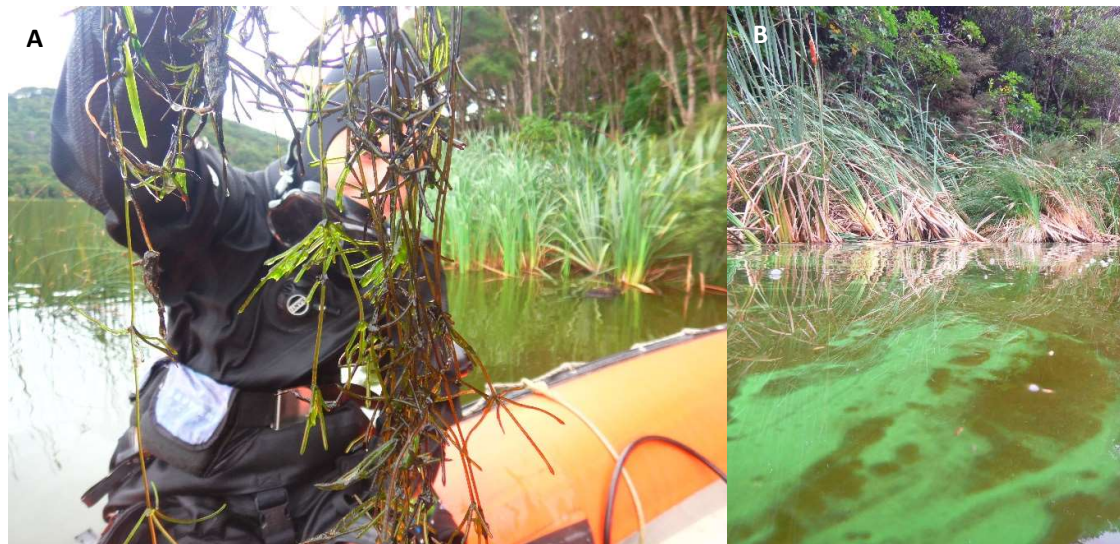
Figure 24: Lake Pounui in 2022. A) the charophyte *Chara australis* and B) algal bloom conditions at the lake.

Native pondweed (*Potamogeton ochreatus*) was the most widespread and deepest growing submerged plant, but it only formed covers of $\leq 25\%$, to the average maximum depth of 2 m at $>10\%$ cover. Scattered pondweed plants at lower cover were recorded to a maximum depth of 3.3 m. These plants appeared to be in poor health, black and stalky, with little fresh green growth.

The only invasive weed species detected comprised scattered plants of elodea (*Elodea canadensis*) to 2 m depth at one of the five surveyed sites. An algal bloom reduced the water clarity and had formed scums along the margin in downwind areas (Figure 24B).

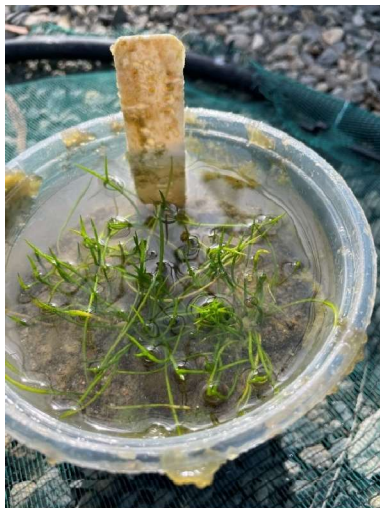
Figure 25: *Isoetes kirkii* plants collected from Lake Pounui, grown in culture for over a decade.

Quillwort plants from Lake Pounui were earlier collected and cultured and were used in a genetics study undertaken by NIWA for Department of Conservation (Hofstra and de Winton 2013). Lake Pounui quillwort were genetically similar to plants found in Lake Waikaremoana and Lake Taupo (Hofstra and de Winton 2016) but they displayed a relatively high level of genetic variation in comparison with the other populations (Hofstra and de Winton 2013). These plants are still maintained within NIWA's macrophyte culture facility in Hamilton (Figure 25).

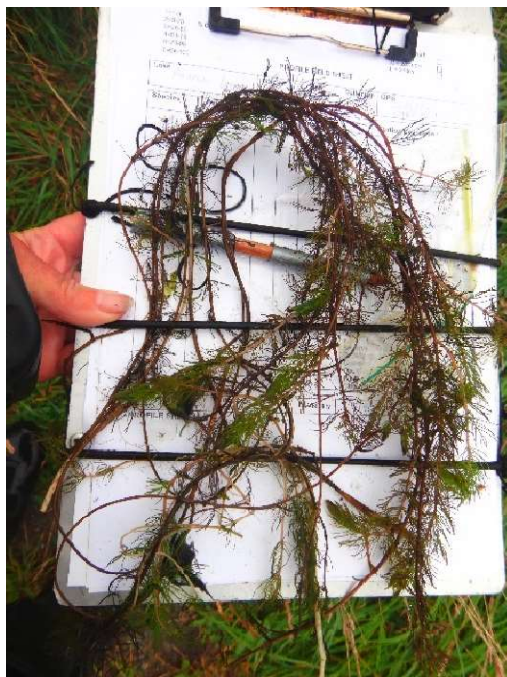
Figure 26: Native milfoil dominated Pounui Lagoon.

In 2022, the most abundant submerged plant was native milfoil (*Myriophyllum triphyllum*), which formed average covers of 50% to the maximum surveyed depth of 0.5 m (Figure 26). Also common was *Ruppia polycarpa* and *Zannichellia palustris*, which appeared to have colonised disturbed patches where milfoil had been grazed by waterfowl. The native turf *Lilaeopsis novae-zelandiae* and charophyte *Nitella hyalina* were recorded at the site in the south of the lagoon. Beds of raupō were common at the lagoon margin. High covers of filamentous green algae were recorded at sites in the northern half of the lagoon that appeared to have prevented development of the shorter-growing plants. The only invasive weed was curled pondweed (*Potamogeton crispus*), which was uncommon.

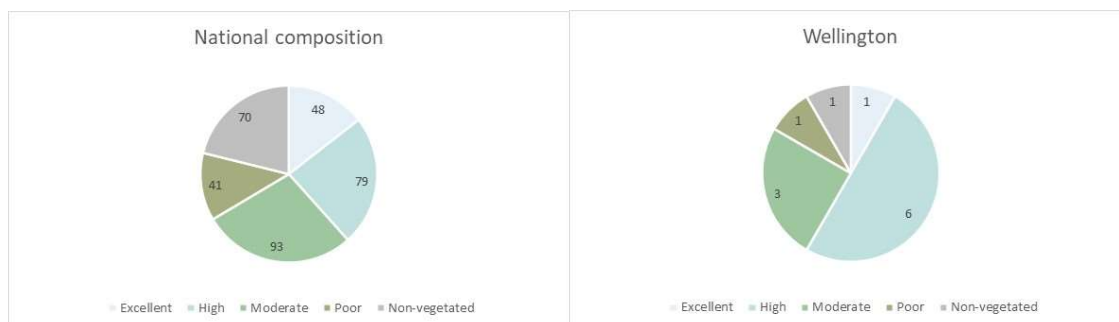
Figure 28: Proportion of lakes that fall into each of five categories of LakeSPI Index. A) Wellington Region (12 surveyed lakes) and nationally (331 lakes), with number of lakes assessed shown for each category.

- A similar proportion of lakes were recorded in the ‘moderate’ category for Wellington Region and nationally.
- A lower proportion of Wellington waterbodies were recorded in the ‘poor’ and ‘non-vegetated’ categories.

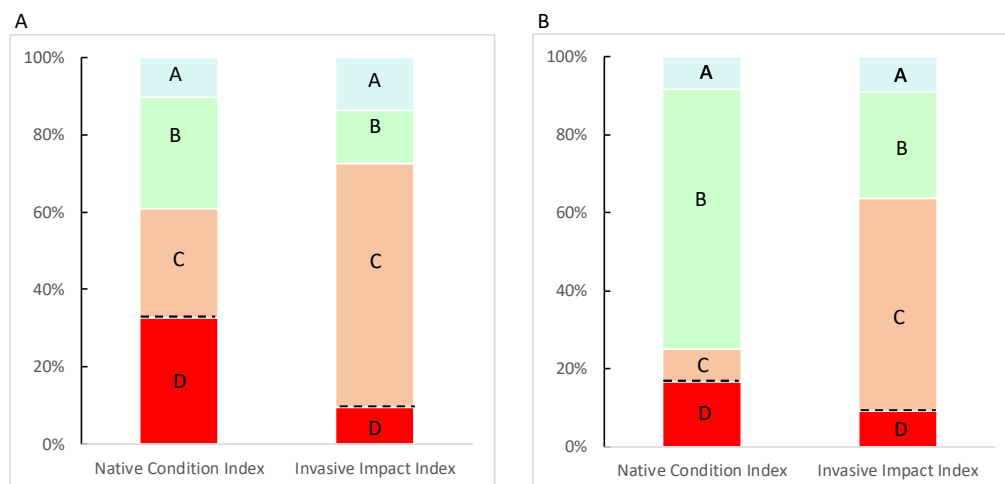
*Non-vegetated lakes are not scored for Invasive Impact Index under the NPS-FM.
