Eastern Bays Shared Path: Freshwater Fish Passage Requirements

EOS Ecology Report No. HUT01-18016-01 | March 2019

Prepared for Hutt City Council

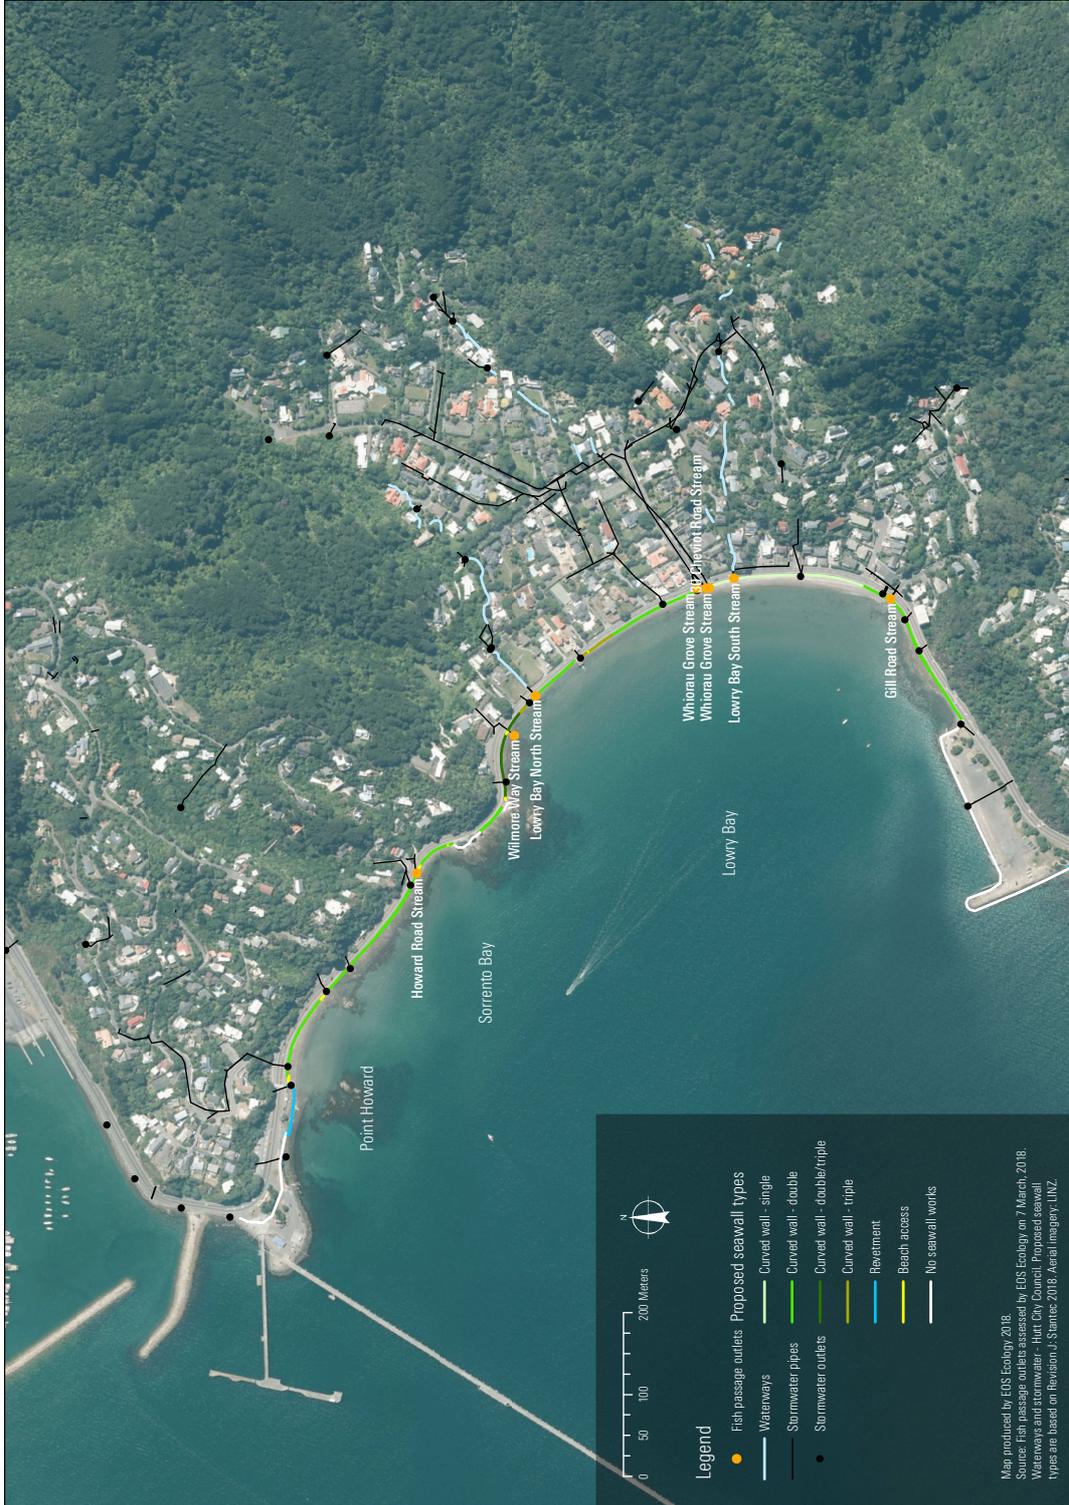
Figure 3 Pipe outlets within Sorrento Bay and Lowry Bay assessed for fish passage on 7 March 2018 by EOS Ecology.

The Wilmore Way Stream outlet discharges to the intertidal zone with an approximately 45 cm vertical drop (at low tide) over the edge of the existing seawall to a pebble beach below (Figure 3, Table 2, Figure 4.). Banded kokopu whitebait could climb this small drop, which will only be evident at low tide. The elevated position of this pipe means it is rarely, if ever, blocked by intertidal gravels. The natural open stream upstream is too small to appear on topographic maps, the REC, or the HCC hydrology GIS layer and drains a short, steep forested catchment. It has limited fish habitat available with some shallow pools observed interspersed by sections of very shallow surface flow (1–2 cm water depth). It is possible fish are present. It is probable this stream has sections of intermittent surface flow during dry periods. A double/triple curve concrete seawall is proposed at this location.

The Lowry Bay North Stream outlet consists of triple 600 mm pipes discharging to a cobble beach and appears to be at least partially blocked by beach substrate much of the time (Figure 3, Table 2, Figure 4). At the time of the site visit surface flow could be seen coming through the central pipe only. Lowry Bay North Stream has a relatively large upstream catchment from which banded kokopu have been confirmed (2002 NZFFD record). This stream is large enough to appear on topographic maps and the REC, and the lower section through the urban area is shown on the HCC hydrology GIS layer. A double/triple curve concrete seawall is proposed at this location.

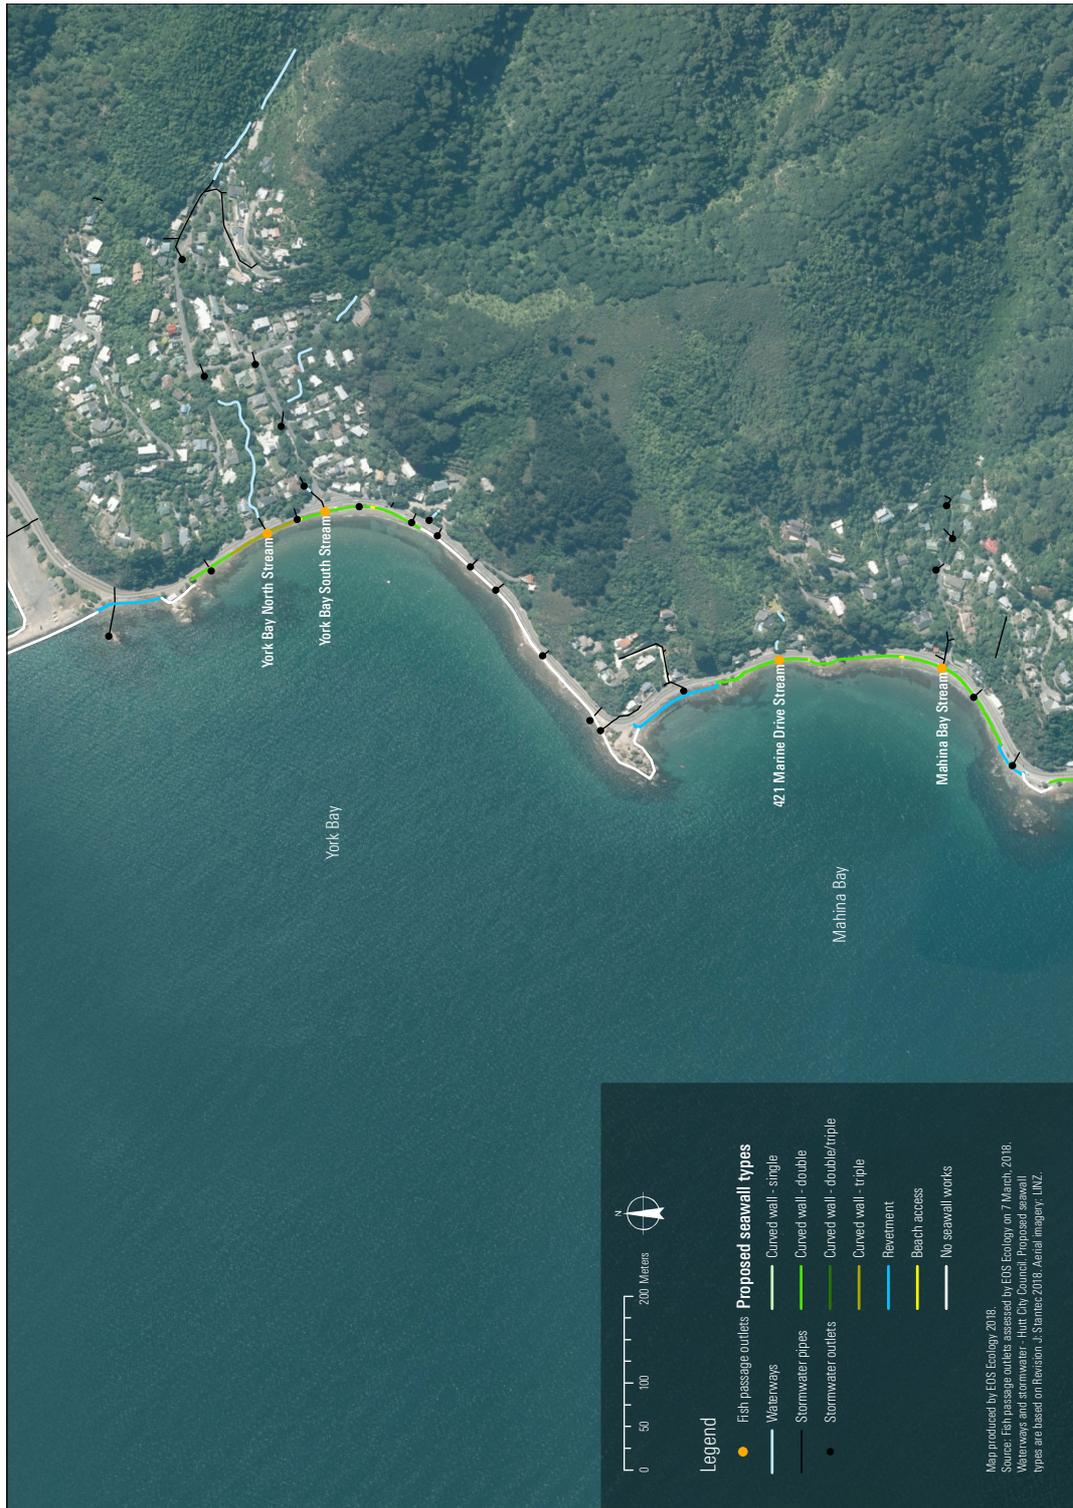
Figure 8 Pipe outlets within York Bay and Mahina Bay assessed for fish passage on 7 March 2018 by EOS Ecology.

The beach outlet pipe of 421 Marine Drive Stream was almost completely filled with gravel with no surface flow evident at the time of the site visit (Figure 8, Table 4, Figure 9). Upstream of the Marine Drive culvert the stream flows through another culvert under a parking area, which has a perched outlet. The upstream catchment consists of a relatively short, steep forested gully and the observed open channel had a very small volume of water present. This stream is too small to appear on topographic maps or the REC, however two short sections are shown on the HCC hydrology GIS layer. It is unlikely this stream has freshwater fish present, although further investigation of upstream freshwater habitats and a fish survey would be required to confirm this. A double curve concrete seawall is proposed at this location.

The outlet of Mahina Bay Stream was completely obscured by sediment at the time of the site visit with the flow of the small stream observed upstream of Marine Drive apparently flowing through the beach gravels (Figure 8, Table 4, Figure 9). This stream is too small to appear on topographic maps and is not shown on the HCC hydrology GIS layer but is depicted in the REC. A fish (likely a banded kokopu) was observed in a pool upstream of Marine Drive during the site visit indicating that the outlet must be open enough to provide fish passage at times. A double curve concrete seawall is proposed at this location.

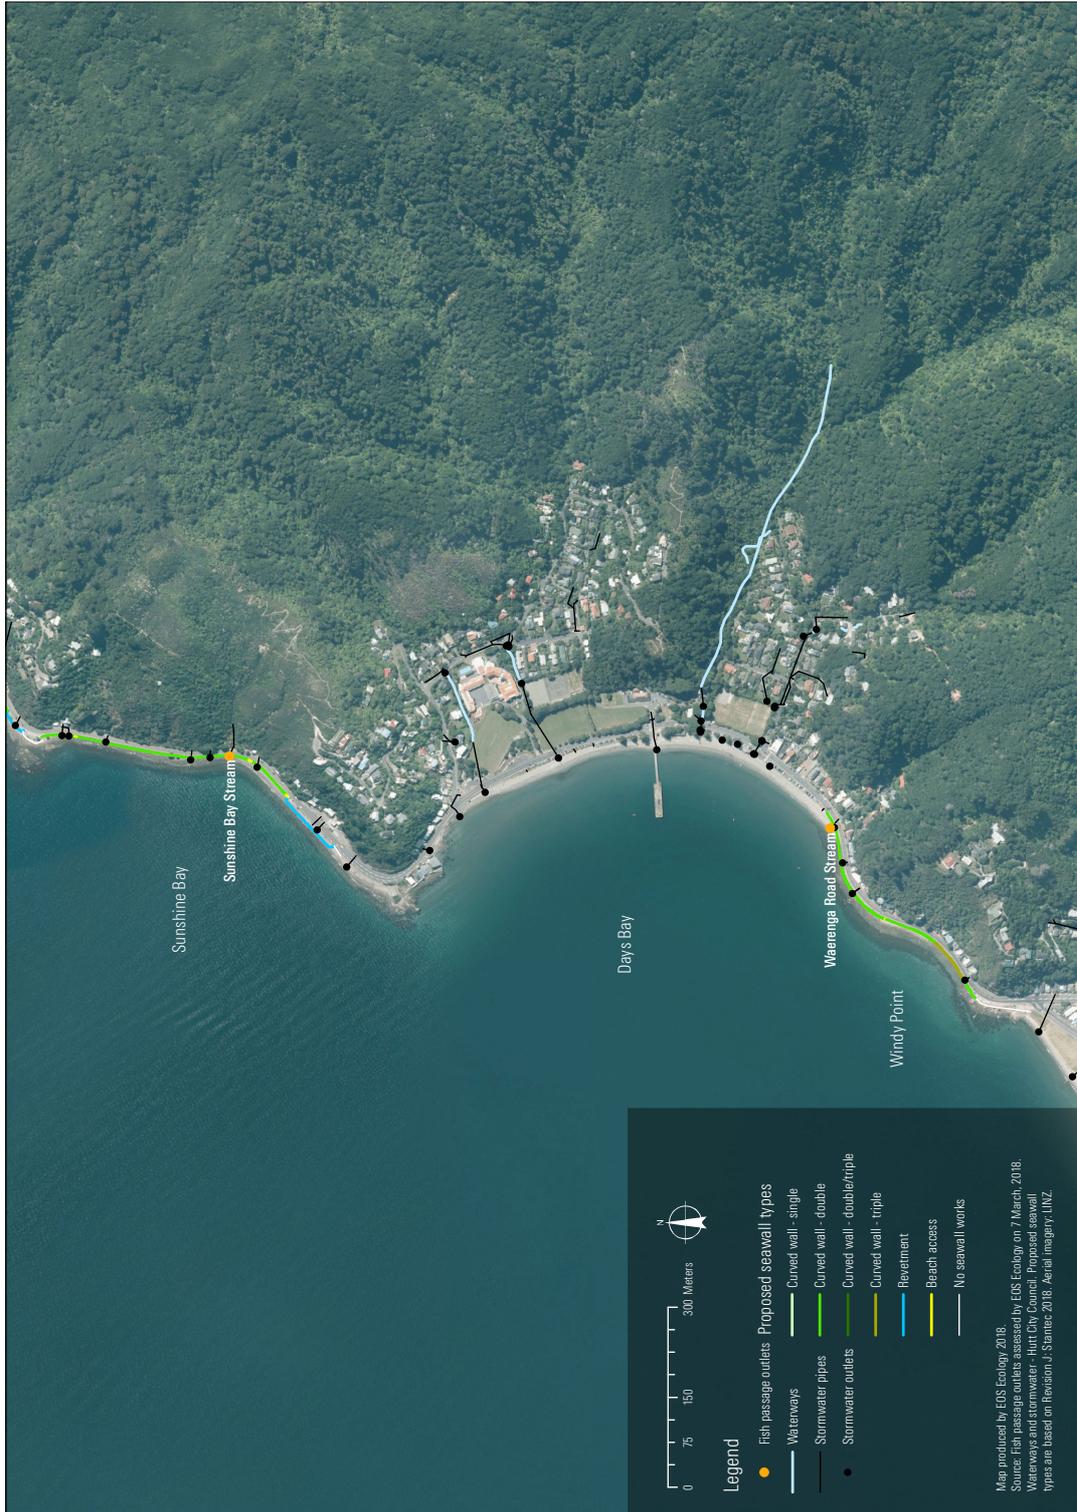
Figure 11 Pipe outlets at Sunshine Bay and Windy Point assessed for fish passage on 7 March 2018 by EOS Ecology.

Sunshine Bay Stream had a fully open outlet set in the existing seawall well above the current beach level (Table 5, Figure 10, Figure 11). The natural open stream upstream does not appear on topographic maps, the REC, or the HCC hydrology GIS layer. The upstream catchment could not be assessed during the site visit; hence the state of the freshwater habitat there not known. However, given the short, steep catchment it is unlikely to have suitable fish habitat upstream although further investigation of upstream freshwater habitats and a fish survey would be required to confirm this. A double curve concrete seawall is proposed at this location.

Waerenga Road Stream discharges to the southern end of Days Bay (near Windy Point) with the pipe almost completely blocked by beach sediments at the time of the site visit (Table 5, Figure 10, Figure 11). The natural open stream upstream does not appear on topographic maps, the REC, or the HCC hydrology GIS layer. The upstream catchment could not be assessed during the site visit; hence the form of the open channel is not known. However, given the short, steep catchment that is unlikely to have suitable fish habitat upstream although further investigation of upstream freshwater habitats and a fish survey would be required to confirm this. A double curve concrete seawall is proposed at this location although this outlet appears to be seaward of the toe of the proposed seawall and hence will not require an extension.
