20 December 2010

5-C1930.00

### **Baring Head – Inspection of World War II Structures**

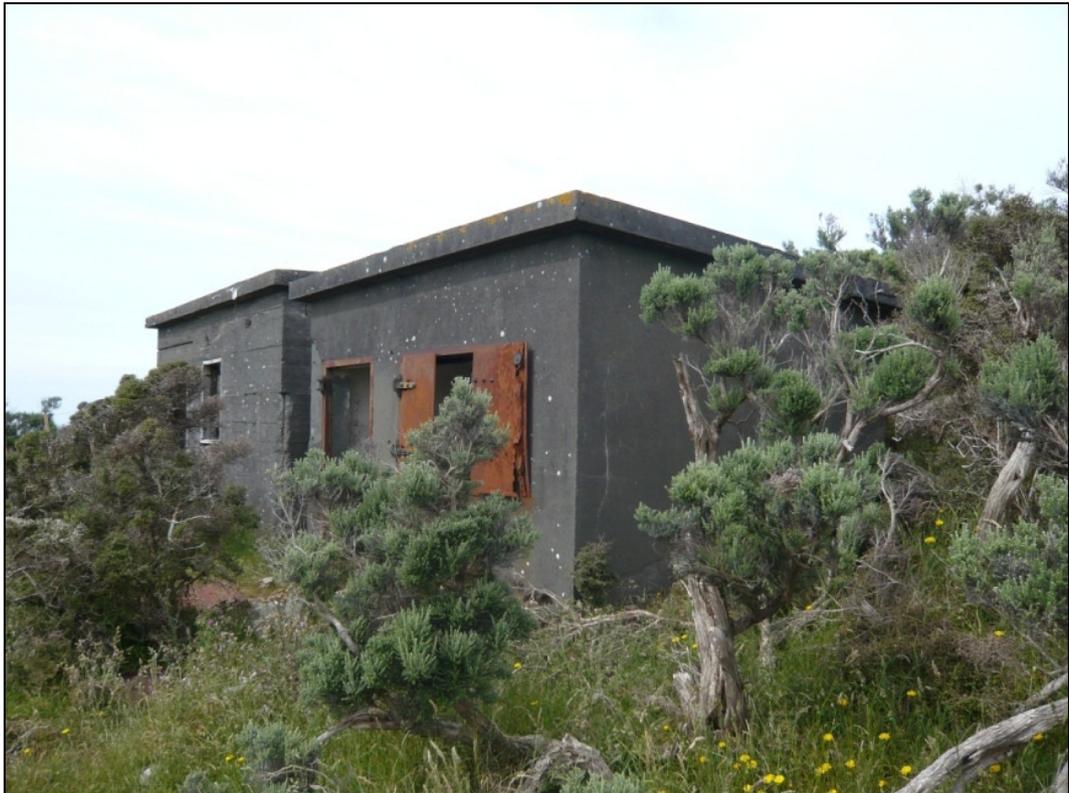
Front view of reinforced concrete buildings

The external faces of the building were found to be in relatively good condition (especially with regard to its age and exposed location), with minor loss to the concrete rendering around the doorway. The building shows signs of neglect internally.

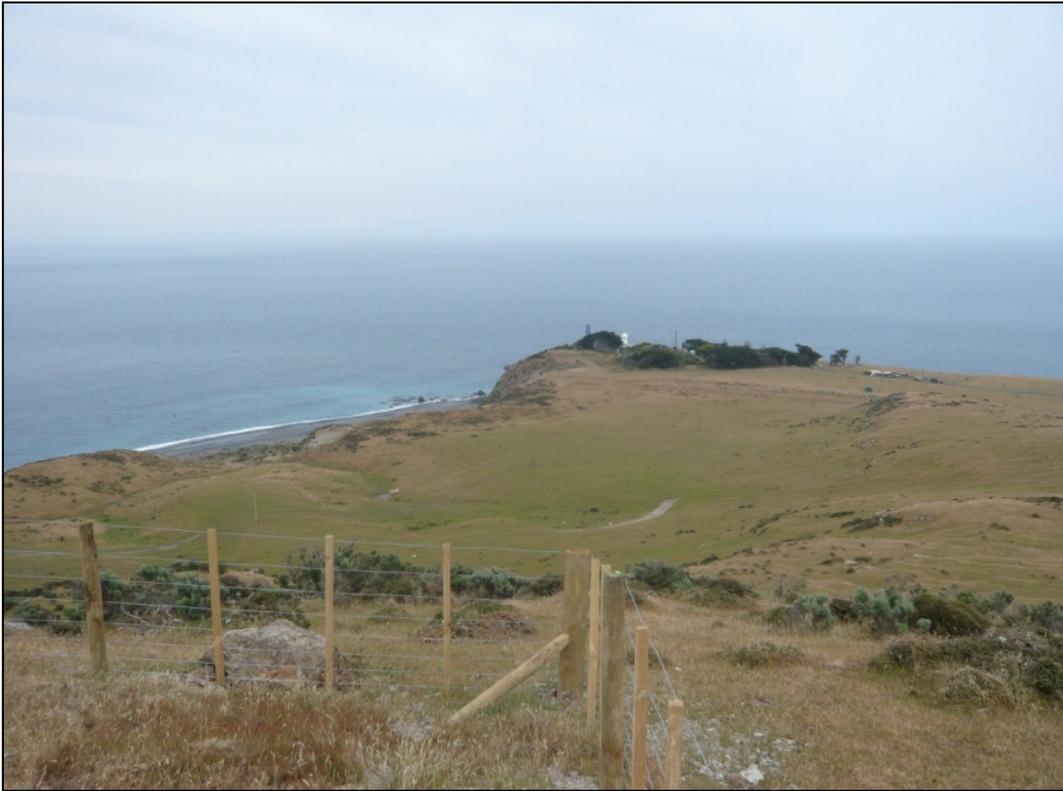
The bunker consists of an cast in situ reinforced concrete partially buried structure. The roof is also cast in reinforced concrete (see **Photos 16 and 17**). In order to provide uninterrupted views, the front half of the bunker roof was originally cast as a cantilever, with steel beams providing roof support.

Photo 17 – Structure 3 - View from observation bunker looking towards Baring Head Lighthouse.

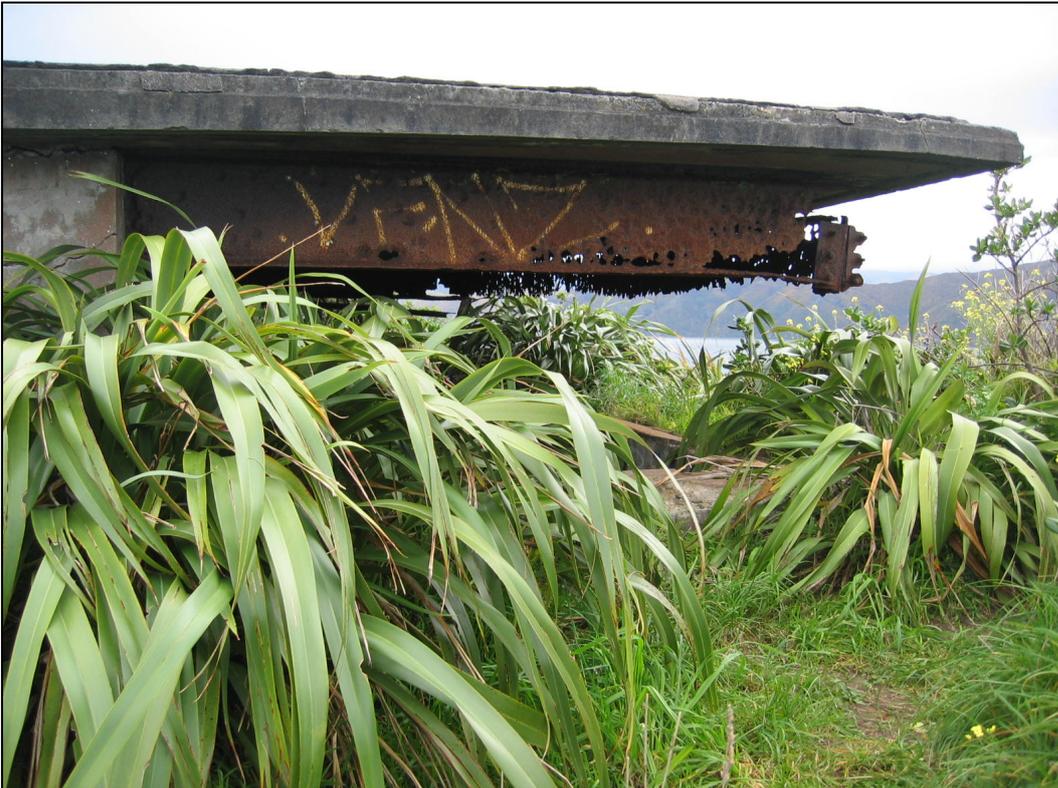
The nature of the location (direct exposure to a coastline environment), coupled with a lack of upkeep, has unfortunately resulted in the collapse of the cantilever portion of the roof into the bunker at some time in the past (see **Photo 18**). For comparative / illustrative purposes of how the bunker would have looked prior to slab failure, **Photo 19** shows a similar structure at Fort Dorset which remains fully intact.

Photo 19 – **FOR COMPARISON / ILLUSTRATIVE PURPOSES ONLY**  
View of intact roof cantilever slab – Fort Dorset
