RESOURCE CONSENT
APPLICATION
FOR THE STAGE 4
EXTENSION OF THE
SOUTHERN LANDFILL,
WELLINGTON

Southern Landfill Stage 4

Phase 1 Geotechnical Report

AUGUST 2013

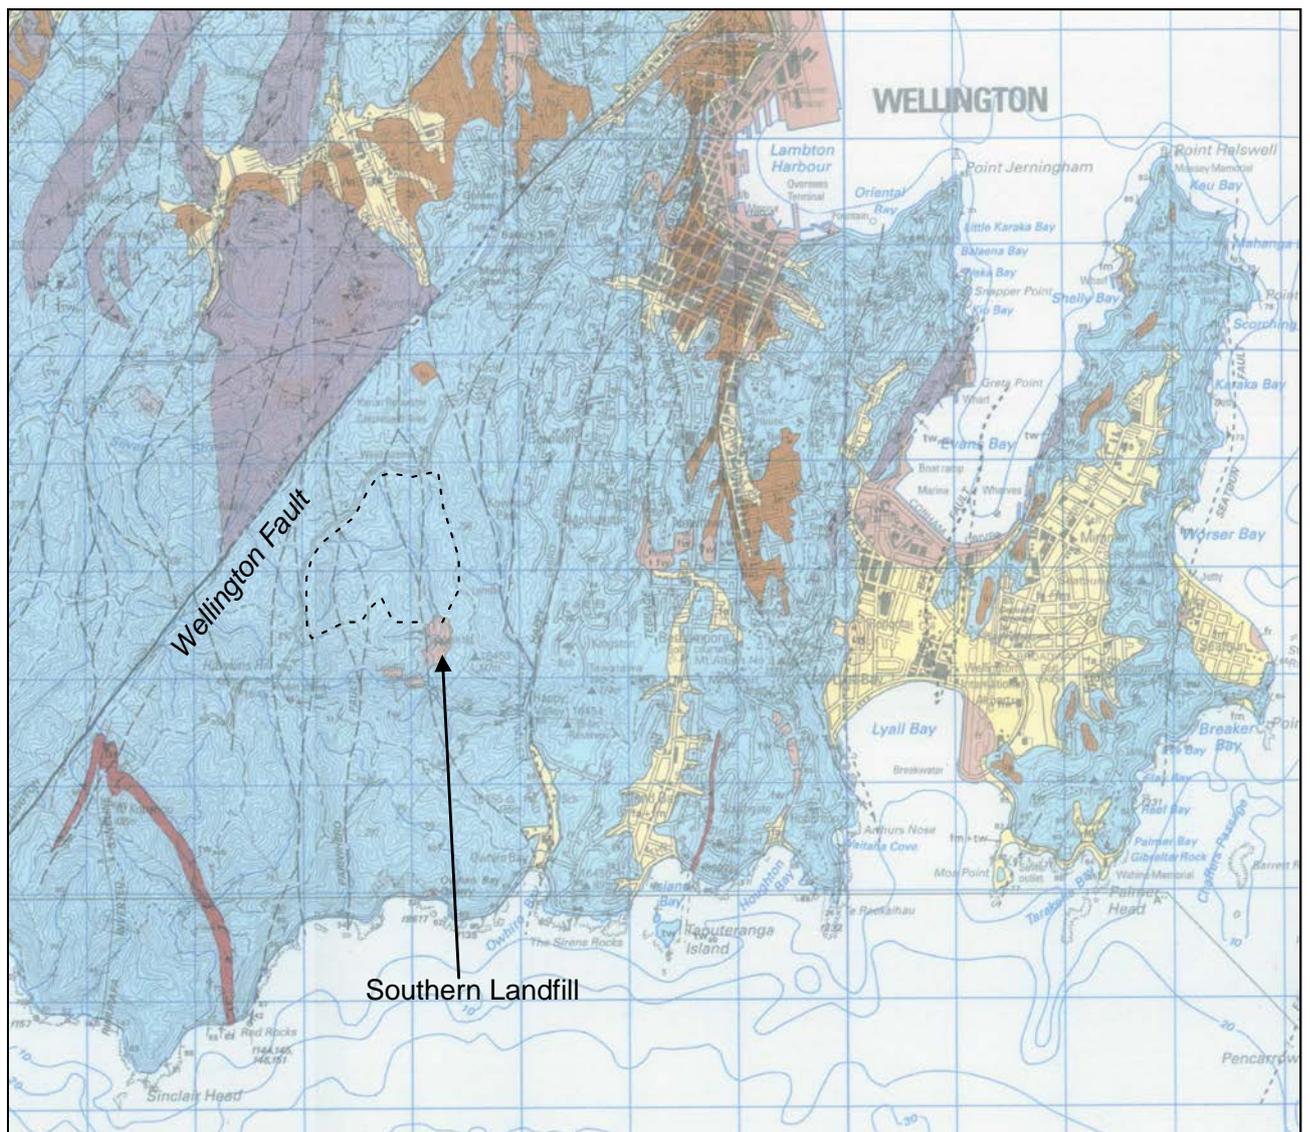
This shows the Stage 4 area to be underlain by Rakaia Terrane (Torlesse Group) indurated sandstones and mudstones, often referred to as "greywacke". The local geology is summarised in **Figure 2-1**, with blue areas underlain by greywacke.

The major structural elements in the region include the Wellington Fault, which strikes approximately northeast and reaches within 1 km of the north-eastern boundary of the site. In addition, several north striking faults (mapped as possibly inactive) are inferred to pass through the site (See **Figure 2-1** and **Drawing G-002**). The regional bedding orientation shown is a moderately steep dip towards the west and northwest.

Figure 2-1 Geological map of the Wellington area (after Begg and Mazengarb 1996). The blue area underlying Stage 4 area outline is Greywacke (Sandstone and mudstone).

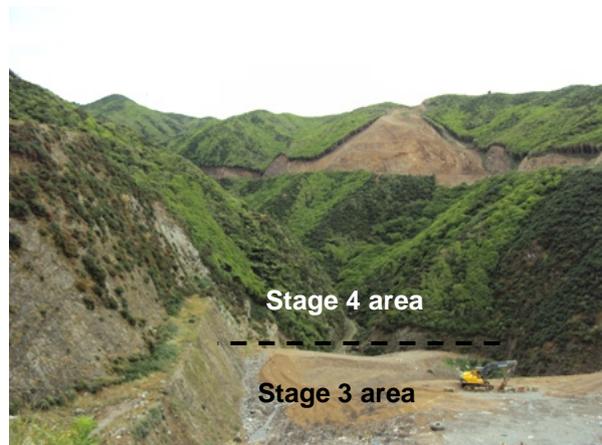
Plate 3-3 View up valley into northern and western areas of the proposed Southern Landfill Stage 4 area, from east and west access roads respectively.

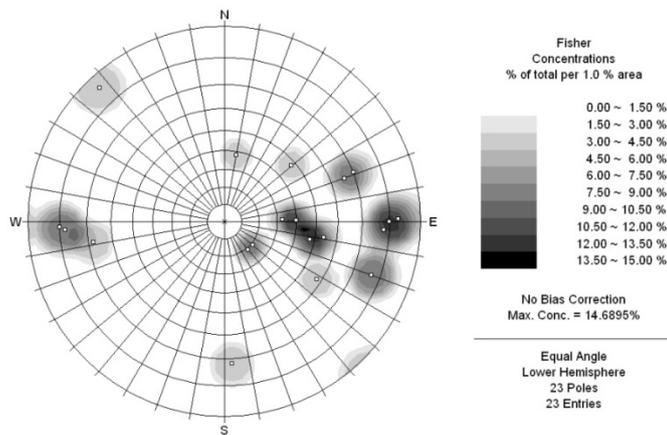
Bedding attitudes have been measured using a structural compass and typical orientations have been plotted on stereonet (**Figure 3-1**). Note that only easily accessible locations were assessed, thus there is bias in the data set.

Figure 3-1 Lower hemisphere equal area projection of poles to all bedding measured in outcrop. Projection generated by DIPS 5.1.

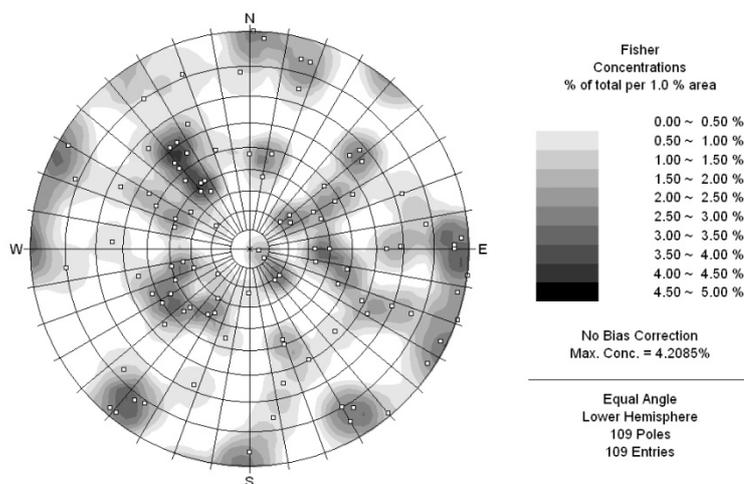
Joints are typically very closely to moderately widely spaced, impersistent (<1 m to 3 m), planar smooth to undulating smooth, very narrow to tight, weathered and minor silt and clay infill. As is typical of Rakaia Terrane sandstones and mudstones, joint orientations do not fall into simple joint sets but there may be in excess of three to five joint sets with additional random joints. The high variation in the joint set orientation may be partly due to the extensive faulting that has taken place in this area. Identifiable joint sets in outcrops were measured during this evaluation and orientations have been plotted on stereonets (See **Figure 3-2**). Note that only unrestricted accessible locations were assessed, thus there is a degree of bias in the data set.

Figure 3-2 Lower hemisphere equal area projection of poles to joints measured in outcrop. Projection generated by DIPS 5.1

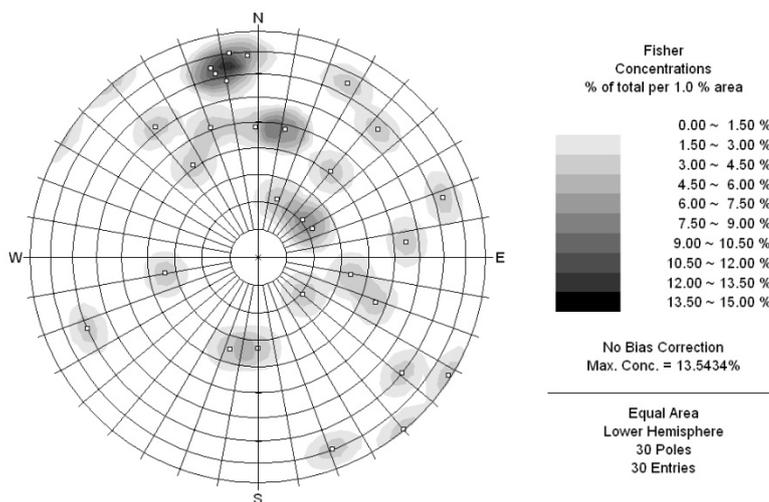
Shears or faults up to about 0.5 m in thickness are common in outcrop (See **Plate 3-4** and **Drawing G-001**). These comprise a zone of intensely fractured rock and contain seams of sheared rock or clay 5 mm to 50 mm in thickness. The shears exhibit variable orientations and have an average spacing of 3 m to 10 m. The orientations of dominant shears or faults exposed in outcrop were measured and have been plotted on **Figure 3-3**. Continuity of the shears or faults was observed to be at least 20 m in places and some features are expected to be continuous for hundreds of metres. Note that only easily accessible locations were assessed, thus there is bias in the data set.

The widest shears or faults observed (refer **Plate 3-5**) have less than 1 m to 3 m thickness of sheared material or fault gouge (angular sandstone gravel and cobbles in silty matrix) and groundwater seepage was observed.

Figure 3-3 Lower hemisphere equal area projection of poles to faults and shear zones measured in outcrop. Projection generated by DIPS 5.1
