Mangaroa River Flood Hazard Assessment

EROSION HAZARD REPORT

GW/FP-G-06/64

- Revision A
- 29 May 2006

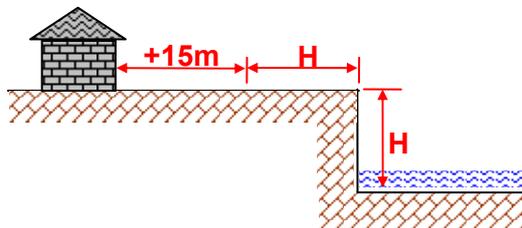
■ Figure 7 Minimum Recommended Setback

Using the outcomes of the risk assessment building exclusion offsets have been recommended for the previously identified erosion and landslip risk areas. As a minimum it is recommended that structures should be setback from the bank crest at least the distance equal to the height of the river bank (H) plus a margin of safety. As the risk ranking (table 4) increases the setbacks should also be increased to reflect this. The following formulae are considered appropriate for the purposes of this study. This methodology is illustrated in Figure 7.

Risk	Proposed Setback from Bank Crest (m)
Extreme	$3H + 15m$
High	$2H + 15m$
Other	$H + 15m$
