KiwiRail

Muri Station Risk Assessment Report

Report Date: 17/06/10

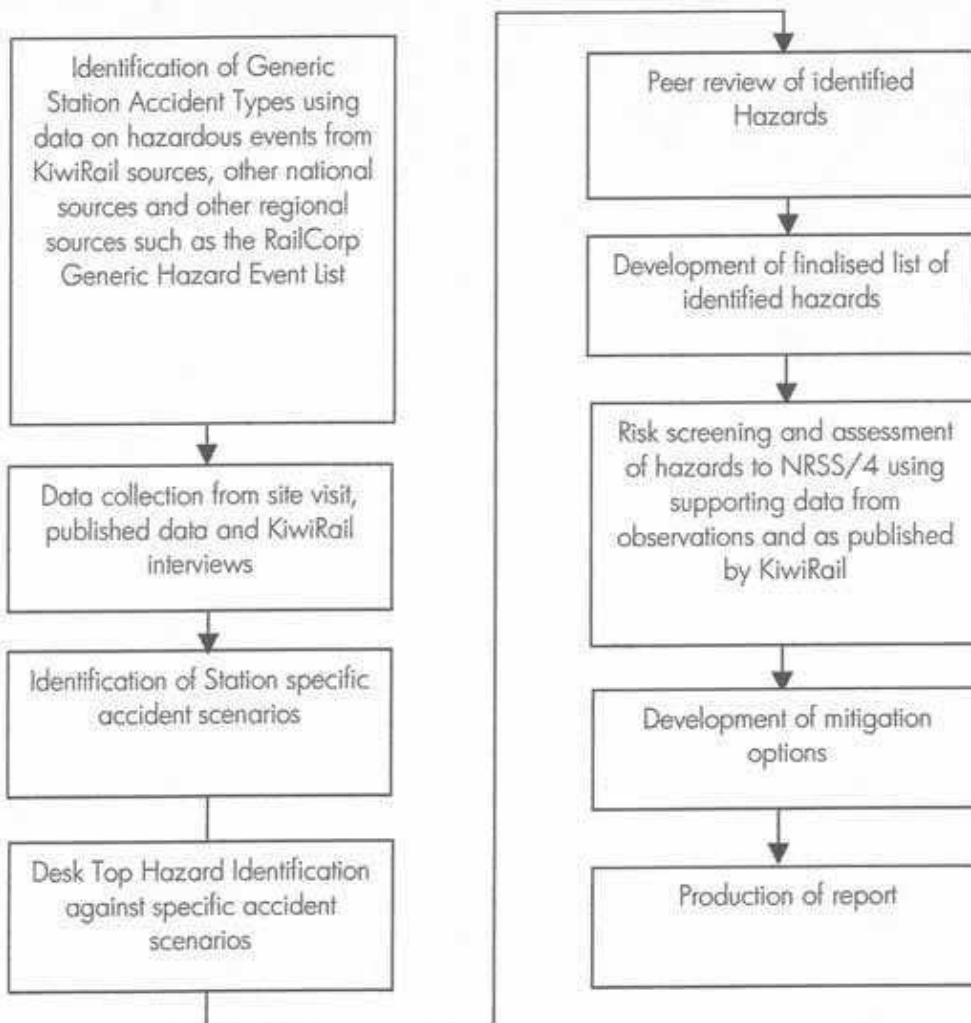
3.2 Applied Methodology

Diagrammatically the following approach has been applied to the hazard identification and risk assessment of the Muri station process:
