Chapter Seven

SCHEME REFINEMENTS 1972 to 1990

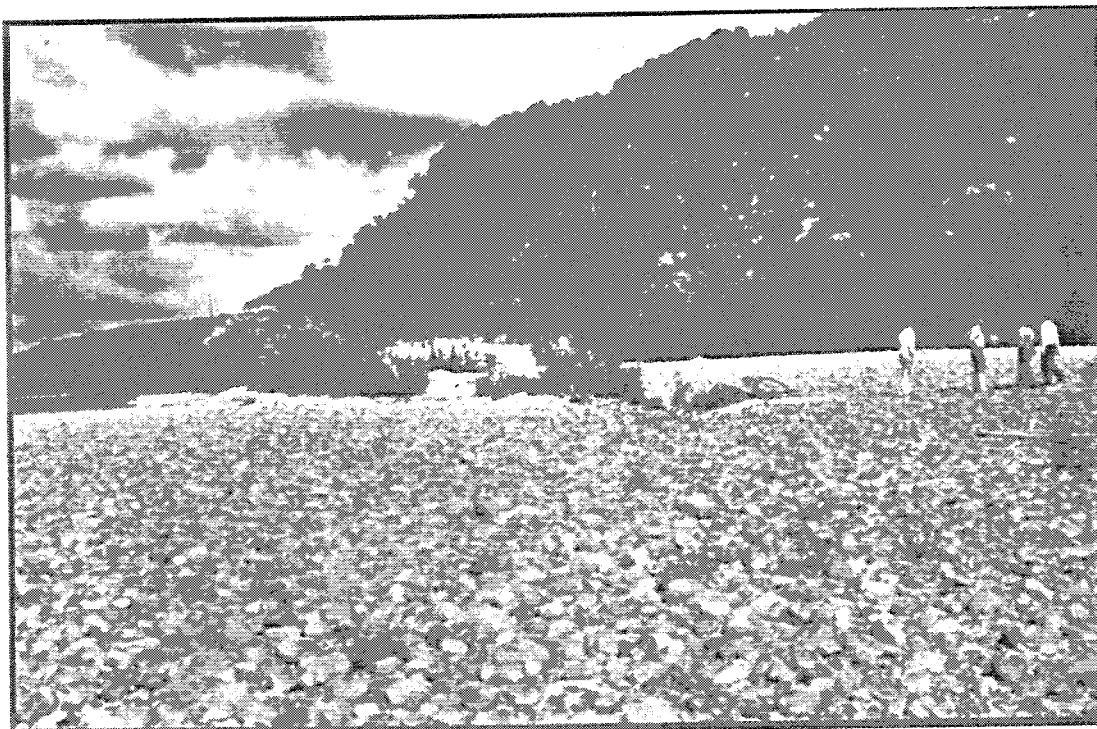
Plate 75: Failure of Silverstream Cut, c. 1984, showing the breach in the western bank protection works and the reactivation of the old western channel.
Source: WRC photo.

In the case of the Silverstream Cut (plate 81, p. 132), essential complementary work was not carried out. The formation of the embankment for the proposed diversion of State Highway 2 - the principal reason for the Cut - on the right (east) bank did not proceed. The old river channel remained unfilled and operated as a diversion during moderate floods. To make matters worse, the old river bed was used as a borrow pit for Ministry of Works and Development roading projects. It was only a matter of time before the River reverted to its original channel.

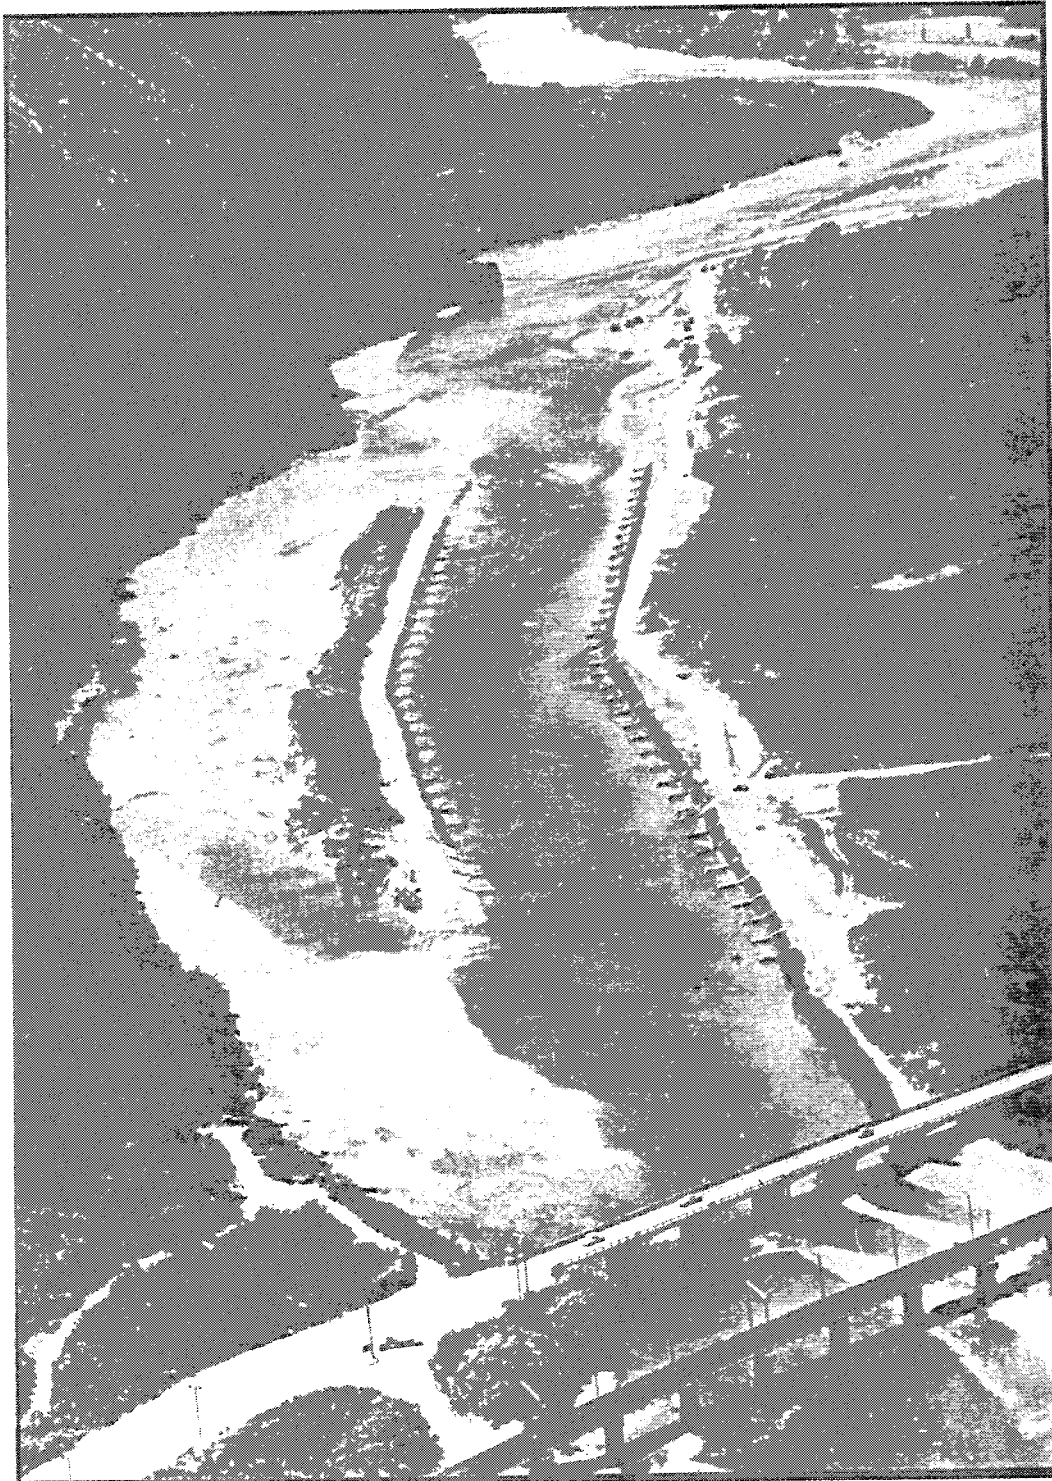
Plate 81: Silverstream Cut 1st Stage, 1960. View looking northwards to Barton's Bush. Source: HRB photo
