Annual groundwater monitoring report for the Wellington region, 2008/09

greater WELLINGTON
REGIONAL COUNCIL

GW/EMI-G-09/234

October 2009

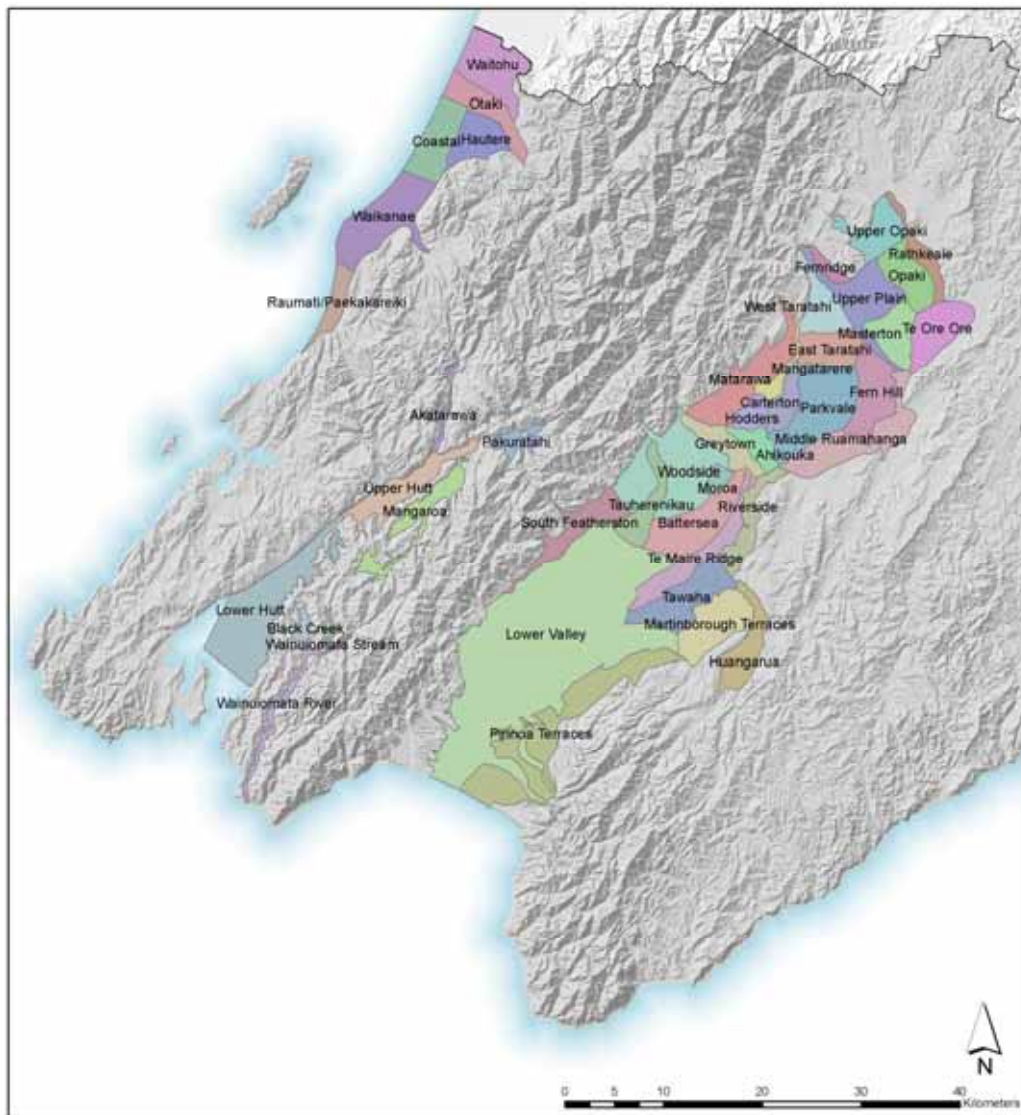
Figure 2.1: Groundwater management zones in the Wellington region

Groundwater management zones have been defined in all principal and some secondary groundwater areas (Figure 2.1). These have been used as a framework for describing groundwater areas in this report.

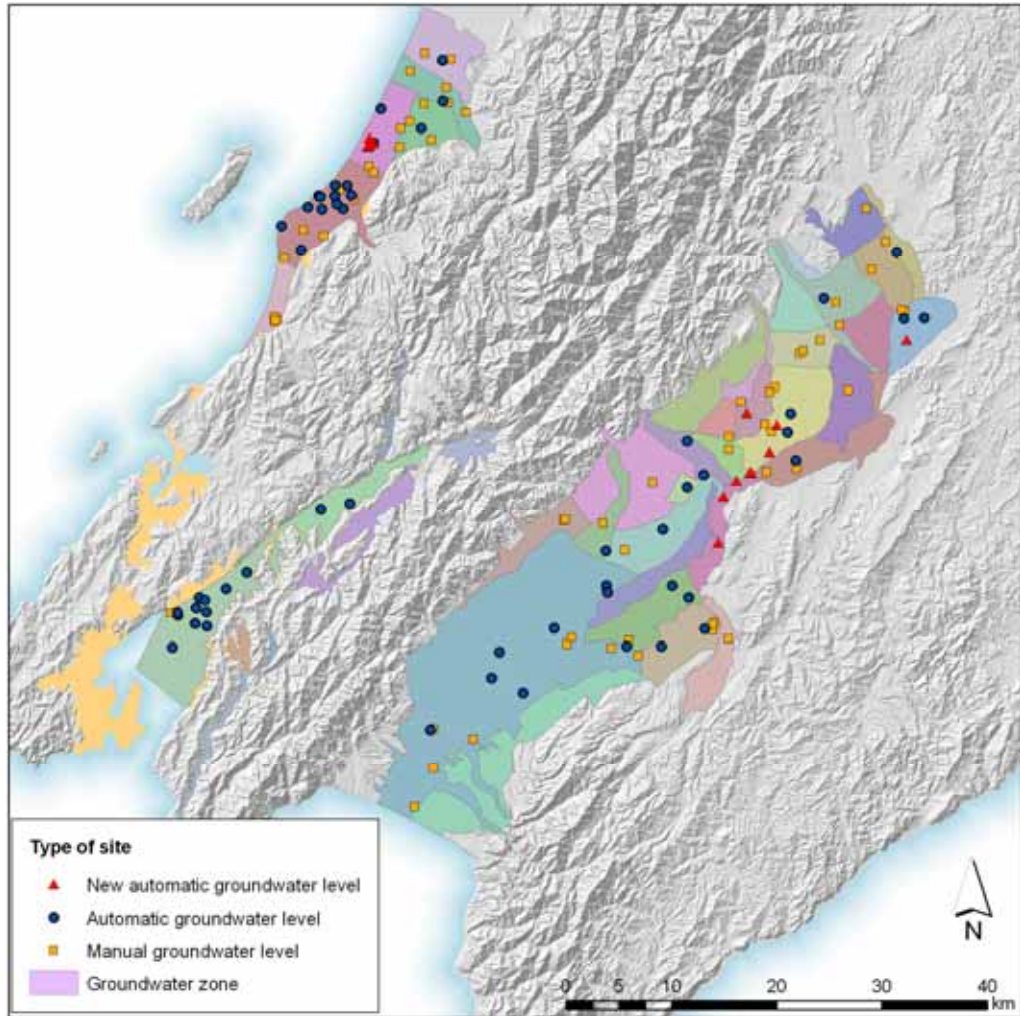
Figure 2.2: Location of groundwater level sites in the Wellington region monitored over 1 July 2008 to 30 June 2009, including new automatic groundwater level monitoring sites installed in the Wairarapa Valley and on the Kapiti Coast

Greater Wellington monitors a network of boreholes for groundwater level and quality. This network utilises dedicated monitoring boreholes as well as used⁵ and un-used⁶ privately owned boreholes. The groundwater level network currently consists of 75 automatic and 72 manually dipped⁷ boreholes (Figure 2.2 and Appendix 1).

- A new water quality monitoring borehole at Riversdale was added to the GWSOE network in September 2008 to increase the network's spatial coverage of the region (Figure 2.2).

- As part of the Wairarapa groundwater investigation (see Section 3.2), 11 new monitoring boreholes were constructed in 2008. These bores were located to provide hydrogeological data in areas with critical 'gaps' in the current monitoring network. Electronic logging equipment was installed in these wells during 2008/09 (Figure 2.2).

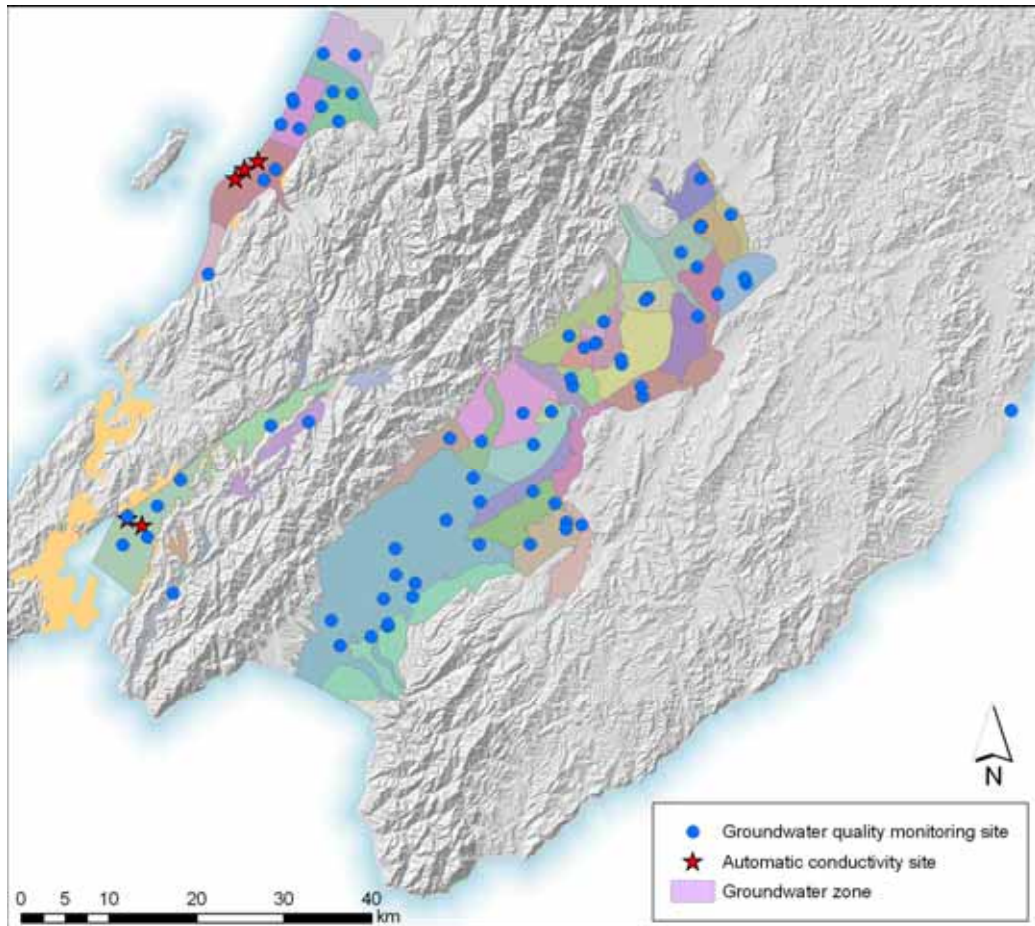
Figure 2.3: Location of existing routine groundwater quality monitoring sites in the Wellington region. Automated saline intrusion groundwater monitoring sites are also shown.

The core groundwater quality monitoring network, referred to as the Groundwater State of the Environment (GWSOE) network, comprises 71 boreholes (Figure 2.3, Appendix 1), sampled quarterly for a wide range of physico-chemical and microbiological variables. A full list of groundwater quality variables monitored, together with details of field and analytical methods, is provided in Appendix 2.

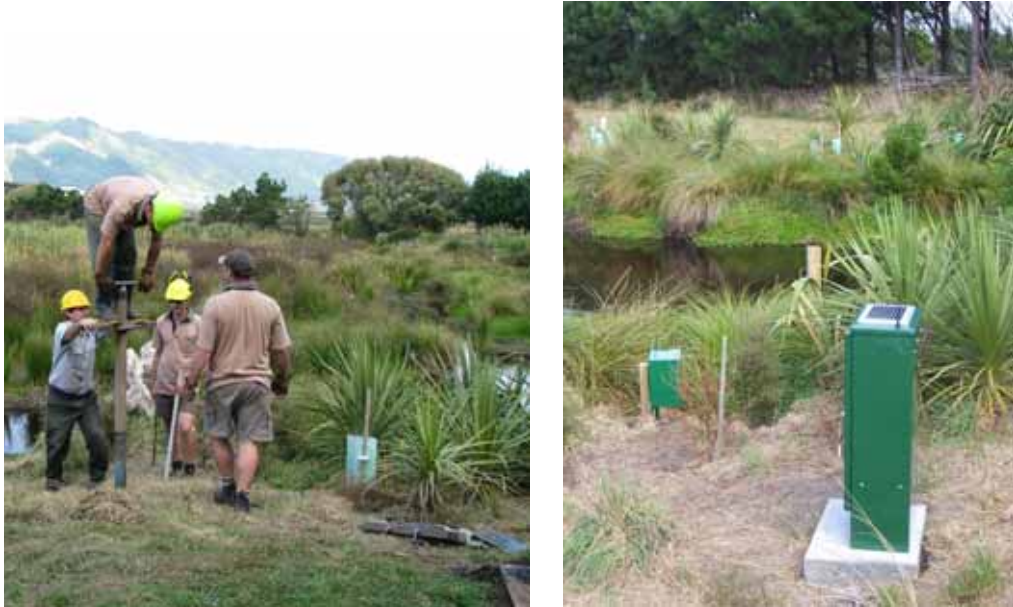
Figure 2.4: Hand-drilling a new borehole next to the Te Hapua wetland on the Kapiti Coast in March 2009 (left) and the final installation, with borehole in the foreground (green box) and wetland staff gauge protruding from open water

- Monitoring equipment was also installed in the Te Hapua wetland on the Kapiti Coast to better understand the relationship between the wetland system and the coastal groundwater aquifers. In March 2009, two new boreholes were drilled (Figures 2.2, 2.4 & 2.5) and two existing boreholes were added to the groundwater level network. In addition, equipment was installed to monitor water levels in the wetland directly. The project is

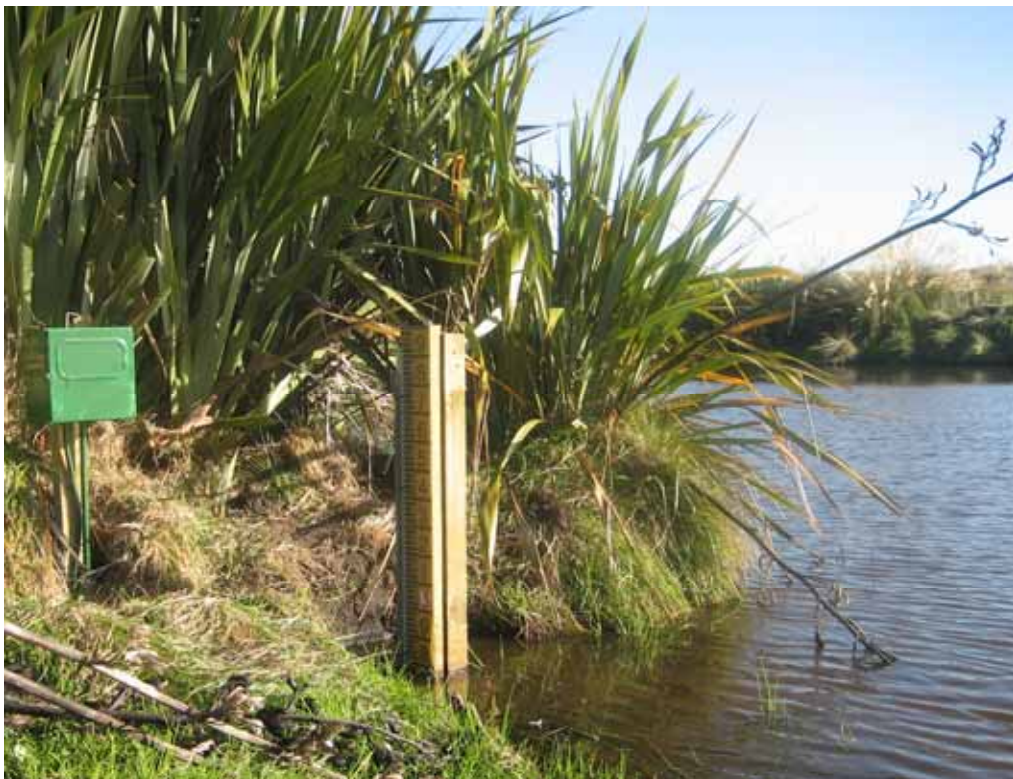
Figure 2.5: Wetland water level gauge installed at Te Hapua wetland on the Kapiti Coast

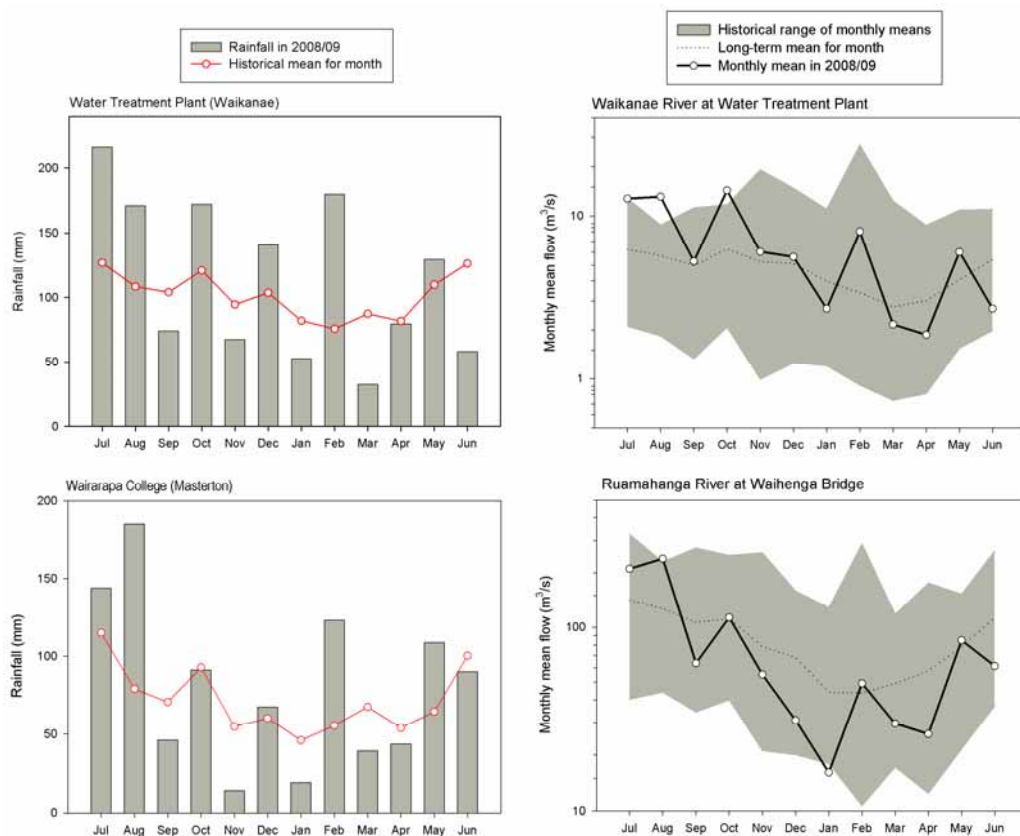
Figure 3.1: Left – monthly rainfall totals for 2008/09 (grey bars) compared to historical mean monthly rainfall (red line) at two rainfall monitoring locations in the Wellington region. Right – monthly mean river flows for 2008/09 (black line) compared to historical mean monthly rainfall (dotted line) for the Waikanae and Ruamahanga rivers (grey area represents the range of historical monthly mean river flows).

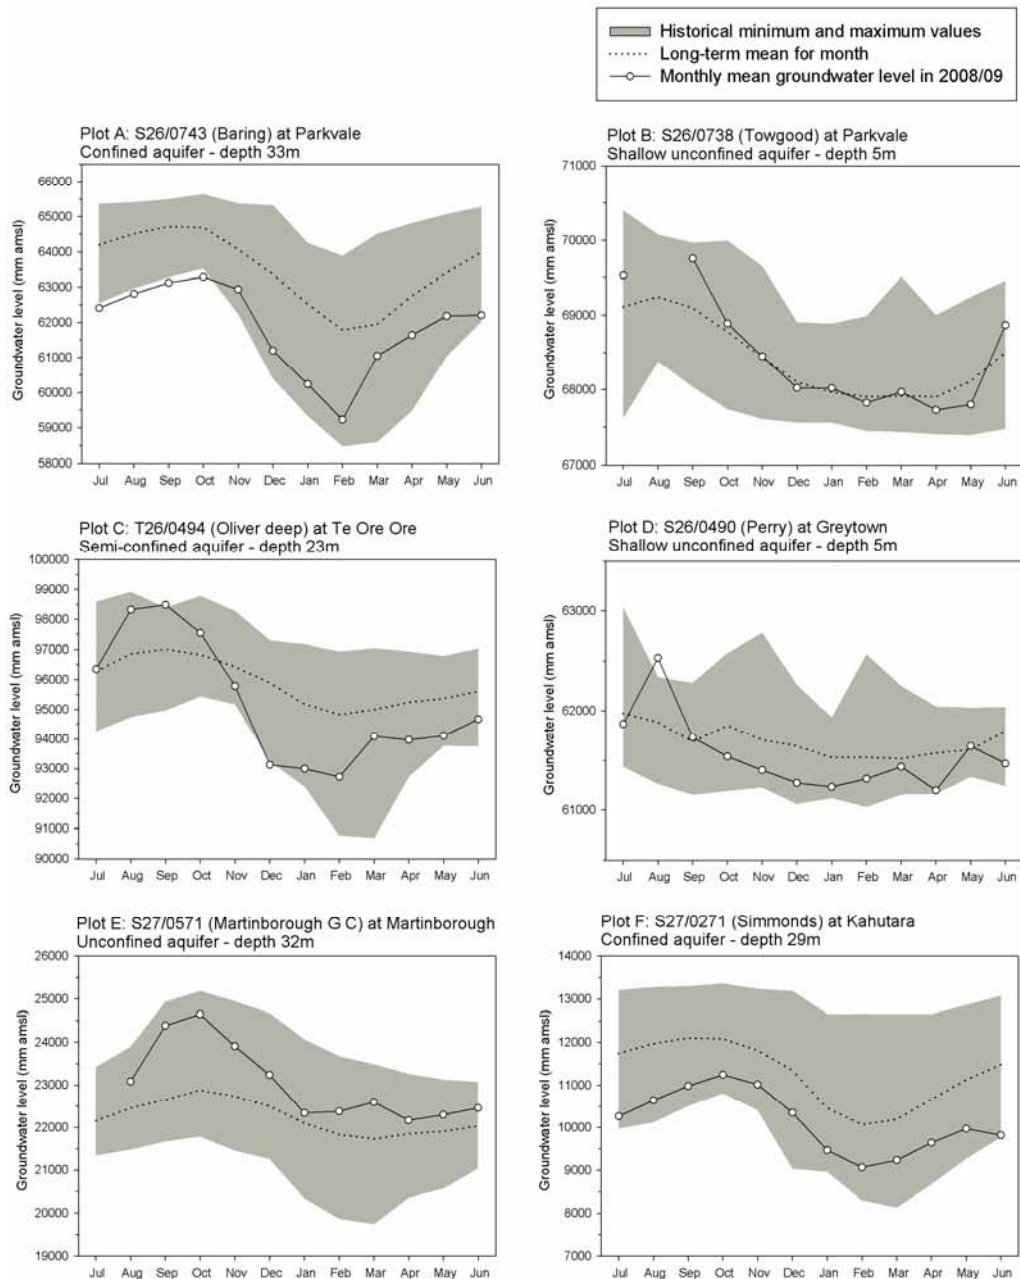
Figure 3.2: Monthly mean groundwater levels for 2008/09 (black line) compared to historical mean monthly groundwater levels (dotted line) at selected sites in the Wairarapa. The grey shaded areas represent the range of historical minimum and maximum monthly mean groundwater levels.

plots (Figures 3.2-3.3), with groundwater levels in a number of the boreholes around or above average.

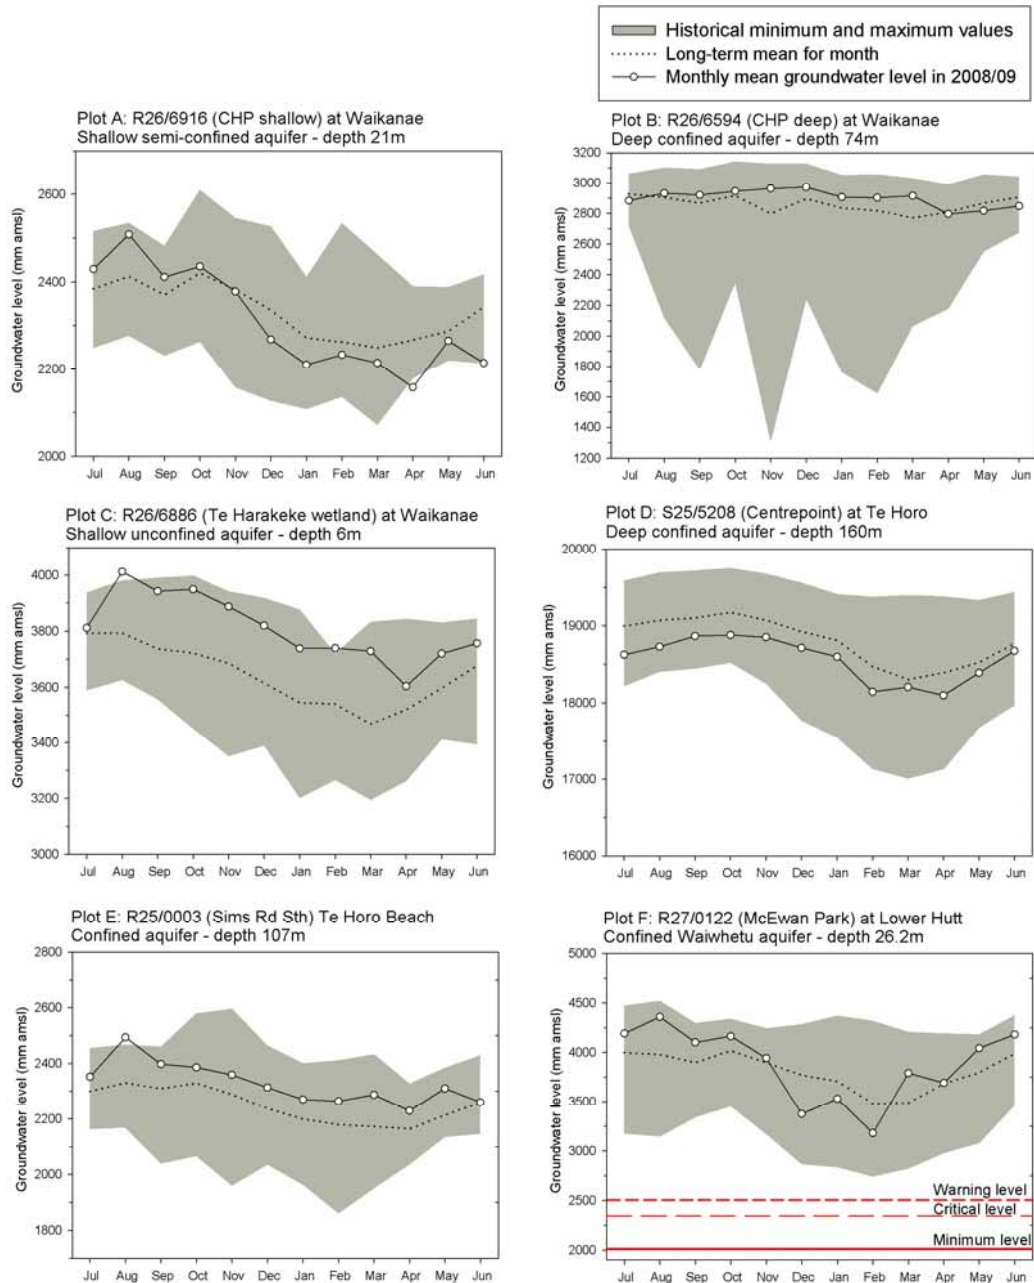
Figure 3.3: Monthly mean groundwater levels for 2008/09 (black line) compared to historical mean monthly groundwater levels (dotted line) at selected sites in Kapiti and Lower Hutt. The grey shaded areas represent the range of historical minimum and maximum monthly mean groundwater levels.

An average year in terms of groundwater levels occurred in the Lower Hutt aquifer system. Levels were well above warning levels for saline intrusion (Figure 3.3, Plot F).

The Waikanae potable borefield had no significant use during the year and therefore there was no significant associated groundwater level drops in the Waikanae aquifer (Figure 3.3, Plot B). New trigger levels have been developed by Kapiti Coast District Council and Greater Council to further safeguard the Waikanae aquifer during borefield operation. These trigger levels will be in operation during the 2009/10 summer period.

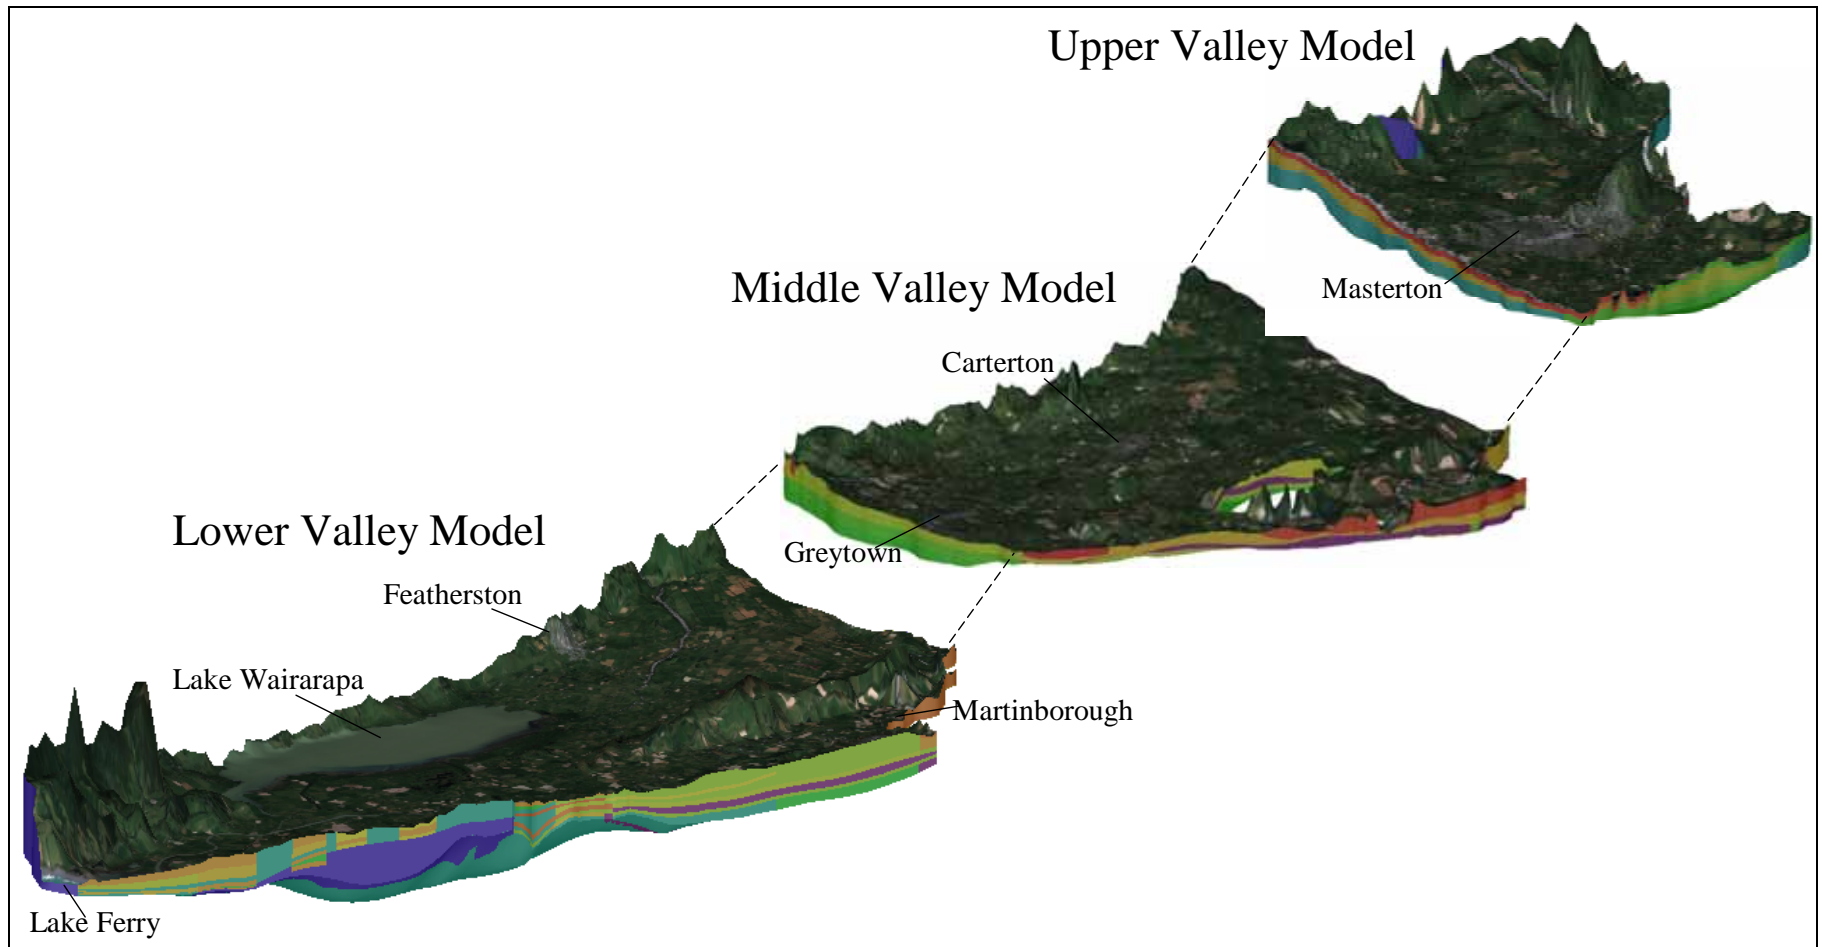
Figure 3.4: Schematic three-dimensional representation of the three modelled Wairarapa groundwater areas. Different groundwater units (aquifers and aquitards) are represented by coloured bands beneath ground level. The vertical axis in this image has been stretched by 25 times. The Wairarapa was separated into the three areas based on hydraulic flow divides at the Waingawa River and south of Greytown.

As reported by McAlister & Tidswell (2008), the Wairarapa groundwater investigation was initiated in response to increasing demand for groundwater for irrigation in the Wairarapa over the last decade and a need to review the allocation limits. Significant progress has been made over the last year, with computer models developed for the lower, middle and upper sections of the Wairarapa Valley (Figure 3.4). The models, which simulate the groundwater and surface water environment, are in their final calibration and reporting phase.

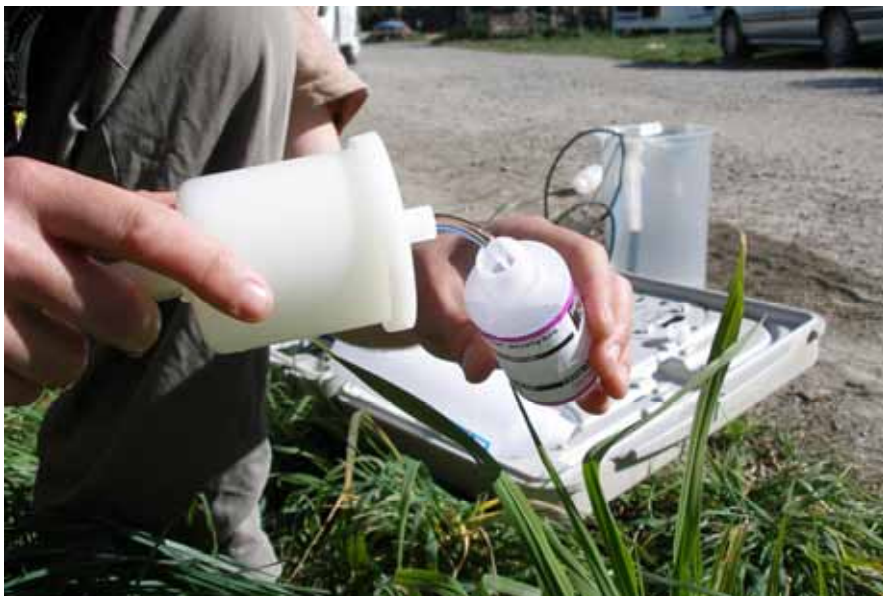
Figure 4.1: Filtering a sample during routine groundwater monitoring

As outlined in subsection 2.2, Greater Wellington routine groundwater quality monitoring involves quarterly sampling of 71 boreholes across the region (Figure 4.1). With only four sets of sampling results per year, a comprehensive evaluation of all of the data is not undertaken on an annual basis. Therefore comments in this report are restricted to two key indicators of groundwater contamination arising from landuse intensification and/or on-site wastewater disposal: nitrate-nitrogen (nitrate) and *Escherichia coli* (*E. coli*) bacteria. In addition, the results of one-off testing for a small number of heavy metals and metalloids in groundwater samples from all 71 boreholes are summarised in this section.

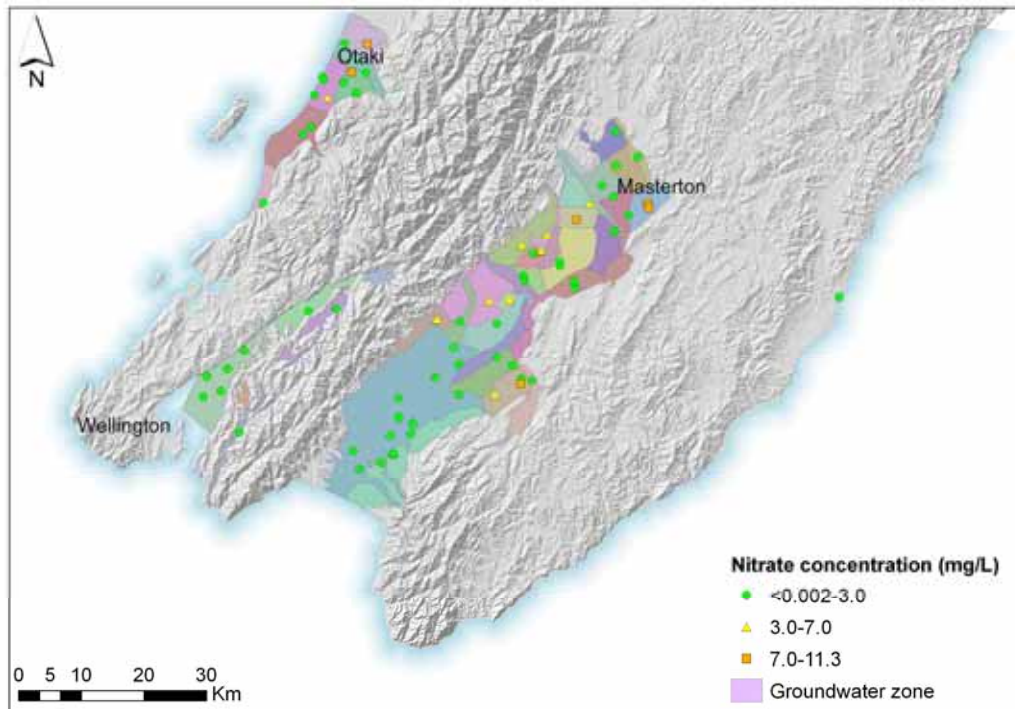
Figure 4.2: Median nitrate nitrogen concentrations recorded in GWSOE monitoring boreholes sampled over 2008/09

Based on median values recorded over 2008/09, 11 of 71 (15.5%) GWSOE boreholes recorded elevated (3–7 mg/L)⁹ concentrations of nitrate (Figure 4.2). A further six boreholes in Kapiti and the upper Wairarapa Valley recorded median nitrate concentrations in the relatively high range (7–11.3 mg/L). Groundwater samples from three of these boreholes exceeded the Ministry of Health Drinking Water Standards (DWSNZ 2005) maximum acceptable value (MAV) of 11.3 mg/L on one sampling occasion. The highest nitrate concentration recorded was 16 mg/L in borehole T26/0538. Nitrate concentrations of 12 mg/L were recorded in boreholes S26/0223 and T26/0489. All three boreholes are located in the upper Wairarapa Valley. Only borehole S26/0223 is used for potable water supply.

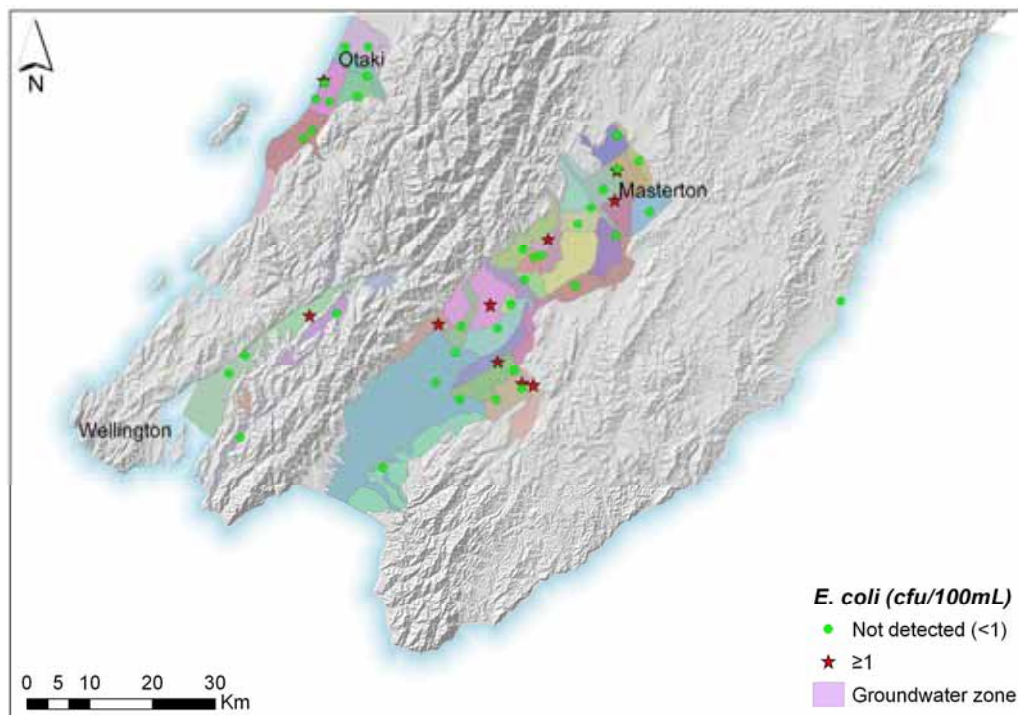
Figure 4.3: Detection (on one or more sampling occasions) of *E. coli* bacteria in GWSOE boreholes sampled quarterly over 2008/09

E. coli was detected in 10 boreholes on 13 occasions during four rounds of GWSOE sampling over 2008/09 (Figure 4.3). The highest *E. coli* count was 3,000 cfu/100mL (R25/5164) at Te Horo Beach in the Coastal Zone of Kapiti. Te Horo Beach is a small settlement reliant on onsite wastewater treatment systems for effluent disposal. Previous studies involving dry tracer tests have confirmed that groundwater at Te Horo Beach is able to move from wastewater

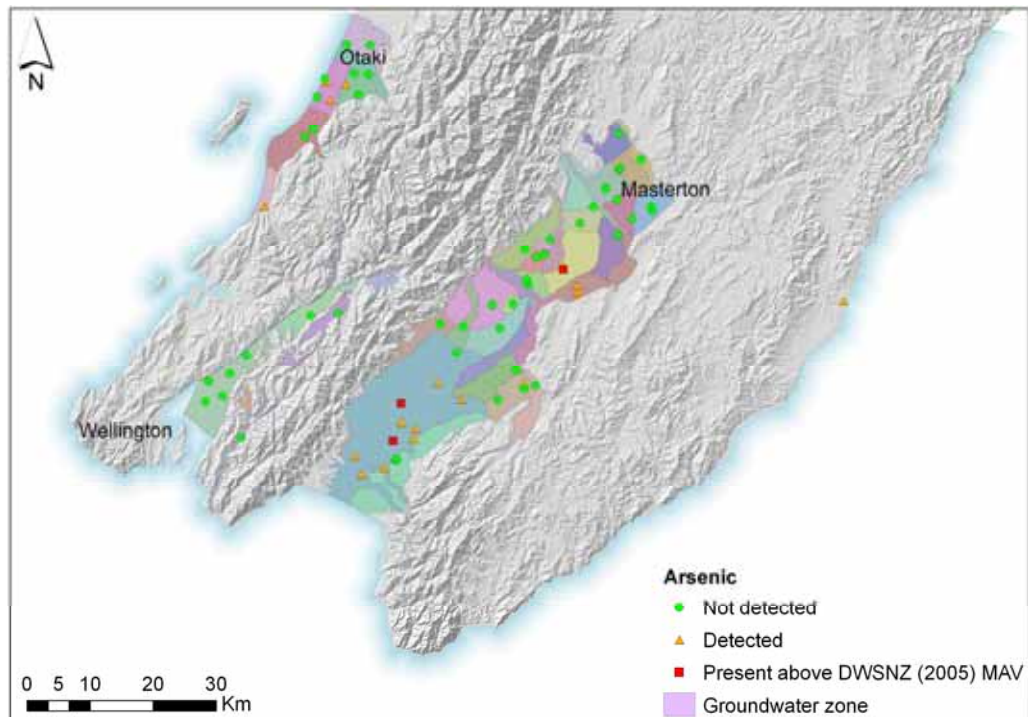
Figure 4.4: Dissolved arsenic concentrations recorded in GWSOE samples collected in March 2009

Arsenic was detected in samples from 20 boreholes, with concentrations in three non-potable boreholes (38-44 m deep) in the Wairarapa Valley exceeding the DWSNZ (2005) MAV of 0.02 mg/L (Figure 4.4). In general the boreholes arsenic was found in were greater than 10m deep, and were in the Wairarapa Valley and on the Kapiti Coast. There were two exceptions; low concentrations of arsenic were detected in shallow coastal boreholes at Riversdale and Te Horo Beach.
